**CEL Quality Services Ltd
GENERAL PRESSURE VESSEL INFORMATION**

Job 10.180239

District: Grande Prairie, AB		Skid No.					
Facility: Came from KEYERA LSD 09-06-63-25 W5M		Location (LSD): NTL Pipeline Storage Yard					
Vessel Name Equipment Number: LPG Storage Bullet // V-2-18A							
Orientation: Horizontal							
Status: In Service		Regulatory Inspection					
PRESSURE VESSEL NAMEPLATE DATA							
"A" or "G" or "S" (Sask.) or BC Registration Number. A0094591		CRN Number B 6331.2					
Vessel serial number: C 5427		Size: 130 in x 60 ft					
Shell thickness: 25.4 mm		Shell material: SA 516 70					
Head thickness: 17.5 mm		Head material: SA 516 70					
Tube wall thickness:		Tube material:					
Tube diameter:		Tube length:					
Channel thickness:		Channel material:					
Design pressure	Shell: 1724 kpa	Design pressure	Shell:				
	Tubes:		Tubes:				
Design Temp.	Shell: 121 Deg C	Design Temp.	Shell:				
	Tubes:		Tubes:				
X-ray: RT 1		Heat treatment: HT					
Code parameters: ASME VIII / Div 1		Coated: No

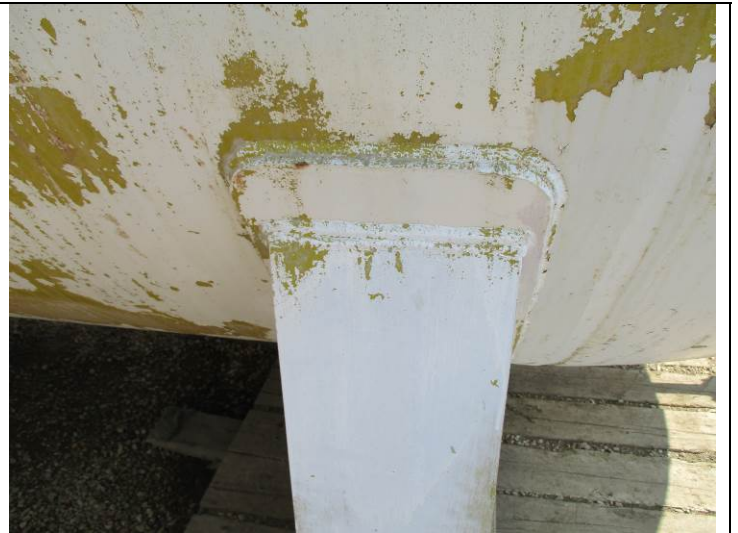
Saddle to shell

External Inspection Items	G	F	P	N/A	Comments
Insulation Verify sealed around manways, nozzles, no damage present, and there is no egress of moisture.				X	Vessel not insulated.
External Condition Assess paint condition, areas peeling, record any corrosion, damage, etc (record location, size and depth of corrosion or damage)		X			Paint in fair condition – Flaking and peeling off with oxidized surface to 30% of area.
Leakage Record any leakage at flanges, threaded joints, weep holes on repads, etc.	X				No leaks observed.
Saddle/skirt Assess condition of paint, fire protection, and concrete. Look for corrosion, buckling, dents, etc. Look at vessel surface area near supports. Verify no signs of leakage at attachment to vessel and attachment welds are acceptable. Ground wire attached?	X				Saddles: No buckles or distortion – currently this vessel is not mounted onto supports. No corrosion at saddle to shell area – no previous leaks. No ground attached at this time.

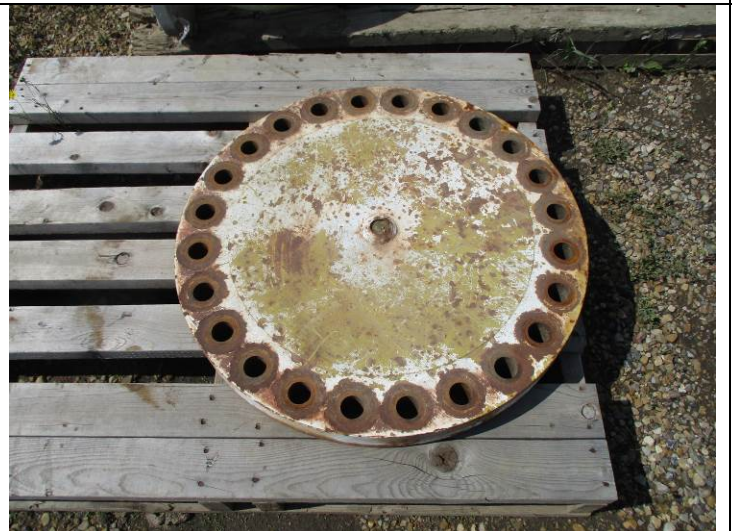
Man way cover

External Piping Ensure pipe is well supported. All clamps, supports, shoes, etc. in place. Look for evidence of structural overload, deflection, etc. Paint condition, external corrosion?				X	Piping is not attached at this time.
Valving Ensure no leaks are visible. Valves are properly supported and chained if necessary.				X	No valves attached.
PSV Ensure PSV is set at pressure at or below that of vessel.				X	No PSV attached at this time.
NDE methods Was UT/ MPI done on vessel (MI coordinator to review results)				X	No external NDE at this time.
Flange faces: Any corrosion – any damage to seating face?				X	No access to flange faces other than man way – no corroded sections of man way – the cover is not on at this time and it was hard to tell if there was any water inside this vessel. All other nozzles have blind flanges installed and could not be viewed.
Recommendations or corrective actions : (Vessel is Fit for Service or describe corrective actions required) (MIC to review corrective actions with Operations, discuss with Chief Inspector where necessary, and get remedial action implemented) Recommendations: 1. Plan for internal inspection to determine if there is any pitting from water. 2. Open flanged connections to view surfaces – to identify any corrosion or pitting. Summary: Currently, this vessel appears in good condition, no distortion to saddles and no corrosion to man way gasket seating face.

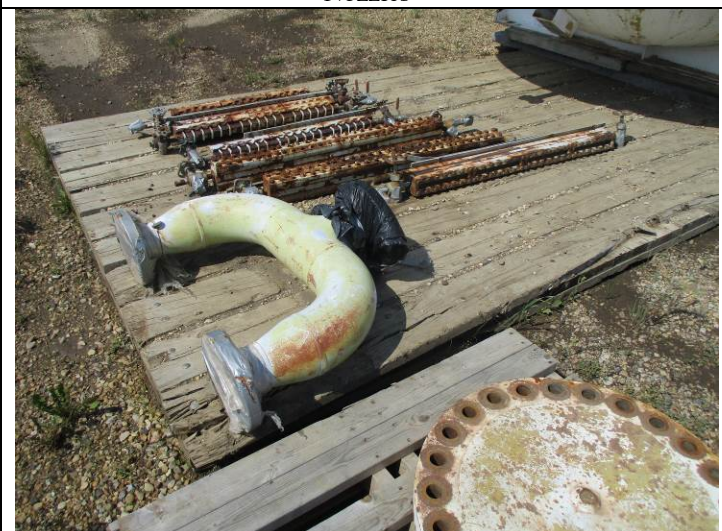
Anchor Bolts Hammer tap to ensure secure. Look for cracking in treads or signs of deformation.	X				This vessel is located in a lay down yard – not bolted to supports at this time.
Concrete foundation Check for cracks, spalling, etc.				X	None
Ladder / Platform Describe general condition, ensure support is secure to vessel, and describe any hazards.		X			Ladder and platform are not attached at this time – both are in good condition – no missing sections.
Nozzle Assess paint, look for leakage, and ensure stud threads are fully engaged. Record any damage, deflection, etc. Are nozzles gusseted?	X				The flanges have not been opened and the piping is not attached at this time. No deflection – no apparent leaks. Nozzles are not gusseted.
Gauges Ensure gauges are visible, working, no leakage, and suitable for range of MAWP/ Temp.				X	Sight glasses have been removed and are lying on a pallet – these are not obstructed.
