Bootis Hill Integrity Management Inc	Installation Inspection	Form No. 001
Revision # 1	Form (Electronic)	Effective Date: 2013-02-18

Owner	Yoho Resources	Location	04-06-087-09W6					
		Field	Worsley					
Vessel Data								
Vessel Description	1 st Stage Suction Scrubber	PWHT	NO					
Manufacturer	Henry Technologies Ltd.	Diameter	12"					
A# / NB#	A0530764	Length	60"					
Serial #	C250106C-4	Radiography (RT)	2					
CRN#	R6017.231	Corrosion Allowance						
Date Built	2005	Shell Thickness						
MAWP	655 PSI	Shell Material						
MAWT	300 ° F	Head Thickness						
MDMT (-29C)	-20 ° F	Head Material						
	PSV	Data						
P	SV #1		PSV #2					
PSV Location	Vessel Shell	PSV Location						
Manufacturer(s)	Farris	Manufacturer(s)						
Serial #	Missing Nameplate	Serial #						
CRN#		CRN#						
Model #		Model #						
Set Pressure	PSI	Set Pressure						
Capacity	scfm	Capacity						
Service or Built Date		Service or Built Date						
Service Company		Service Company						
Inlet Size	1"	Inlet Size						
Outlet Size	1"	Outlet Size						
Inlet Type	Threaded	Inlet Type

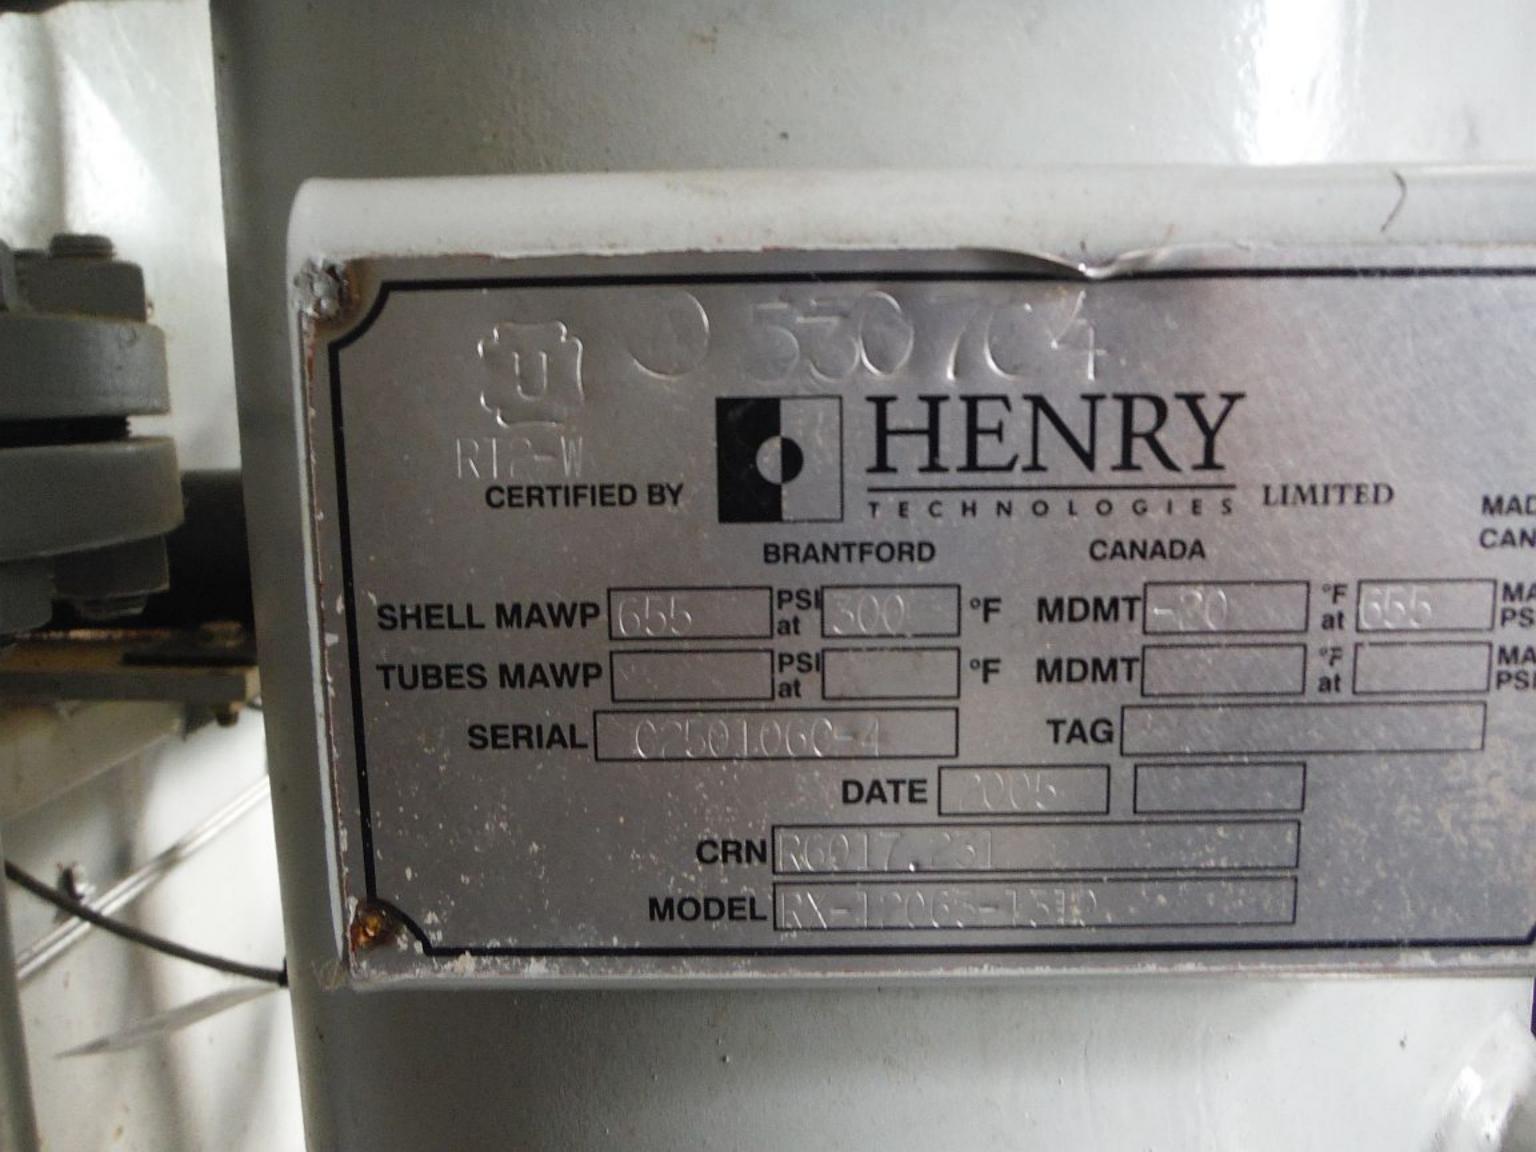
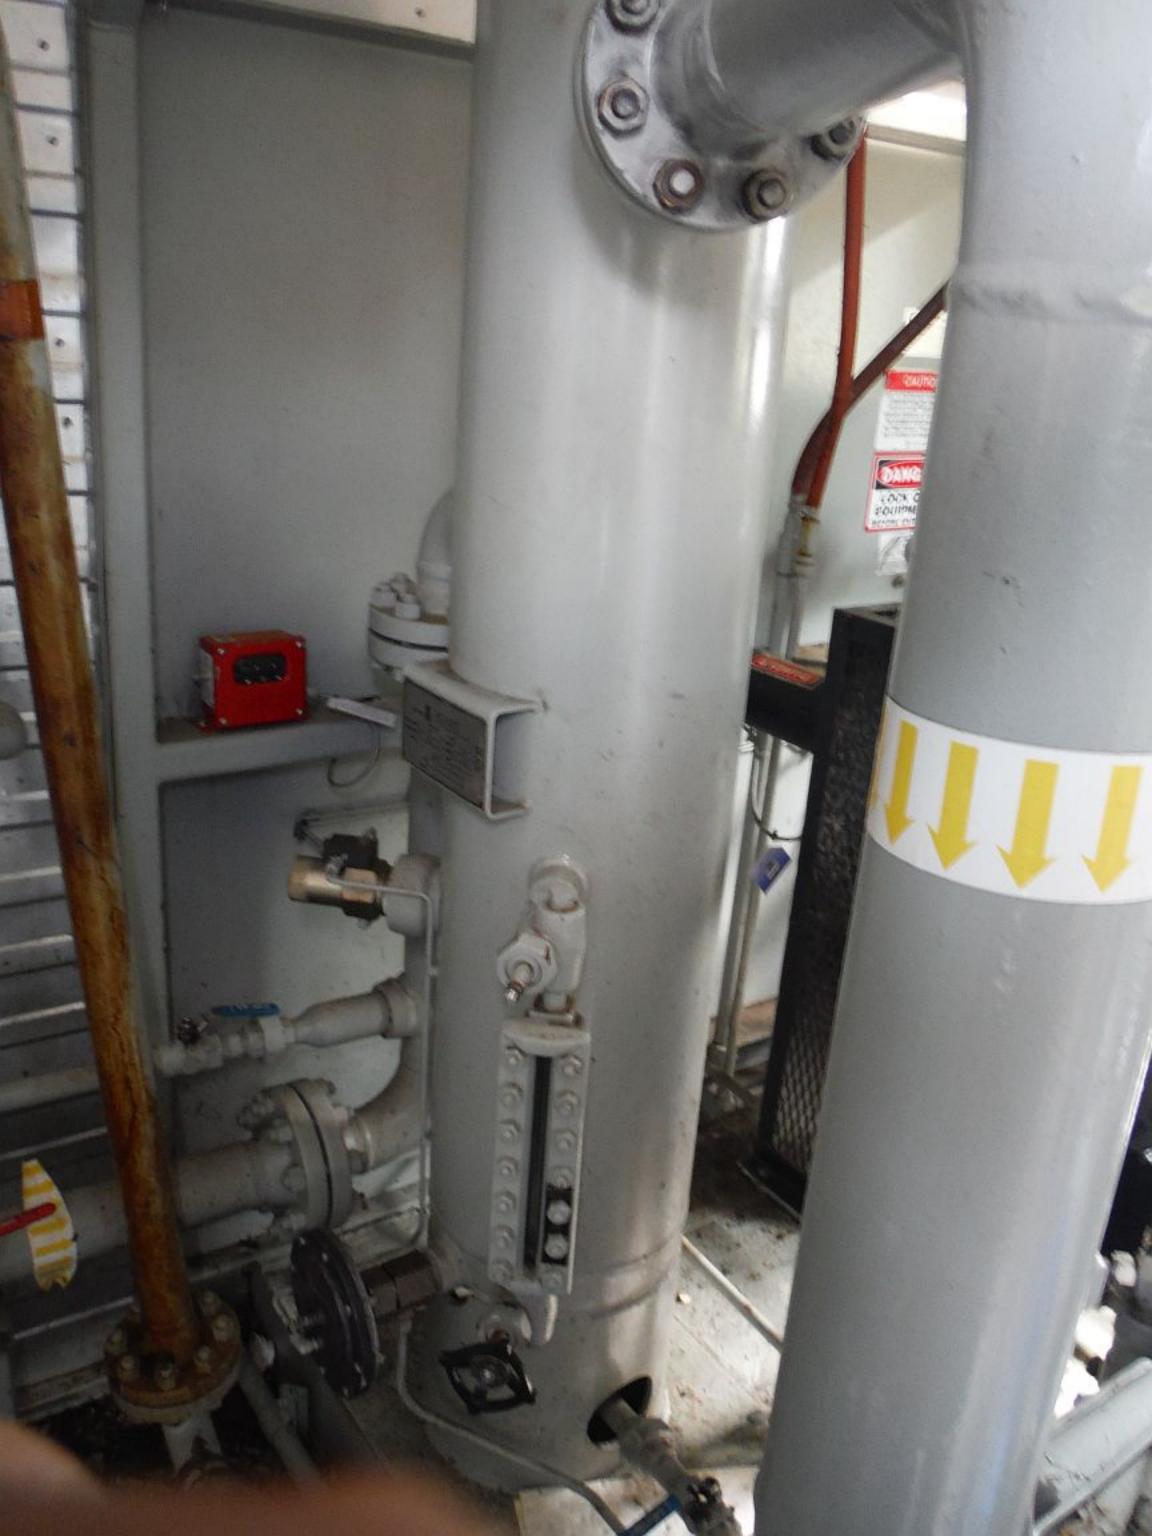
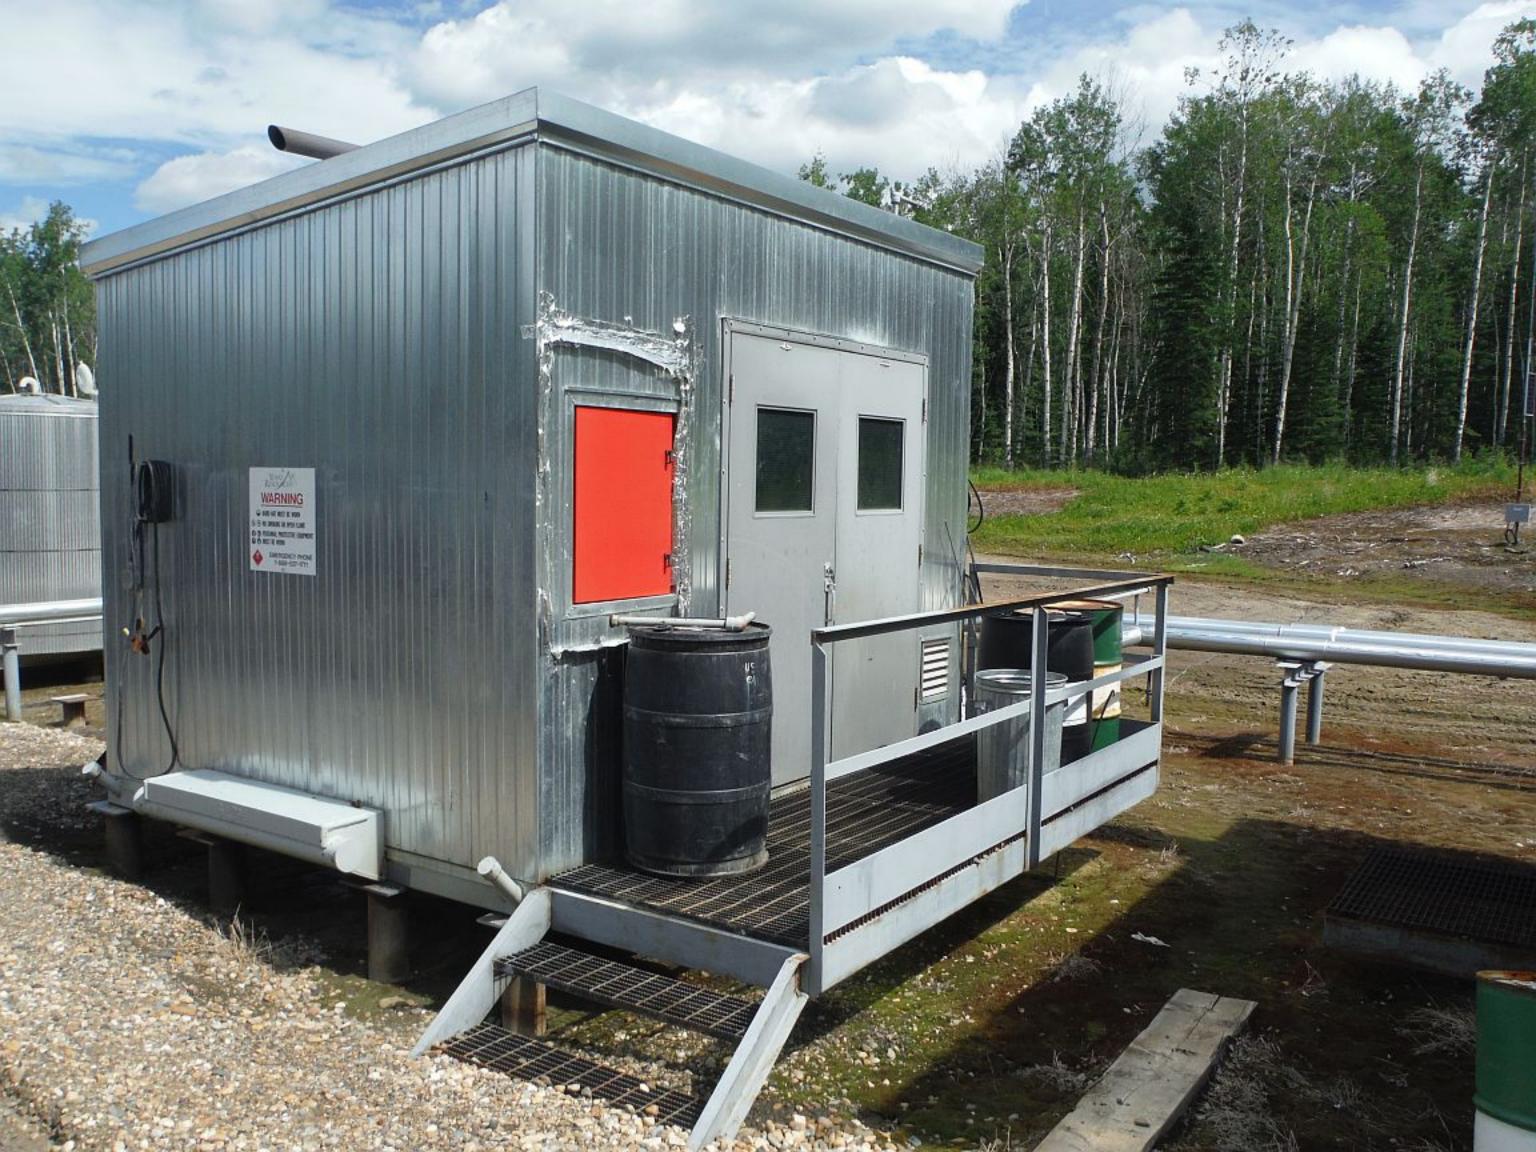
The vessel is located inside a building. The nameplate is legible and secure. The vessel is identified by an A-number and a serial number stamped on the nameplate. The heads, shell, nozzles, and bolting appear in good condition. There is no damage or distortion evident. There appears to be no stress to piping or to nozzle connections. The vessel is supported by a full skirt and is bolted to skid. The skid is welded to pilings and there is minimal risk of shifting. The vessel is fully painted and the paint has not deteriorated. There is no external corrosion or pitting. The vessel does not have structural attachments. The vessel is considered fit for continued service under present conditions.

The associated piping appears in generally good condition. There is no damage or distortion on piping. The piping is

supported adequately by clamps. The primary piping is mainly threaded. The piping is fully painted and the paint is in good condition. There is no external corrosion or pitting on piping.

PSV was located on vessel piping and is in the vertical plane. PSV could not be verified set at or below the MAWP of vessel. PSV does require calibration as per AB-506. PSV nameplate missing and must be found and reattached. Seal wires intact and secure, valve well supported with no body damage noted. Service report has not been reviewed. No valves in the critical path. No internal inspection of the valve was completed. PSV condition unsatisfactory and is not considered fit for continued service under present conditions. PSV must be serviced or replaced prior to being returned to service.
