Bootis Hill Integrity Management Inc	Installation Inspection	Form No. 001
Revision # 1	Form (Electronic)	Effective Date: 2013-02-18

Owner	Yoho Resources	Location	04-06-087-09W6			
	·	Field	Worsley			
	Vess	el Data				
Vessel Description	2 <sup>nd</sup> Stage Suction Scrubber	PWHT	NO			
Manufacturer	Henry Technologies Ltd.	Diameter	12"			
A# / NB#	A0530765	Length	60"			
Serial #	C250106D-4	Radiography (RT)	2			
CRN#	R6017.231	Corrosion Allowance				
Date Built	2005	Shell Thickness				
MAWP	655 PSI	Shell Material				
MAWT	300 ° F	Head Thickness				
MDMT (-29C)	-20 ° F	Head Material				
	PSV	<b>Data</b>	·			
	PSV #1		PSV #2			
PSV Location	Vessel Shell	PSV Location				
Manufacturer(s)	Farris	Manufacturer(s)				
Serial #	Missing Nameplate	Serial #				
CRN#		CRN#				
Model #		Model #				
Set Pressure	PSI	Set Pressure				
Capacity	scfm	Capacity				
Service or Built Date		Service or Built Date				
Service Company		Service Company				
Inlet Size	1"	Inlet Size				
Outlet Size	1"	Outlet Size				
Inlet Type	Threaded	Inlet Type				
Outlet Type	Threaded	Outlet Type

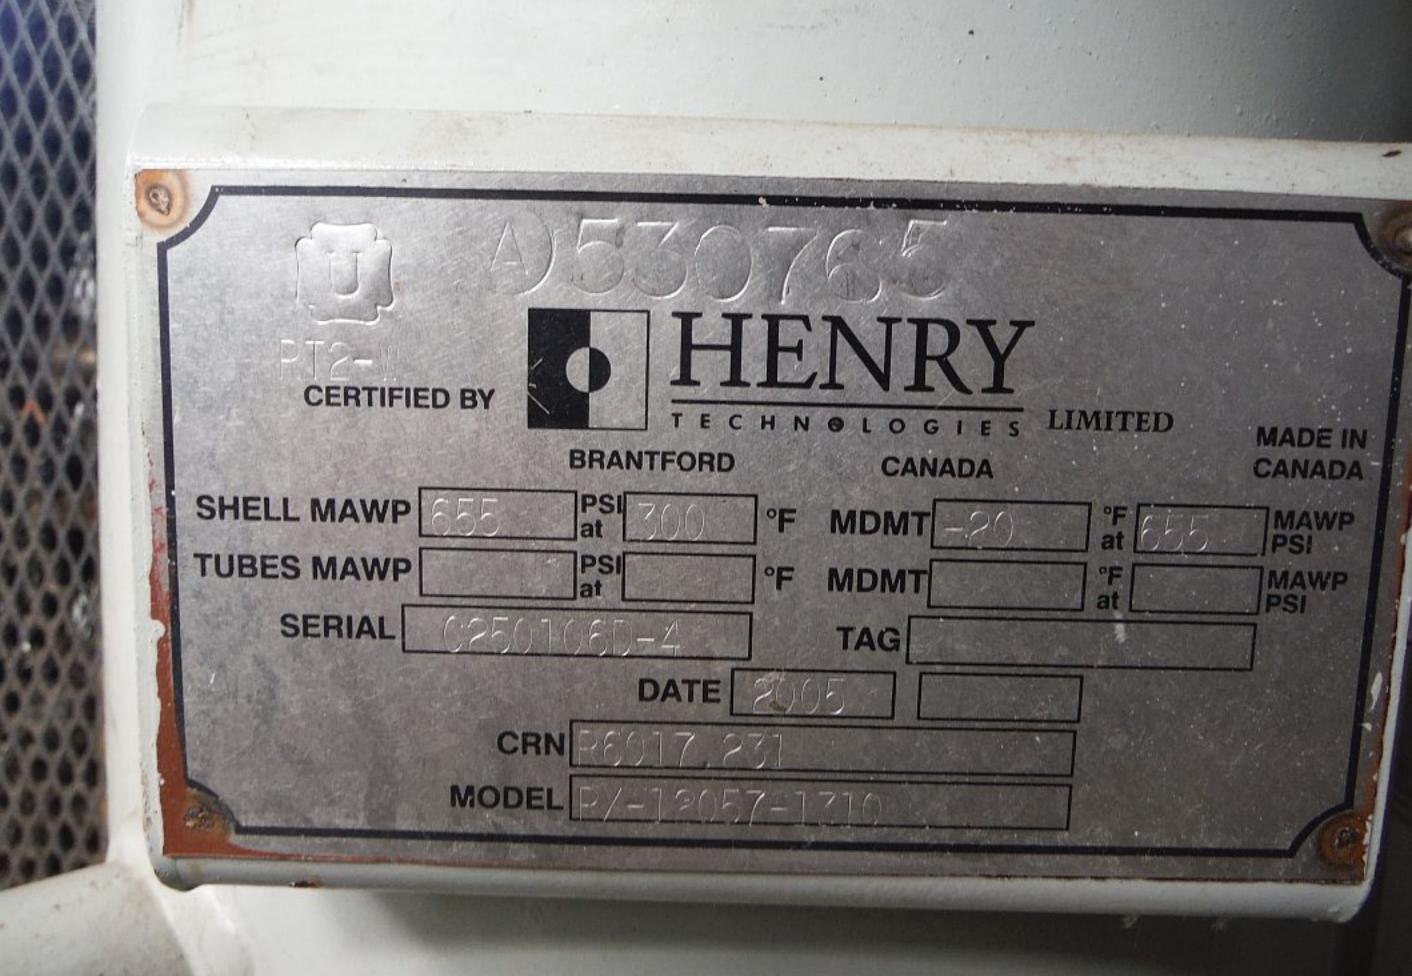
The vessel is located inside a building. The nameplate is legible and secure. The vessel is identified by an A-number and a serial number stamped on the nameplate. The heads, shell, nozzles, and bolting appear in good condition. There is no damage or distortion evident. There appears to be no stress to piping or to nozzle connections. The vessel is supported by a full skirt and is bolted to skid. The skid is welded to pilings and there is minimal risk of shifting. The vessel is fully painted and the paint has not deteriorated. There is no external corrosion or pitting. The vessel does not have structural attachments. The vessel is considered fit for continued service under present conditions. Piping:

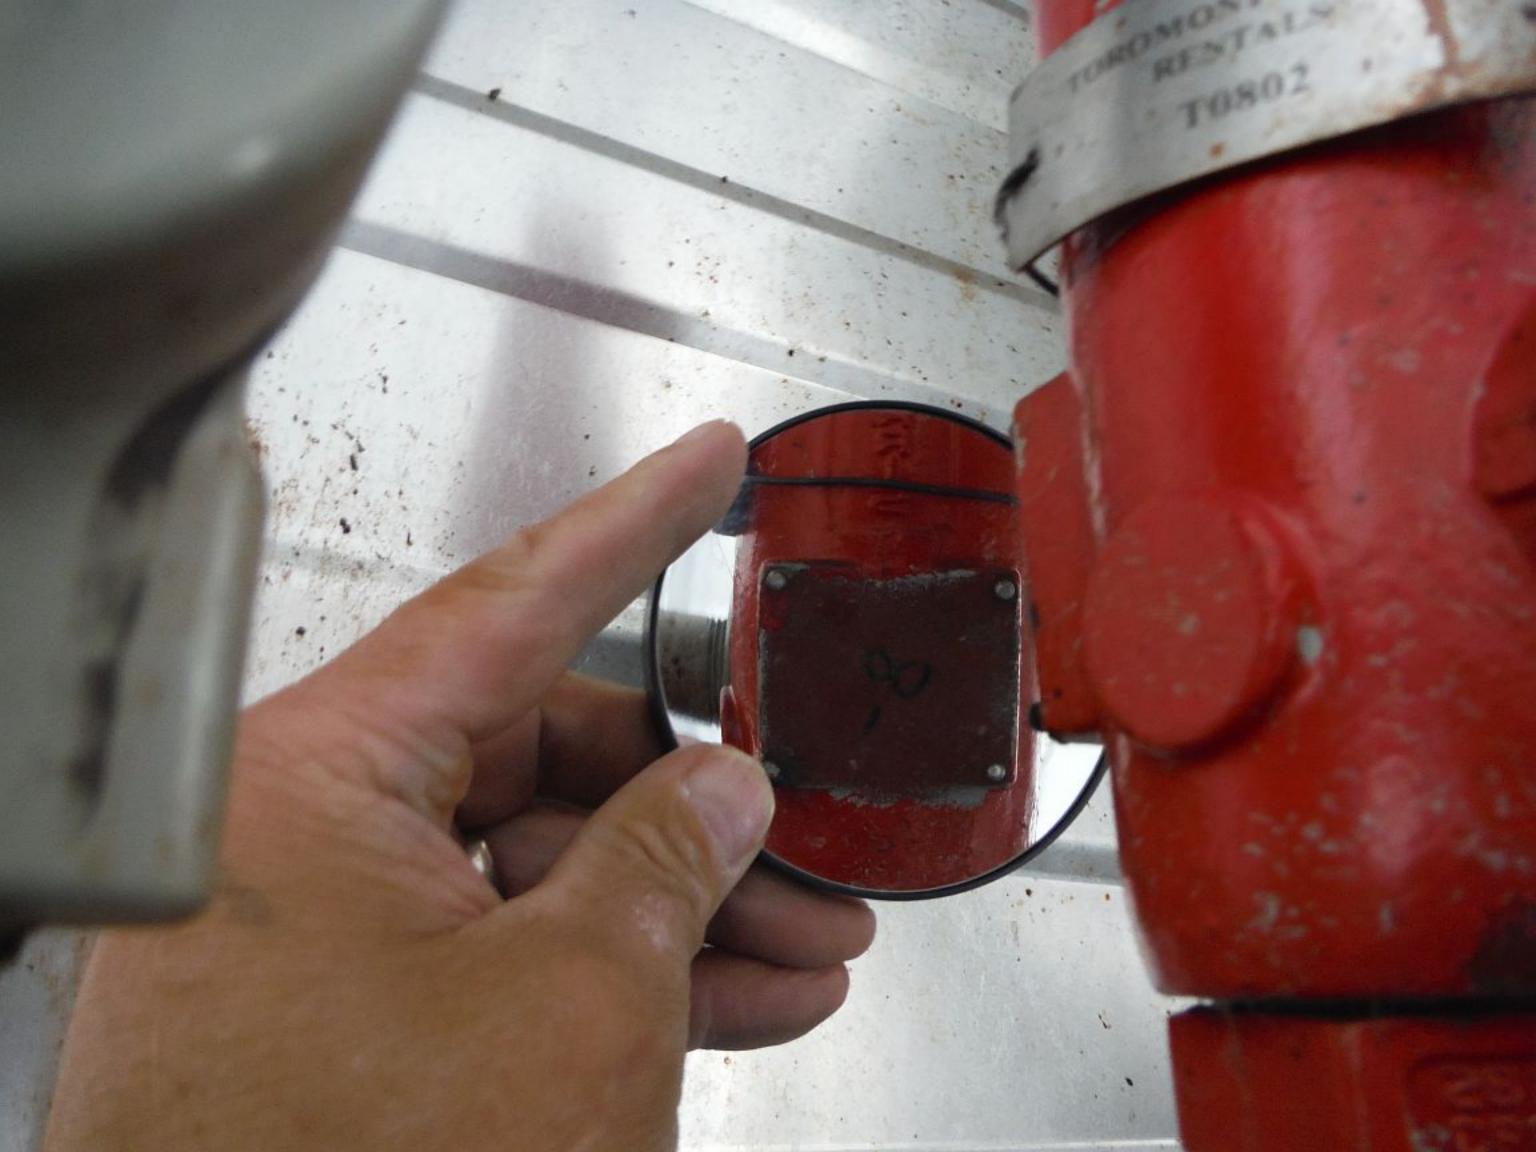
PSV was located on vessel piping and is in the vertical plane. PSV could not be verified set at or below the MAWP of vessel. PSV does require calibration as per AB-506. PSV nameplate missing and must be found and reattached. Seal wires intact and secure, valve well supported with no body damage noted. Service report has not been reviewed. No valves in the critical path. No internal inspection of the valve was completed. PSV condition unsatisfactory and is not considered fit for continued service under present conditions. PSV must be serviced or replaced prior to being returned to service.
