Bootis Hill Integrity Management Inc	Installation Inspection	Form No. 001
Revision # 1	Form (Electronic)	Effective Date: 2013-02-18

Owner	Yoho Resources	Location	04-06-087-09W6
		Field	Worsley
	Ve	ssel Data	
Vessel Description	1 st Stage Cooler	PWHT	NO
Manufacturer	air-x-changers	Diameter	
A# / NB#	A0530766	Length	
Serial #	054063.2D	Radiography (RT)	
CRN #	R5817.231	Corrosion Allowance	
Date Built	2005	Shell Thickness	
MAWP	655 PSI	Shell Material	
MAWT	300 ° F	Head Thickness	
MDMT (-29C)	-20 ° F	Head Material	
	P	SV Data	
	PSV #1		PSV #2
PSV Location	Vessel Shell	PSV Location	
Manufacturer(s)	Farris	Manufacturer(s)	
Serial #	Missing Nameplate	Serial #	
CRN #		CRN #	
Model #		Model #	
Set Pressure	PSI	Set Pressure	
Capacity	scfm	Capacity	
Service or Built Date		Service or Built Date	
Service Company		Service Company	
Inlet Size	1"	Inlet Size	
Outlet Size	1"	Outlet Size	
Inlet Type	Threaded	Inlet Type	
Outlet Type	Threaded	Outlet Type	
PSV Outlet Trapped	NO	PSV Outlet Trapped	
PSV Inlet Restricted	NO	PSV Inlet Restricted	
PSV Outlet Restricted	NO	PSV Outlet Restricted

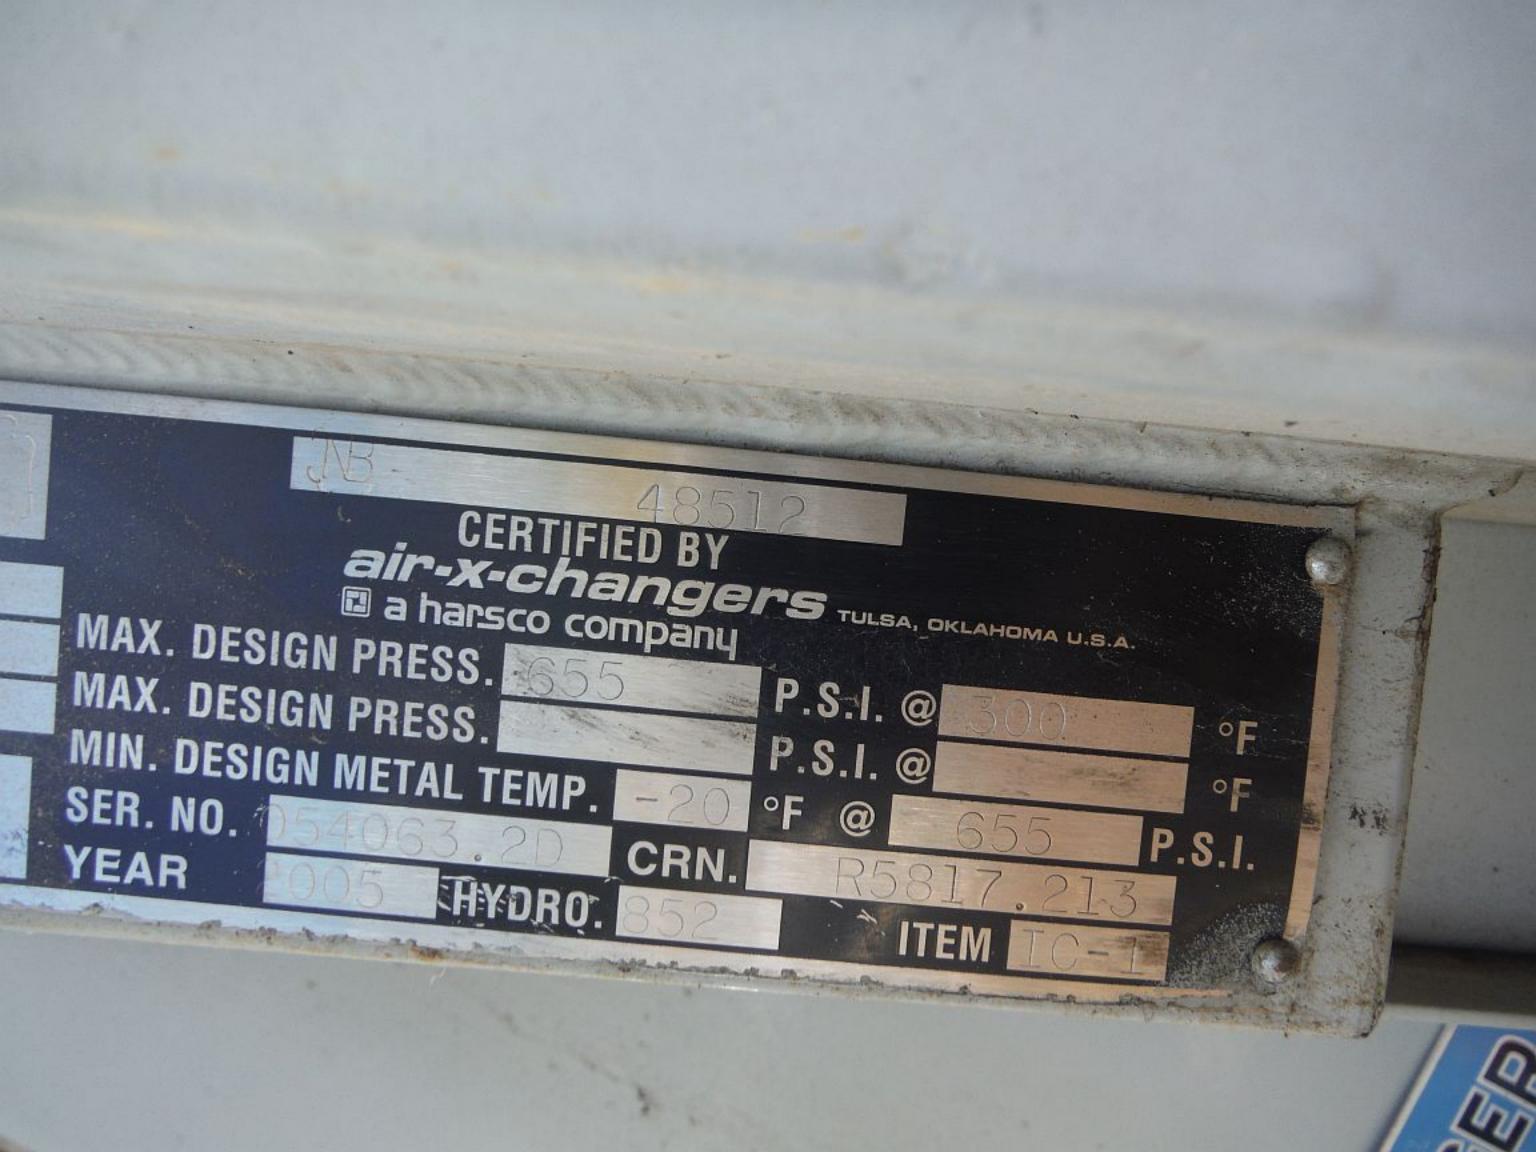
The vessel is located outside a building. The nameplate is legible and secure. The vessel is identified by an A-number stamped on the shell and a serial number stamped on the nameplate. The heads, shell, nozzles, and bolting appear in good condition. There is no damage or distortion evident. There appears to be no stress to piping or to nozzle connections. The vessel is supported by a structure and is bolted to skid. The skid is welded to pilings and there is minimal risk of shifting. The vessel is fully painted and the paint has not deteriorated. There is no external corrosion or pitting. The vessel does not have structural attachments. The vessel is considered fit for continued service under present conditions. Piping:
