ULTRASONIC EXAMINATION REPORT (Tank)

REPORT No.: **UT - 2-2865 - 01 - AAC**

Client: Enerplus Corporation
 District: Shallow Gas: Shackleton LSD: 12-26-021-20W3M
 Facility: Lancer
 Item(s) Examined: 750 BBL Tank Internal Corrosion Survey
 Acceptance Criteria: For Client Review Rev. / Date: N/A
 Procedure No.: ITS UT 02 Rev. / Date: Rev. 1 / Oct. 2011
 Technique No.: 2 Rev. / Date: Rev. 1 / Oct. 2011

SCOPE: To perform a ultrasonic corrosion survey on various sections of Tank SN#7439 in the Lancer area looking for corrosion and wall thinning.

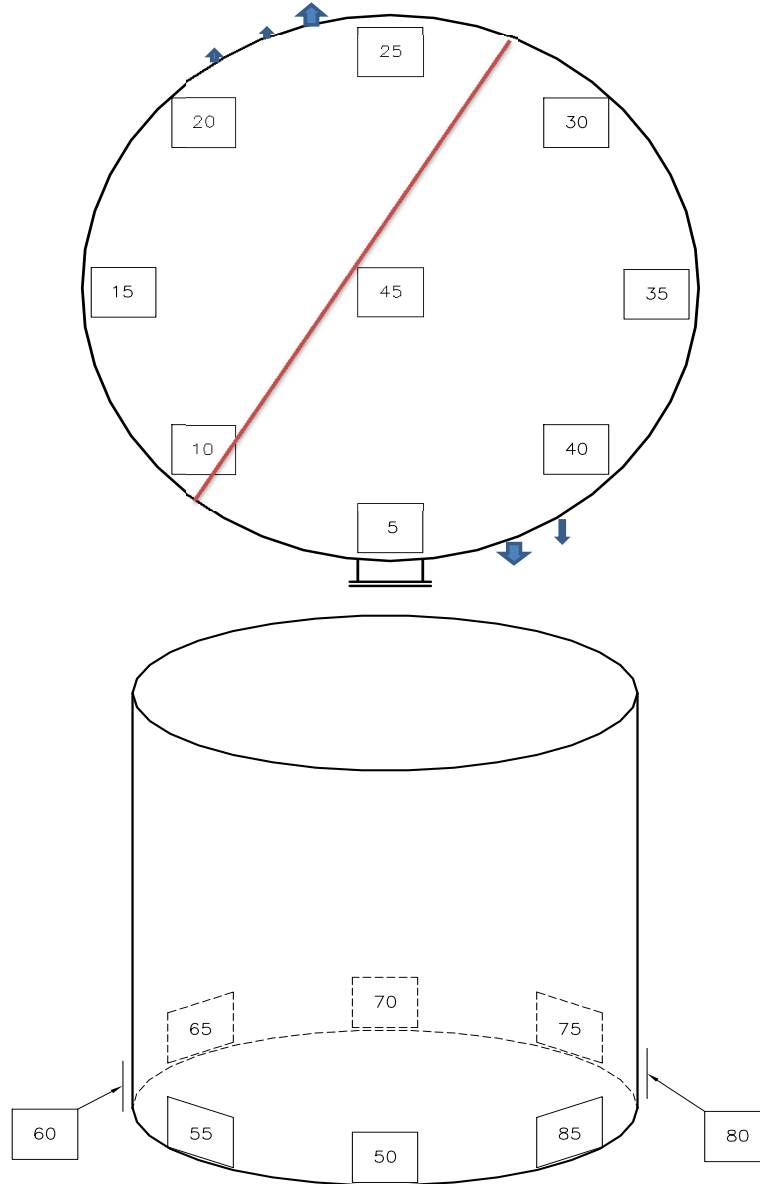
Shell Comments: Corroded area is around nozzle welds down to 4.3 mm.
