**STATIC EQUIPMENT INSPECTION REPORT - Exhibit # 300**

**COMPANY:** Signalta Resources **SIGMA JOB #:** SIG-05-13

District: Forestburg Facility: Forestburg Gas Plant Lsd 13-14-042-16W4 Skid: \_\_\_\_\_

Item Insp.: Inlet Separator

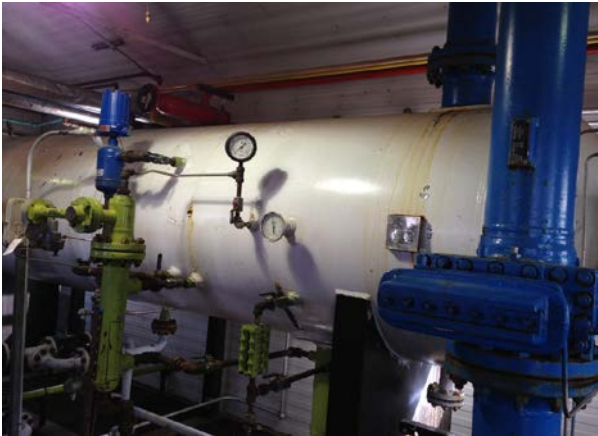
Vessel External in good shape  
Vessel is welded to the floor and is well supported

Overview

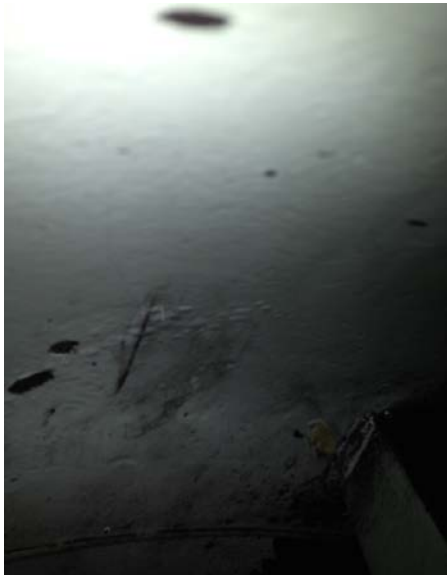
- Vessel had previous coating repair. The previous repair is bubbled and flaking off. There are too many holidays to be repaired by a patch kit.  
- There is no metal loss where there is bare steel

Coating Damage

- Monitor exposed steel and watch for active corrosion. If corrosion becomes an issue, sand bottom half of vessel and recoat

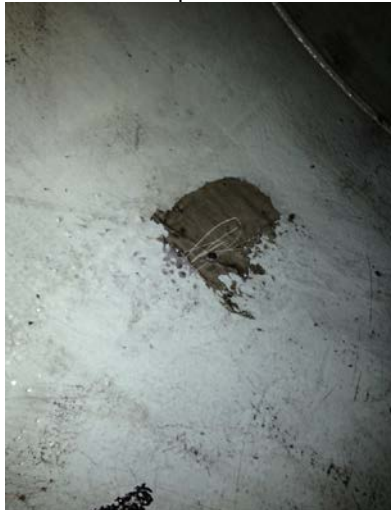
Past Repair

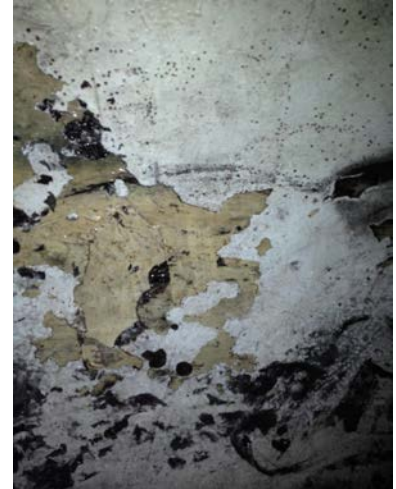
Past Repair

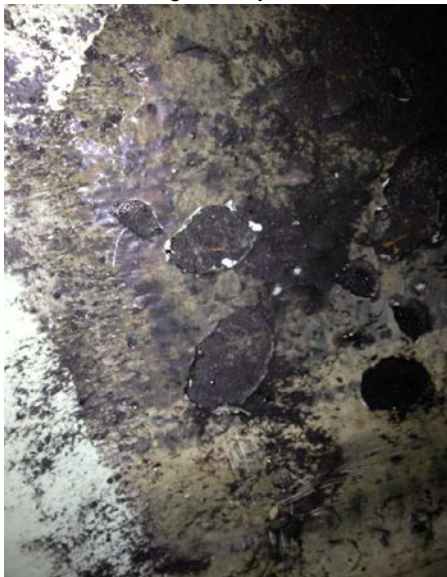
Coating Holidays
