STATIC EQUIPMENT INSPECTION REPORT - Exhibit # 300

COMPANY: Signalta Resources **SIGMA JOB #:** 2843

District: _____ Facility: Forestburg Lsd 13-14-042-16W4M Skid: _____

Item Insp.: Heat Medium Boiler

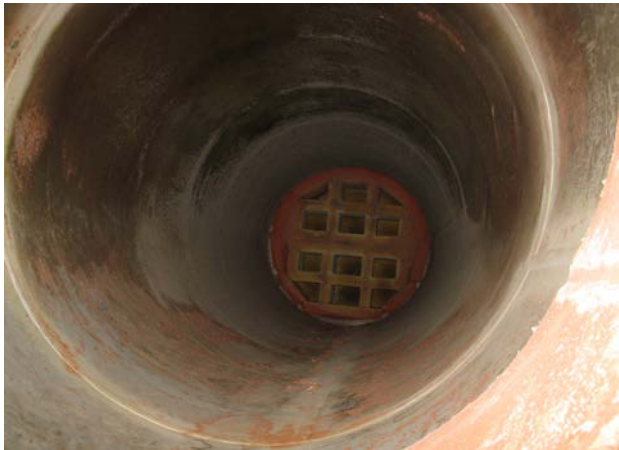
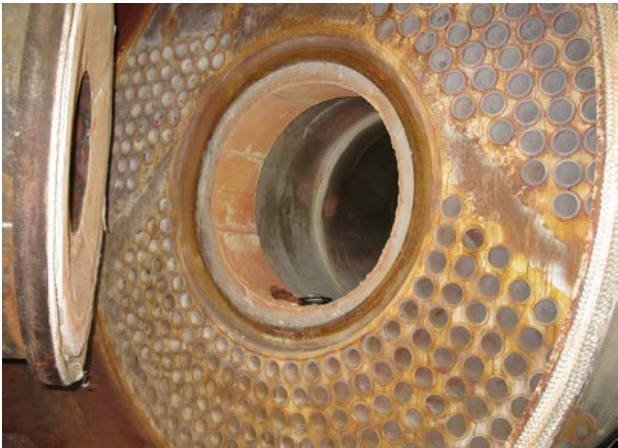
NCR- #001

-Overall vessel is in good condition with no deformation noted.
-Instrumentation piping was calibrated by Saskatoon Boiler in June 2010.
-PSV was serviced in 2005 and then stored on shelf. PSV requires resetting as interval has expired even though PSV was not installed until June 2010.
-Isolation valves under PSV on section 1 boilers is not permitted and needs to be removed. NCR #001-Sigma 3 Engineering (NCR #7996- CEL Quality Services Ltd.)

1. Service PSV.
2. Remove isolation valve from below the PSV.
