June 5, 2019

Re: LPG Bullet at Northland Transport Yard

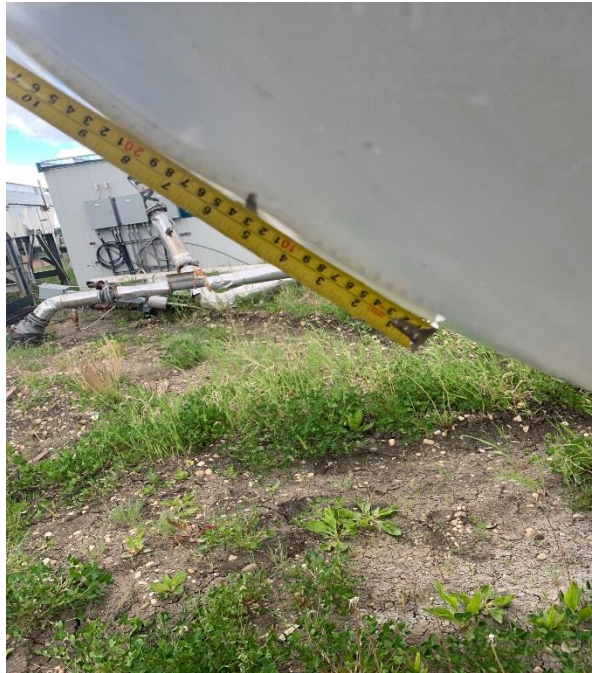
PHOTOGRAPH 1

Depth of deformity shown to be no greater than 4-5 mm as found June 3/19

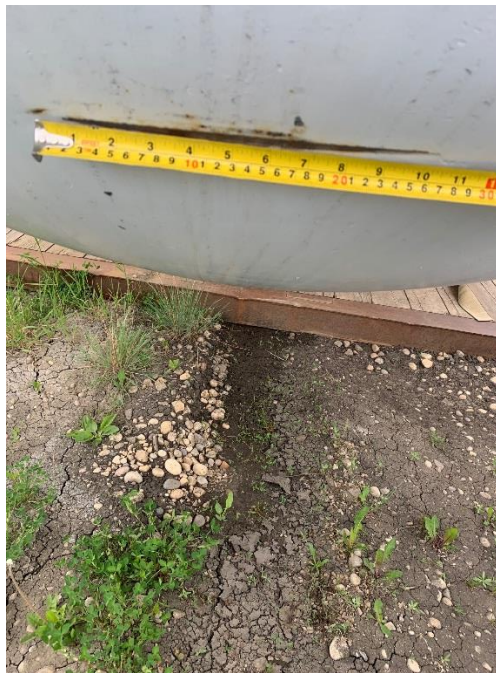
PHOTOGRAPH 2

Length of rub mark shown to be around 10" long. June 3/19

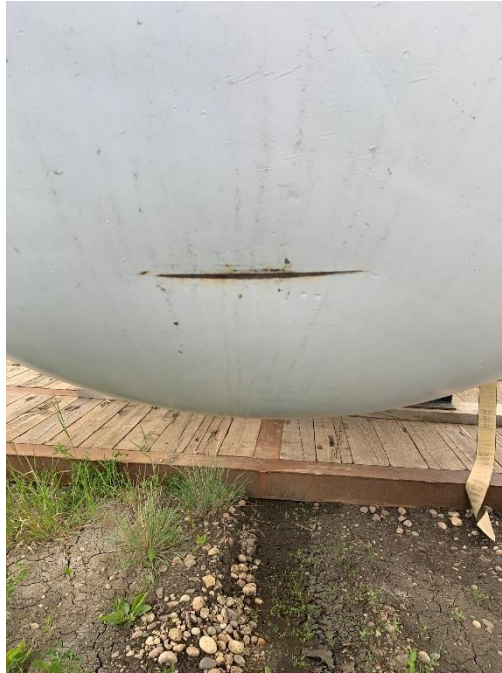
PHOTOGRAPH 3

It is the findings of the writer that after travelling to the Northland Transport Yard and completing a visual inspection of a mark on the head of the LPG bullet that the mark in question is superficial and has no effect on the integrity of the vessel. As found in Photograph 3 the mark appears to be from rubbing on another object sometime during the life of the vessel. The mark in question shows clear signs of being caused by a rubbing effect with no metal loss at point of the rub or gouging or impact marks, only the removal of the surface paint and a slight flattening of the head end curvature with the deviation noted in Photographs 1 and 2 to be less than 4-5 mm in depth. Further review of photographs at the time of the removal of the bullet from the 7-33 Altagas location clearly shows the mark was present on the vessel at the time of its last operating state as shown in Photograph 4 and time of transport in Photograph 5. As the vessel was in service and undergone routine in service inspection it is a fair assumption that the vessel has passed inspections related to the integrity of the head end.

End view of rub/scuff mark. Close visual inspection shows no gouging or metal loss just appearance of a rub mark which removed paint. June 3/19

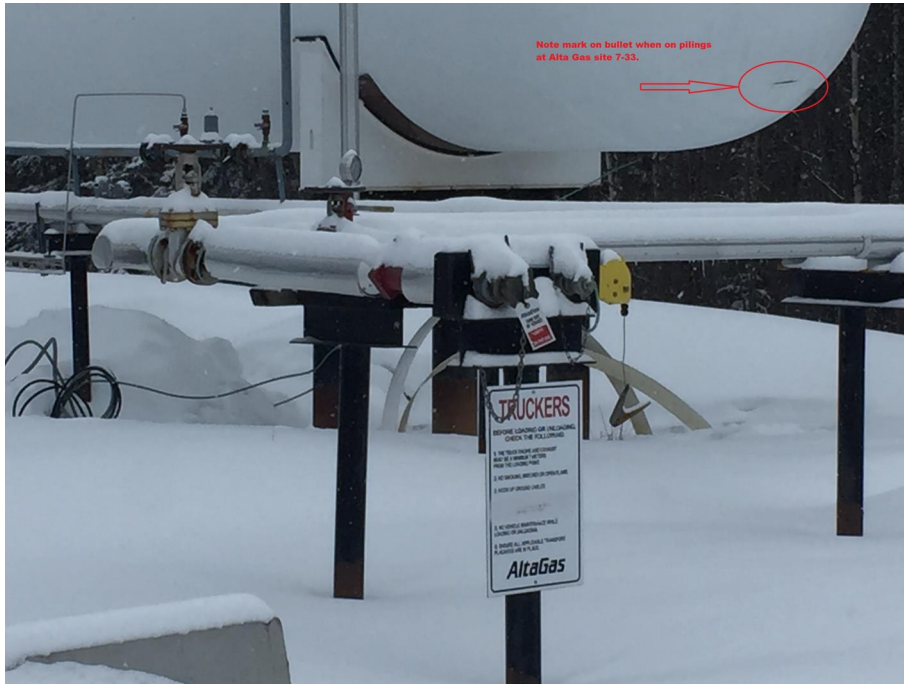
PHOTOGRAPH 4

View of bullet on piles at 7-33 AltaGas location in service with rub mark clearly visible.

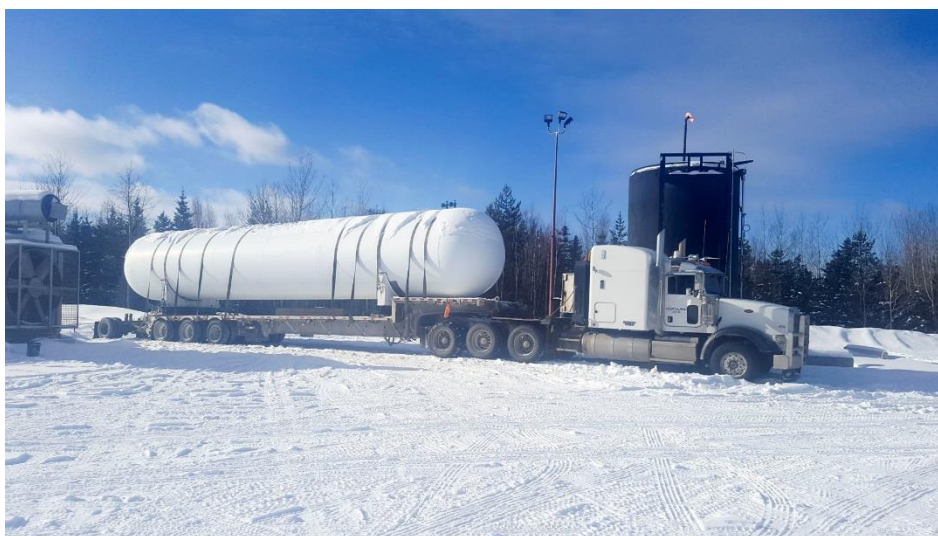
PHOTOGRAPH 5

Bullet loaded at 7-33 Altgas location for transport to Northland yard. Mark visible on bullet on trailer.
