**Procedure:** 4.2 Rev 2 **Client:** Taku Gas Limited **Date:** 19-Dec-16  
**Technique:** UT STRAIGHT BEAM **IRISNDT #:** LYD1601755 **WO #:** .  
**Code:** CLIENT INFO: ASME V ARTICLE 23. **Location:** Calroc Shop **PO #:** .  
**Other:** **Item Inspected:** SCUD

<b>Type of Inspection:</b> Visual	<b>Client:</b> Taku Gas Limited	<b>Date:</b> 19-Dec-16
<b>Test Technique:</b> N/A	<b>IRISNDT #:</b> LYD1601755	<b>Other:</b> ..
<b>Equipment:</b> Camera, Scraper, and Flashlight	<b>Location:</b> Lloyd, Ab	<b>PO #:</b> .
<b>Code:</b> Coating Inspection	<b>Item Inspected:</b> FWKO Skud vessel internals

**Purpose:** visual examination carried out on the following FWKO Scud style vessel internal coating. Asses for overall coating integrity and to identify any isolated coating defects.

FWK-048 Internal Photos

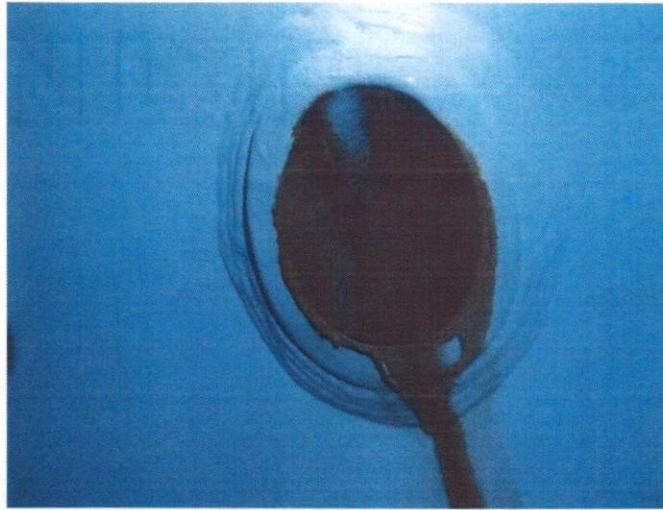
As new coating on a Cat D fillet weld. no defects

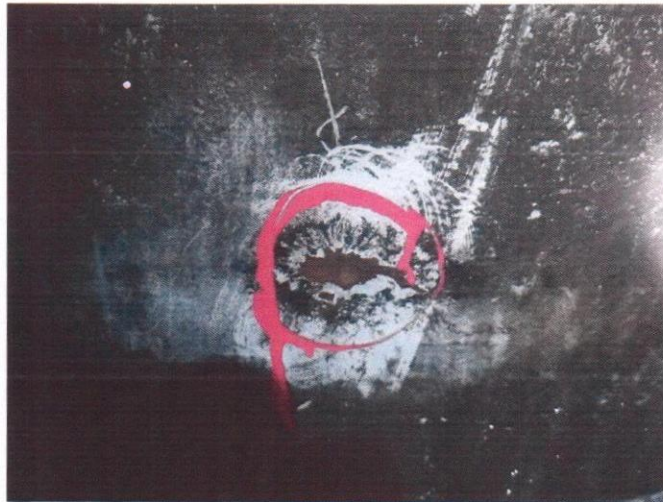
Baffle plate Dent and Coating Damage

**Recommendations:** Sand down areas of coating damage and apply coating patch repair of equivalent or superior epoxy as per manufacturers directions.

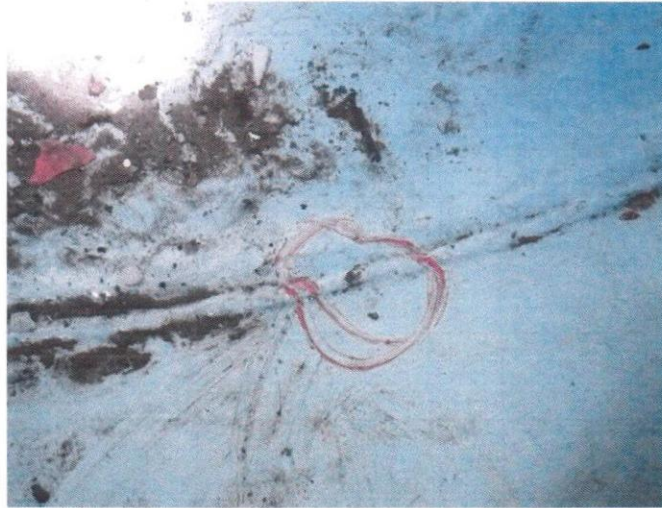
Bottom Head Butt weld coating chip

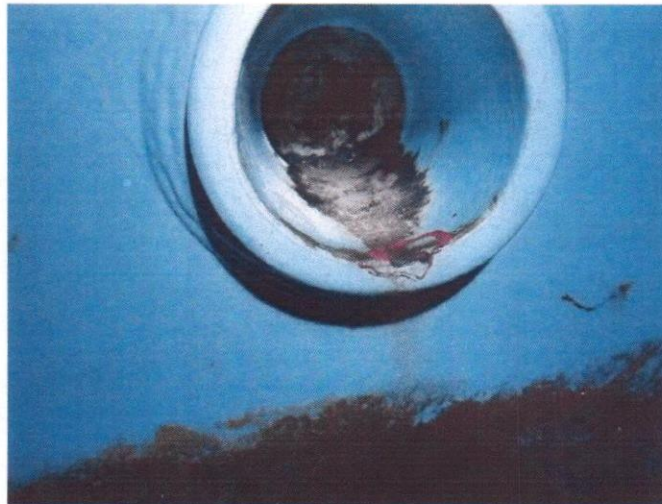
Coating chip on internal nozzle

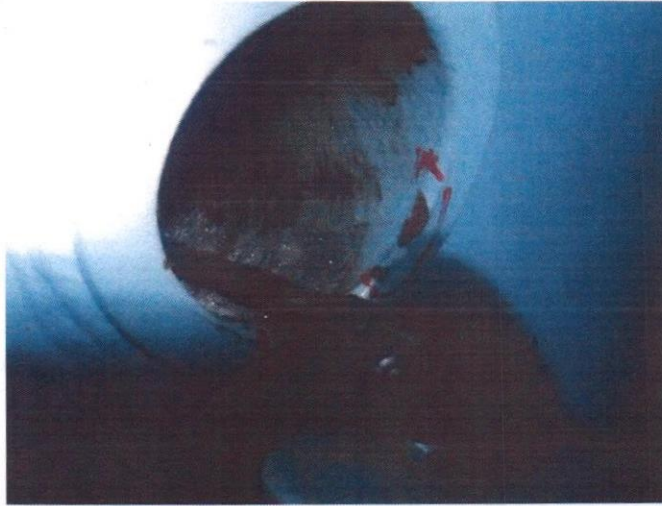
Coating damage caused by Float

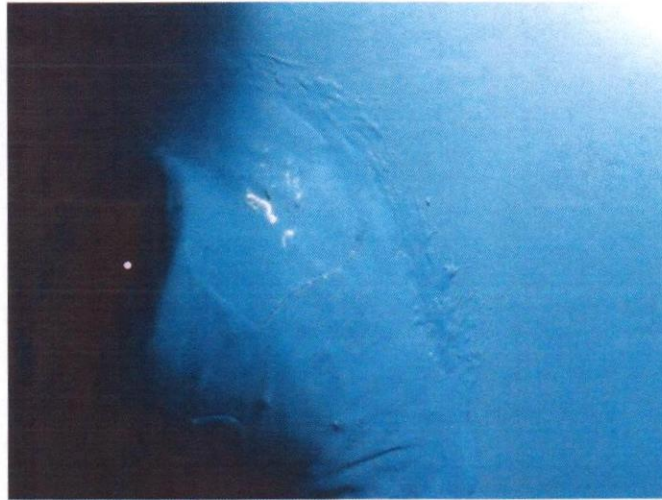
Coupling Coating chip in a patched area

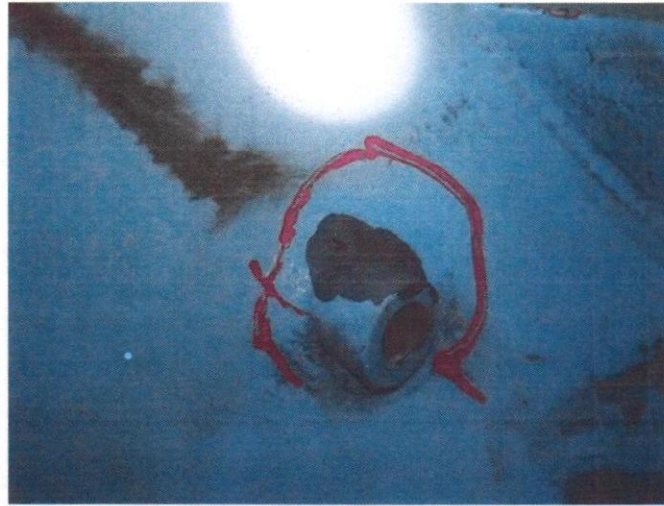
Coupling coating patch failure

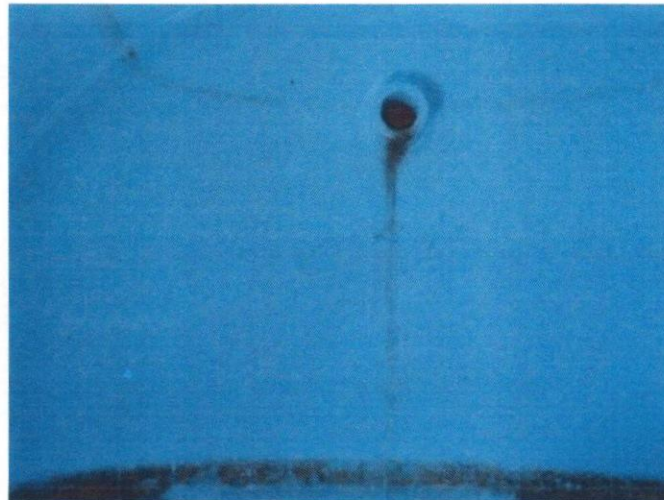
Head seam coupling

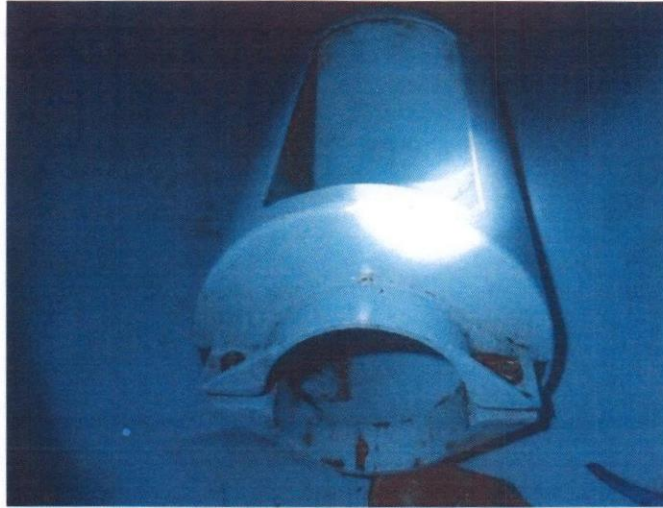
Horse cock defoamer loose on bottom of the vessel

Remove defoamer or Bolt into operation position prior to moving the vessel to prevent further coating damage. Thread stainless steel bolts into the unused baffle nuts.

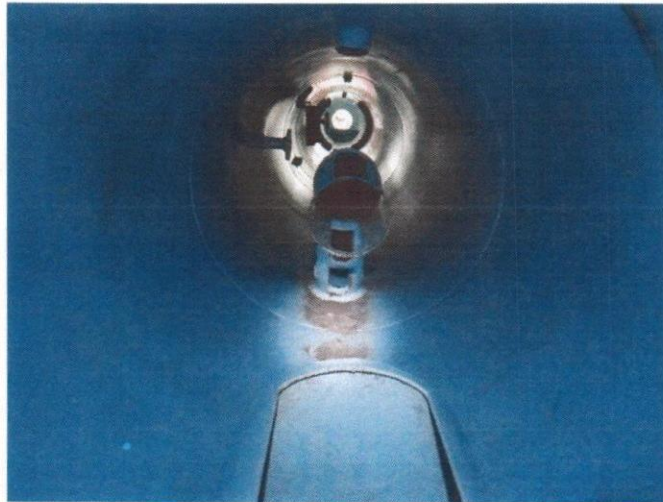
Horsecock Defoamer has been removed

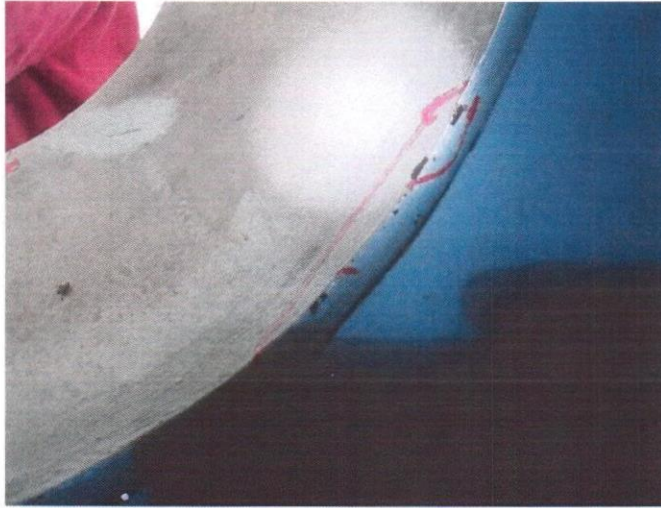
Internal Manway coating defects 2

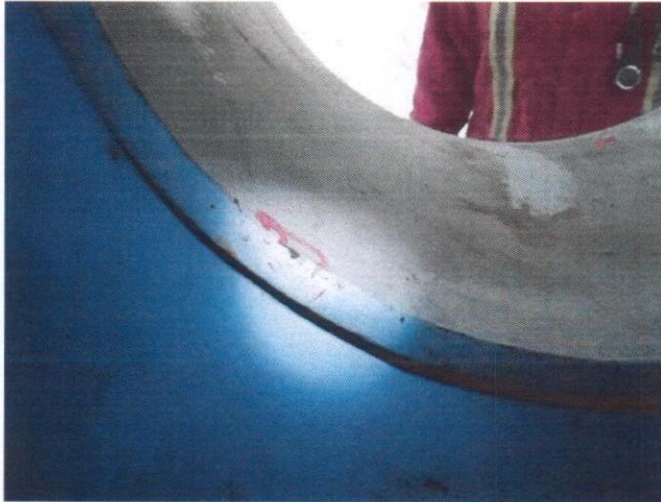
Internal Manway coating defects

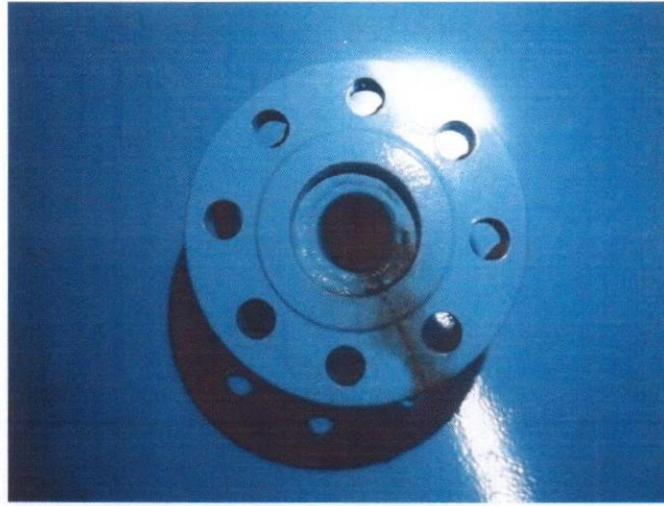
internally flanged nozzle with As new condition coating

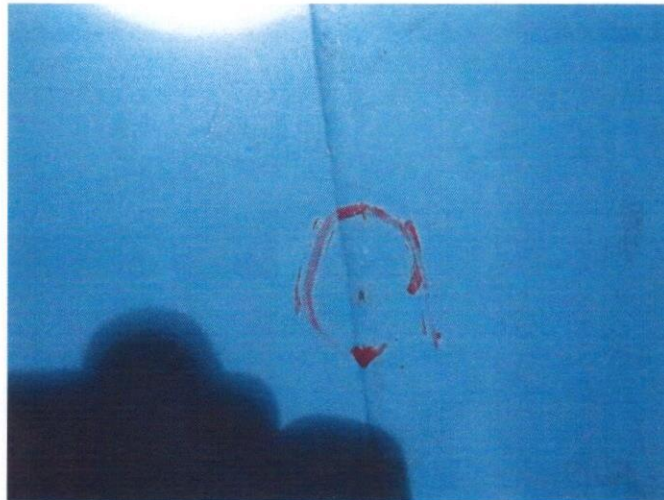
Long seam coating chip

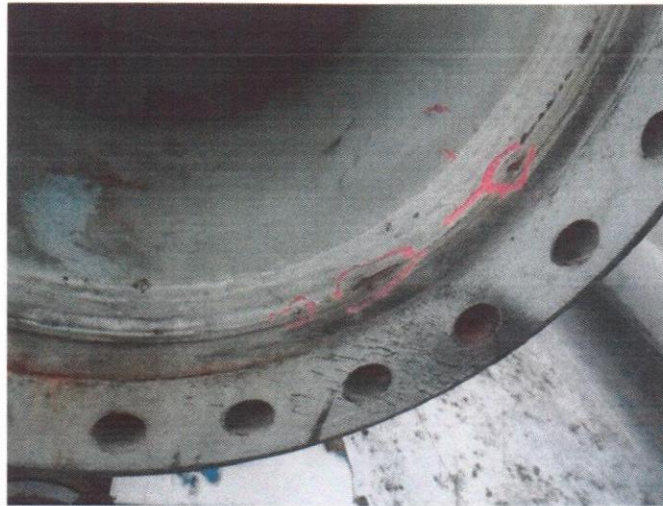
Manway Coating defects at the Gasket interface

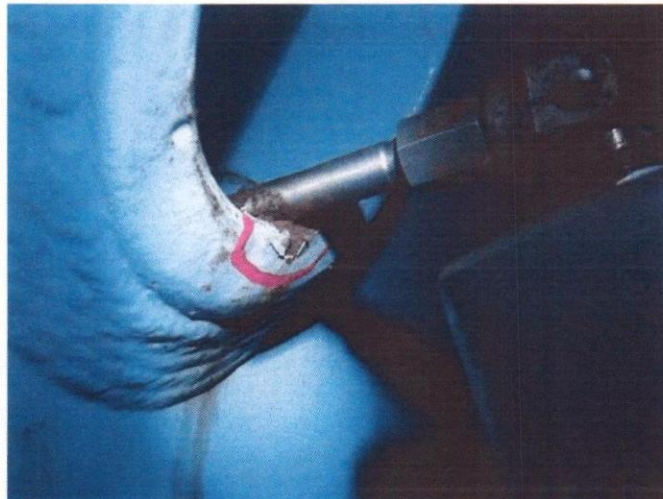
Mechanical damage caused by a float

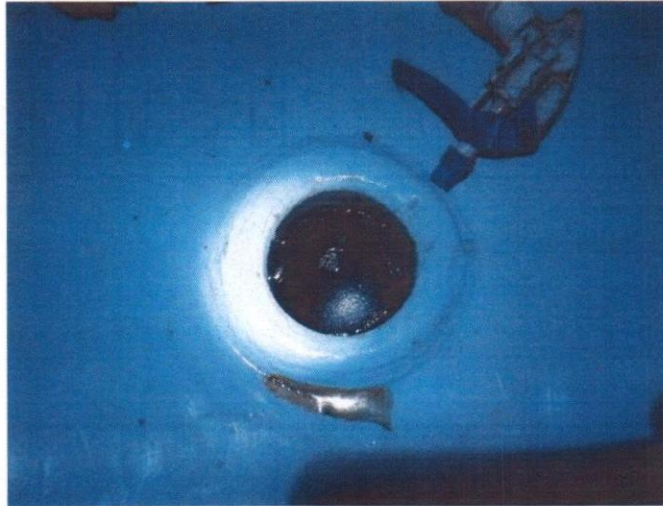
Outlet nozzle full of Oil

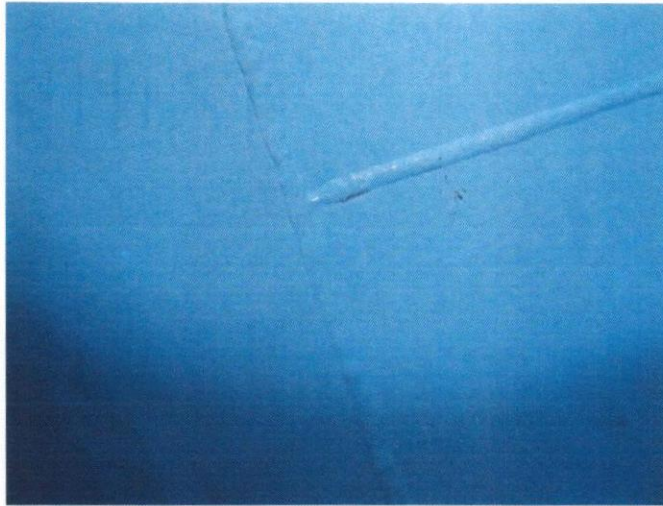
Typical as new coating of a Tee Seam

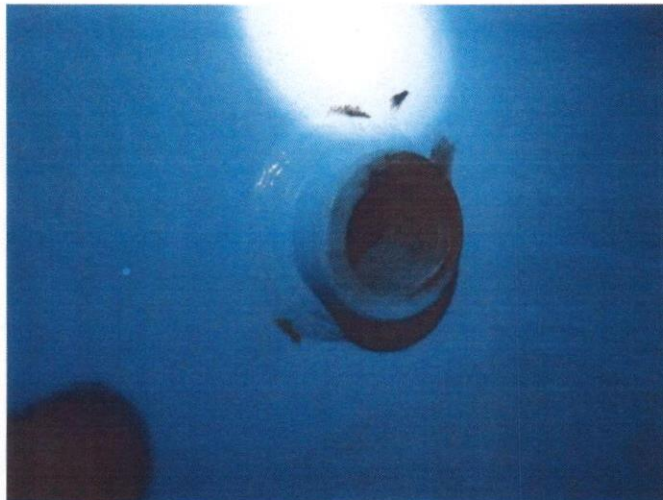
Typical coupling with no damage. Coating in as new condition

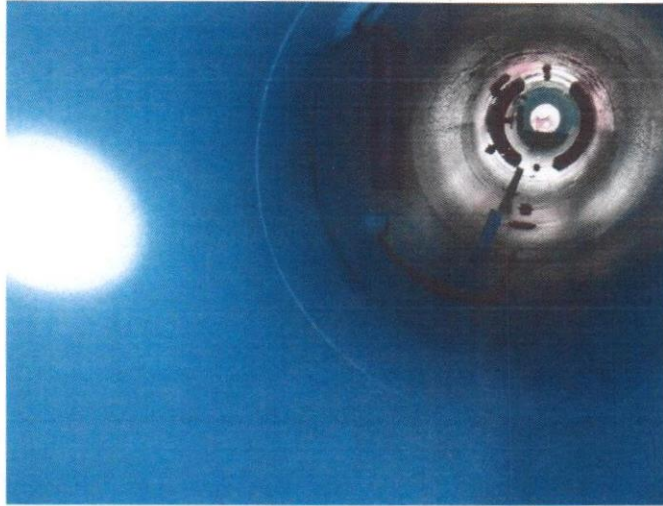
Typical Shell view of as new coating

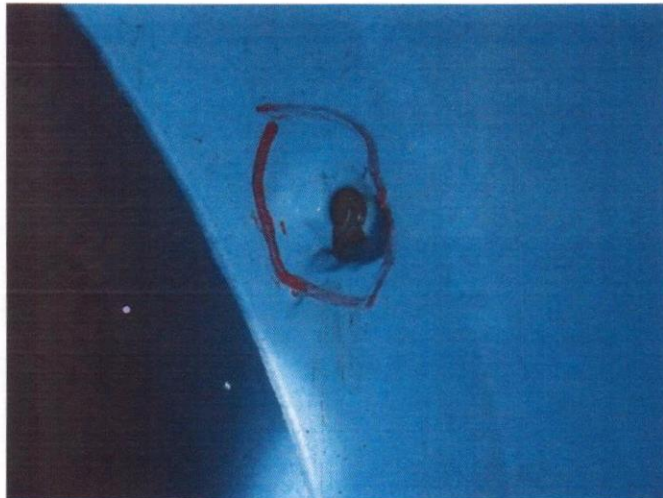
Unused baffle plate mount coating defects on the welded nuts
