FILTER INSPECTION REPORT

Notification Number 6075961 Work Order 6079051
 Notification Desc FILTER, HORIZONTAL 60" OD X 16'0" Maintenance Plan QPFILTER1264
 Tasklist Operation (1Y Inspection Interval) 1Y Code Inspection Filter - Sweet Servi

Equipment Number 66120331 Equipment Description FILTER, HORIZONTAL 60" OD X 16'0"
 Class FILTER Tag Number
 Serial Number 626132 Year Built 2006
 Manufacturer BROMLEY MECHANICAL SERVICES
 Location SS-SK-052-00003 Location Description MATADOR 14-24 COMPRESSOR STATION
 Provincial Number 0557602 PM Activity Code
 Status Codes NOPR ORAS Equipment Status In Service - Fully Utilized

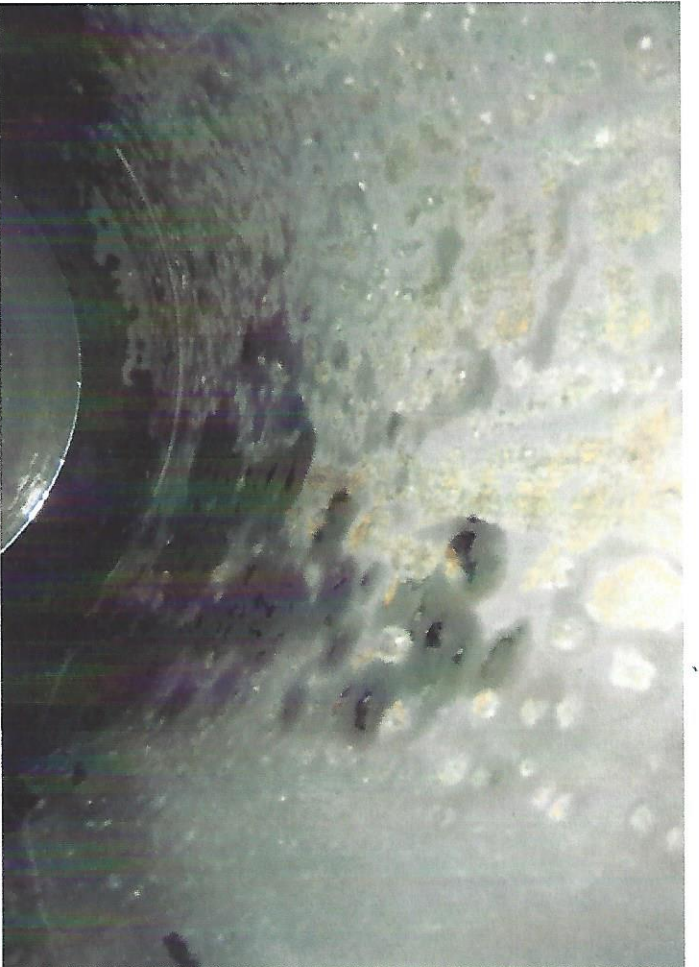
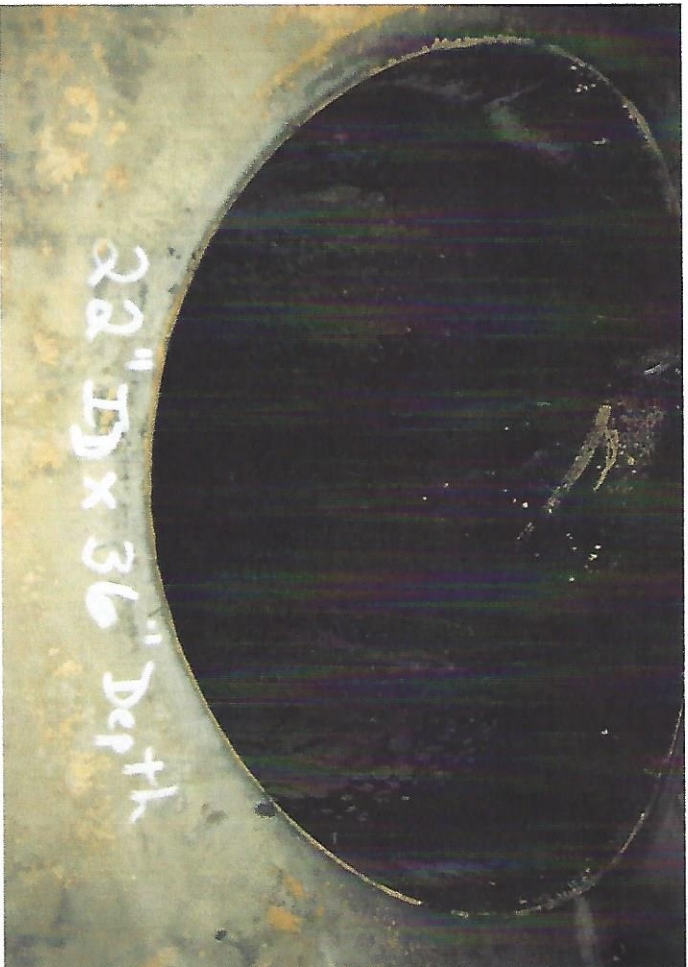
-2" crash dump internal nozzle has a small erosion cut at top of nozzle of 0.035" depth (see photo)

-mid-lower west side - 0.033" , 0.038" , 0.054" (all approx. 0.250" diameter)
 Shell
 -Lower North West shell - 0.023" x 0.375" diameter
 Shell belly 2" crash dump nozzle - small erode cut approx. 0.035" depth x .187" width x 0.250" length

Crash Dump
Eroded Slight
2" Shell
Belly Nozzle
North Half

-recommend applying EC-124 grout repair coating to 2" crash dump nozzle and other minor corroded areas mostly on south head in summer of 2009

-set at a 1 year interval,to have patch coating applied to eroded and small corroded areas,when temperatures are at least 10C for substrate
