## MAGNETIC PARTICLE INSPECTION REPORT

DATE:	SEPT 30, 2010	REPORT #	MDH-100930	PAGE	1 of 2
CLIENT:	FERUS	ECHO JOB #: 2668			
CONTRACTOR:	SAME AS ABOVE				
LOCATION:	BROOKS SCHLUMBERGER YARD	PROJECT:	A# 0511794		
ITEMS EXAMINED:	S/N 38673A				
PROCEDURE:	MT-2A	CLIENT PO # / JOB #:	PO-006669		
ACCEPTANCE CRITERIA:	ASME VIII DIV 1	SPECIFICATION:	ASME V. ART 7

## ULTRASONIC INSPECTION REPORT

DATE: SEPT 30, 2010 REPORT #: UDH-100930 PAGE 2 of 2

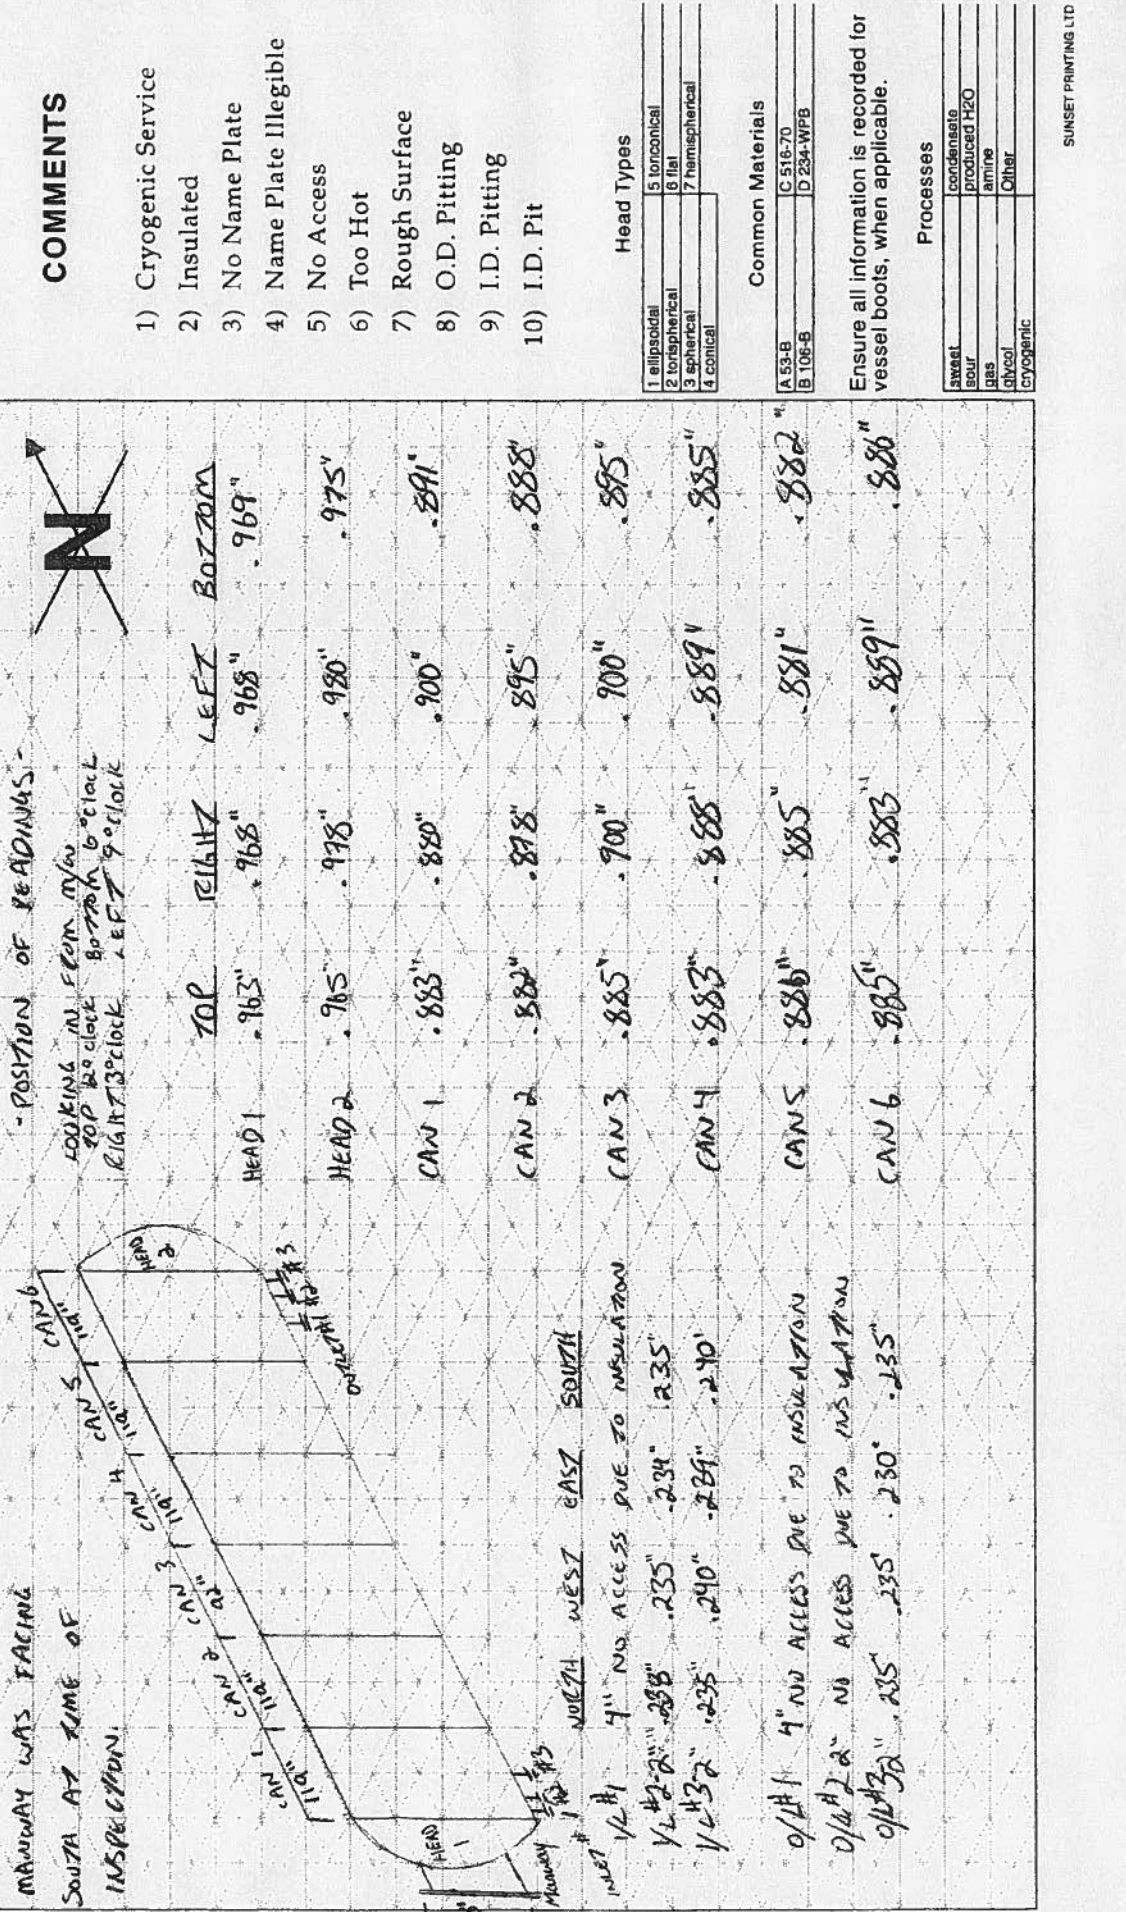
ZERO DEGREE ULTRASONICS WAS PERFORMED ON THE FOLLOWING AREAS OF VESSEL A#0511794 AS REQUESTED BY THE CLIENT. LOWS WERE RECORDED – SEE ATTACHED DRAWINGS FOR LOCATIONS AND LOWS.

- 4 POINTS PER HEAD ( MIDPOINT FOR EACH QUADRANT )
- 4 POINTS PER SHELL SECTION ( TOP, BOTTOM, LEFT, AND RIGHT )
- 4 POINTS PER OUTLET / INLET PIPING ( NOZZLE NECK )
