MAGNETIC PARTICLE EXAMINATION REPORT

REPORT No.: **MT - 1829 - 02 - EDP**

Client: TAQA North Ltd.
District: Northern LSD: C-32-H / 94-H-08
Facility: Chinchaga Gas Plant
Item(s) Examined: **All Nozzles and 100% Circumferential and Longitudinal Welds**
Acceptance Criteria: ASME Sec VIII Rev. / Date: 2010
Procedure No.: ITS-MT04 Rev. / Date: Rev. 1 / Oct-11
Technique No.: Tech 03 Rev. / Date: Rev. 1 / Oct-11

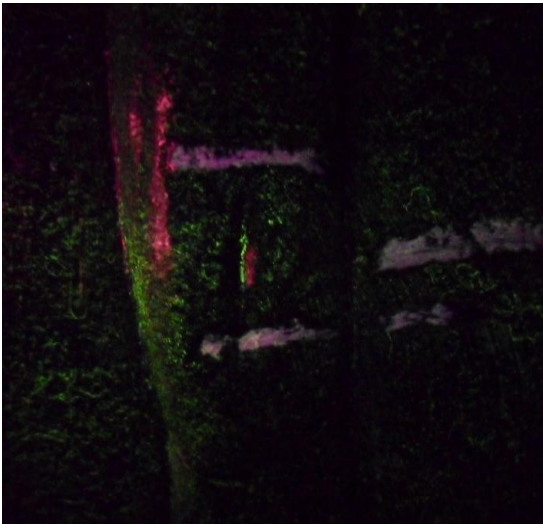
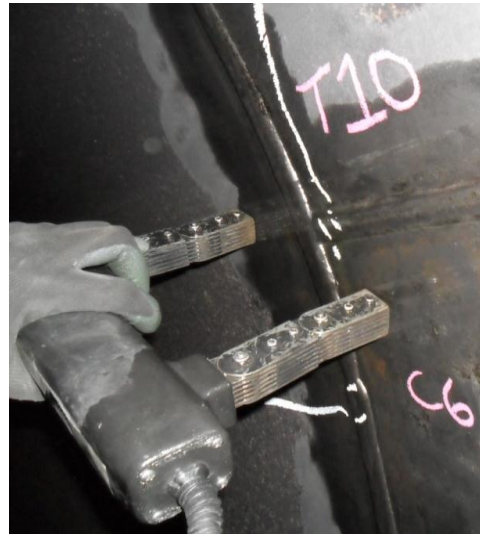
T10 / C6 - 2 Indications in the Start / Stop of the Weld

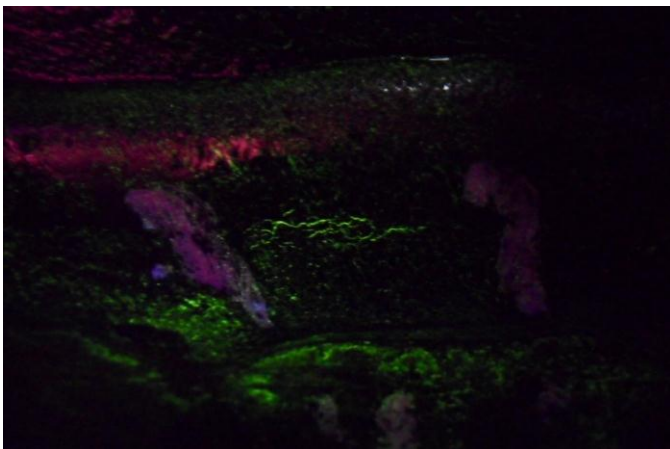
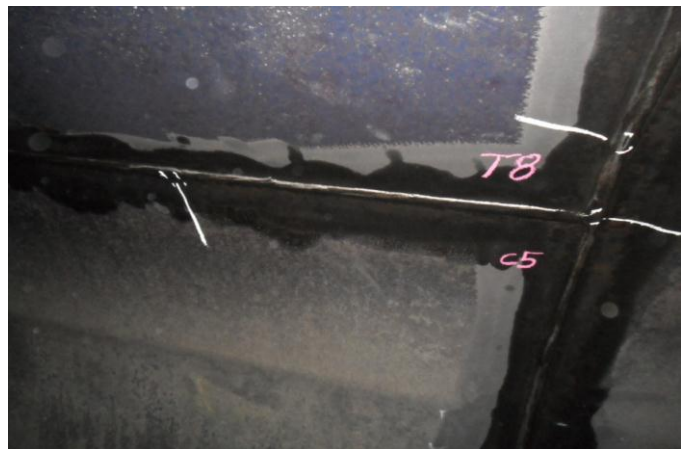
1 of the Indications From C5 / T8

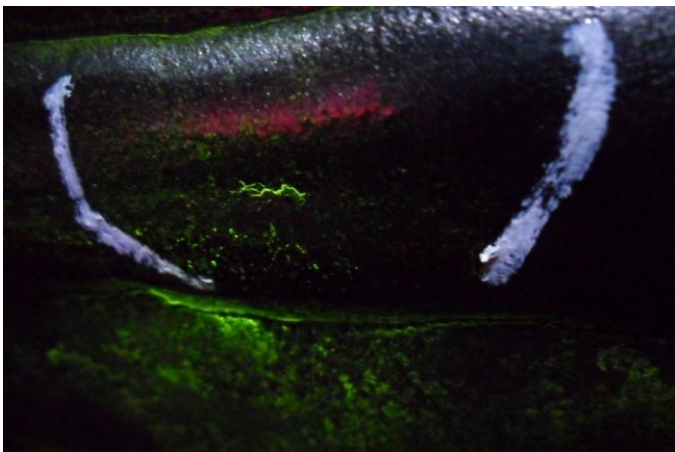
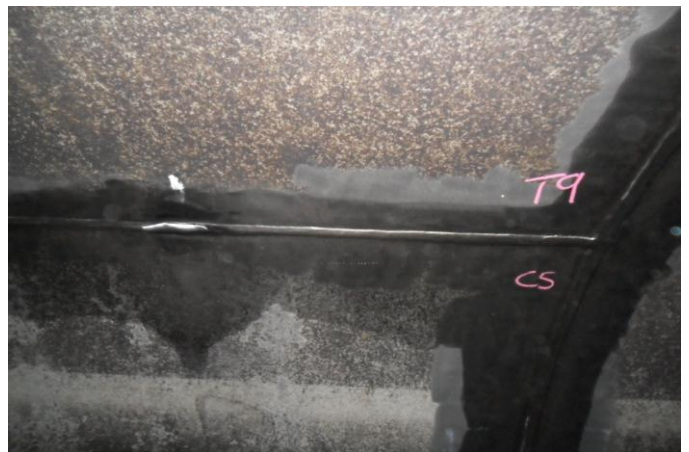
C5 / T9 Indication in Start / Stop 24" West of C5

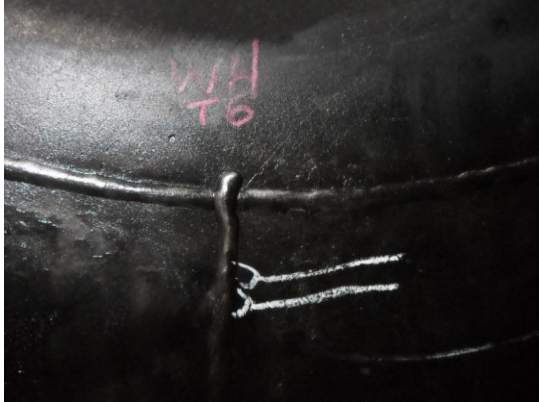
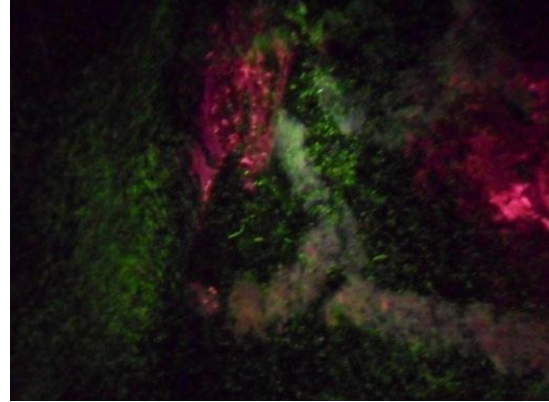
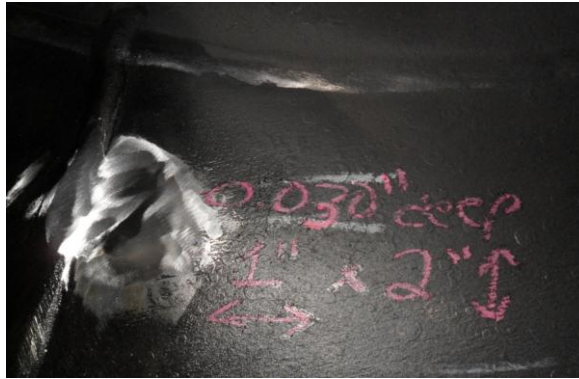
**West Head - WHT6
Up by the Smaller Diameter Circ. Weld**

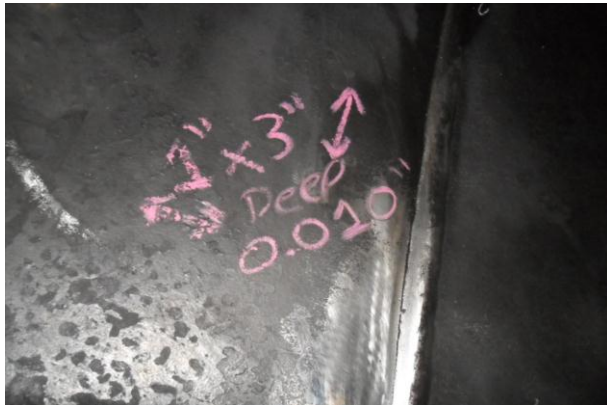
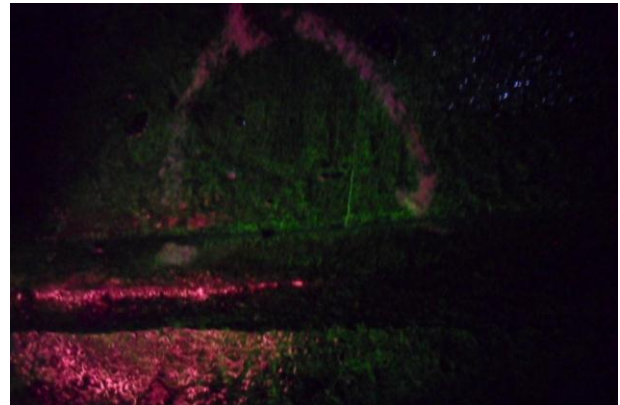
West Head - WHT1: 6" From the C1 Weld
