EQUIPMENT INTERNAL INSPECTION REPORT

Customer:	TAQA North	ITS Job No.:	2506
District:	North Area	Date:	06-Nov-2013
Facility:	Chinchaga Gas Plant	LSD:	C-032-H/094-H-08
Equip. Description:	Propane Bullet	Serial No.:	393508
Equip./OIP No.:	603VP005	PRN:	A0601541
Equip. Type: <input type="checkbox"/> Column <input type="checkbox"/> Cooler <input type="checkbox"/> Exchanger <input type="checkbox"/> Furnace <input type="checkbox"/> Heater <input type="checkbox"/> Plate Exchanger <input type="checkbox"/> Reboiler <input checked="" type="checkbox"/> Vessel <input type="checkbox"/> Other:

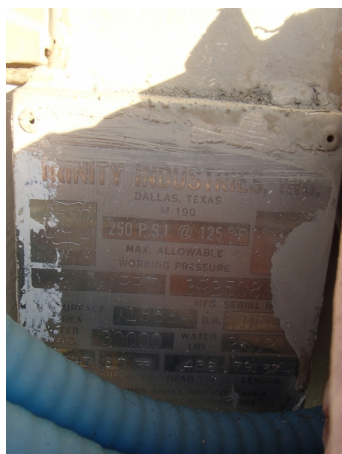
Photo 1: Nameplate

- Label PSV (with serial number 15541) 603SVVP005 and reattach nameplate.

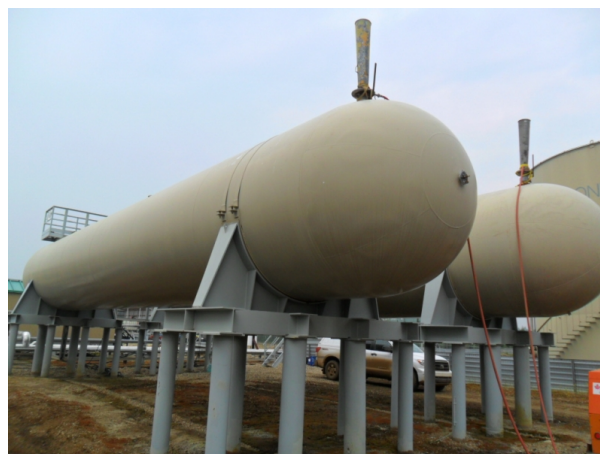
Photo 2: Overall View

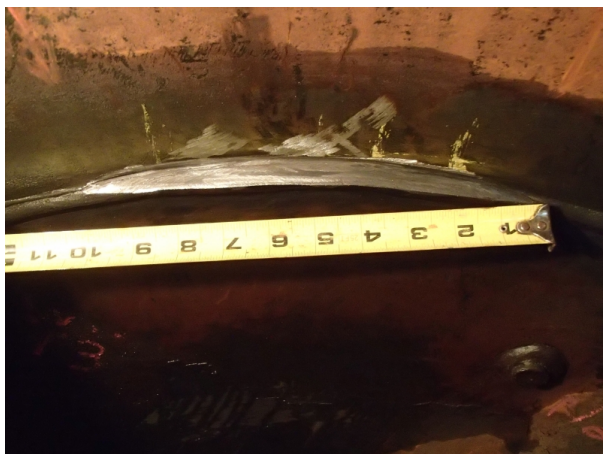
- The weld repair groove on the west head is approximately 254mm long x 19.05mm wide x 4.45mm deep. Wet Fluorescent Magnetic Particle Examination was done after the groove was made to make sure no linear indications were found prior to welding. Pro Pipe from Grande Prairie did the weld repair. Then WTMT was performed after the weld cooled down and then again 24hrs later. No linear indications were found.

Photo 3: West Head Weld Repair

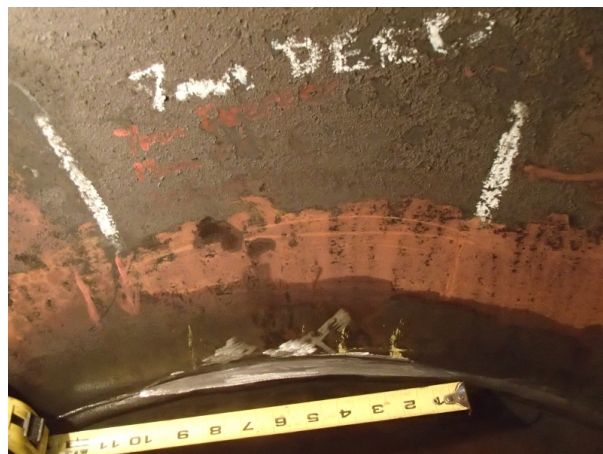
Photo 4: Length of Groove Approximately 254mm Long

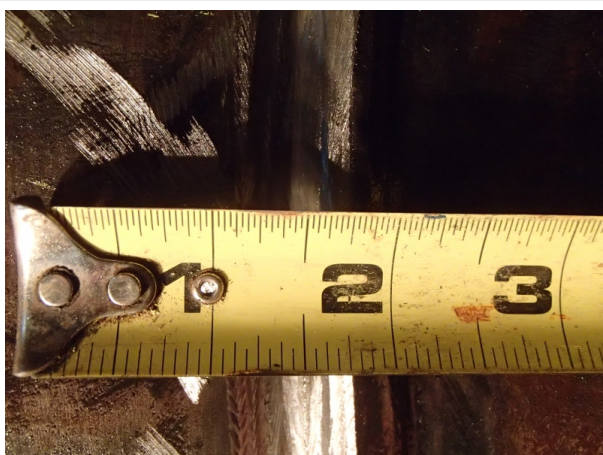
Photo 5: Groove Width Approximately 19.05mm x 4.45mm

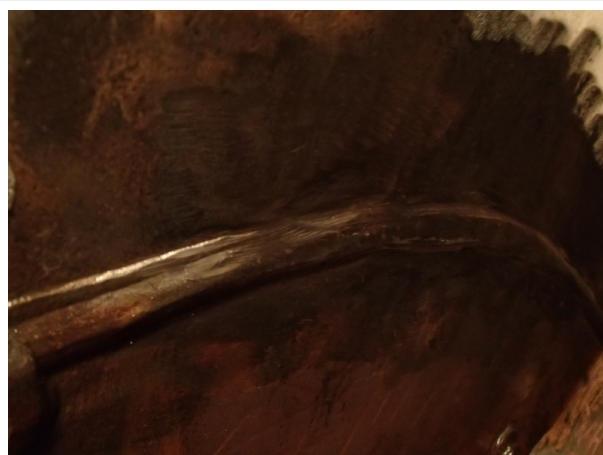
Photo 6: Weld Repair Overview
