MAGNETIC PARTICLE EXAMINATION REPORT

REPORT No.: **MT - 1829 - 01 - EDP**

Client: TAQA North Ltd.
District: Northern LSD: C-32-H / 94-H-08
Facility: Chinchaga Gas Plant
Item(s) Examined: **All Nozzles and 100% Circumferential and Longitudinal Welds**
Acceptance Criteria: ASME Sec VIII Rev. / Date: 2010
Procedure No.: ITS-MT04 Rev. / Date: Rev. 1 / Oct-11
Technique No.: Tech 03 Rev. / Date: Rev. 1 / Oct-11

PRN: (A) **601541** Serial No.: **393508** Equip. No.: **603VP005** CRN: **K0576.1**
Material: **Carbon Steel** Thickness: **Shell - 0.6733" / Head - 0.436"** Other: **N/A**

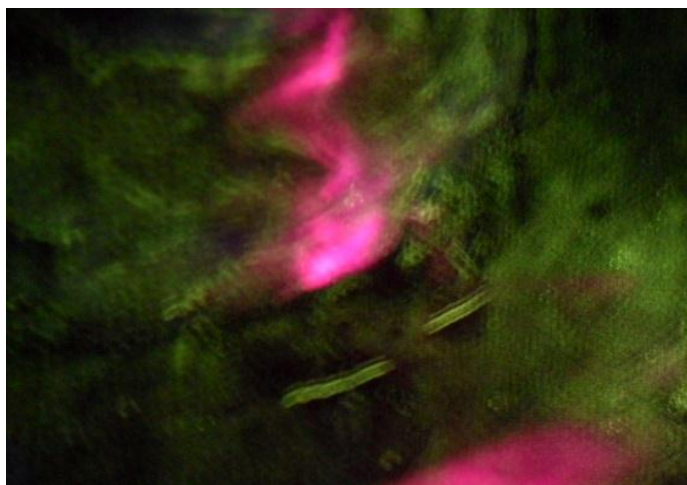
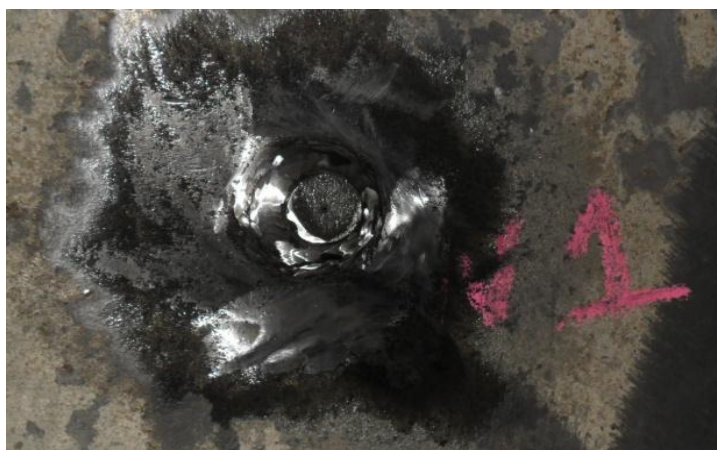
RESULTS: On the C2 weld (north side of vessel) at the 8 O'clock position, an indication was found in the start/stop of a weld. The indication was buffed out and re-examined. No relevant indication was found.
Weld spatter was removed from N1, N2, N3 and N4 prior to do WFMP1 - N1 was found to have 2 indications just below it on the head. These indications were removed by lightly buffing and re-examined. No relevant indications were found. N4 was found to have 2 indications, one on the edge of weld and one in head. These indications were removed by lightly buffing and re-examined. No relevant indications were found.
1 indication was found 24 inches west of C2 at the C2/T2 tee weld in the start/stop of a weld. The indication was buffed out and re-examined. No relevant indication was found.
1 indication was found 23 inches east of C2 at the C2/T3 tee weld in the start/stop of a weld. The indication was buffed out and re-examined. No relevant indication was found.

N1 - 2 Indications Just Below the Nozzle Weld

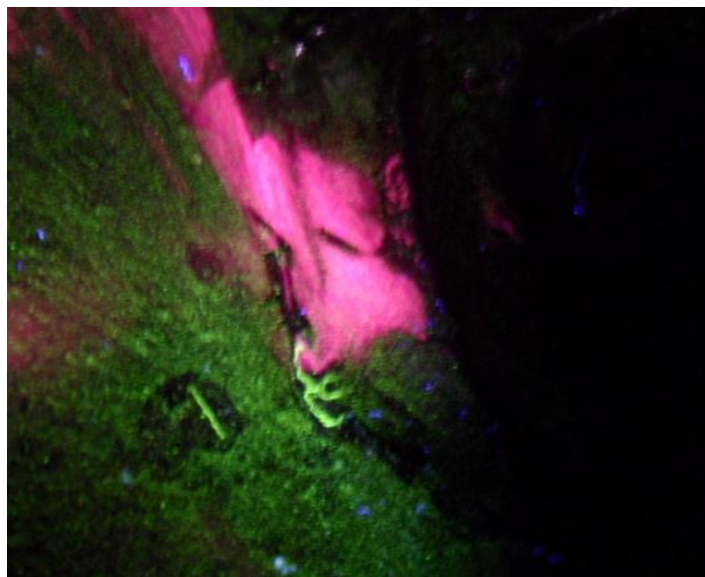
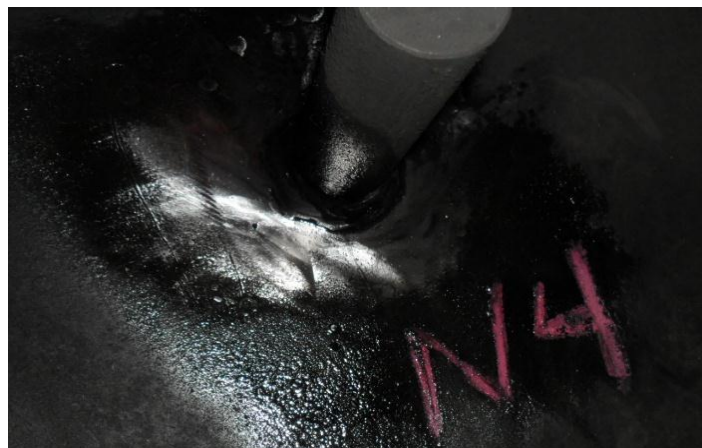
N4 - 2 Indications, 1 in the Head and the Other is in the Weld

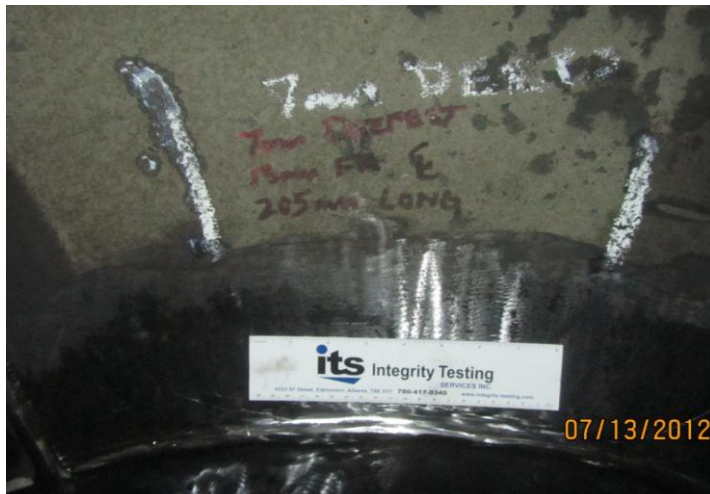
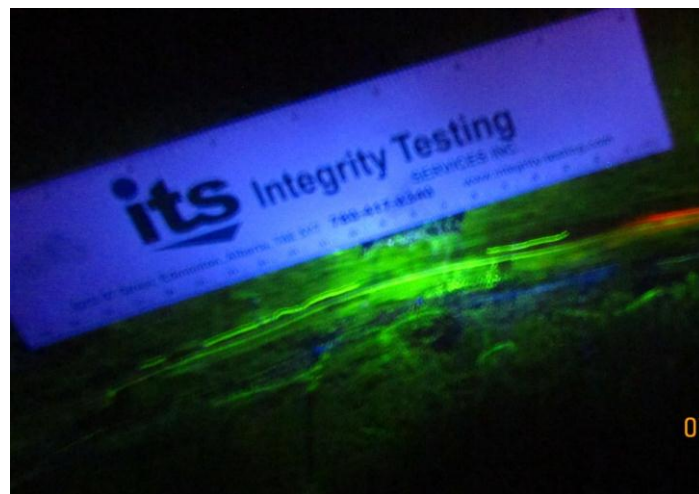
The outer circumference weld between WHT3 and WHT4 an indication was found and could not be removed. Shear wave was done see **UT-1828-01-MAJ** for the results.

CONCLUSION: Based on the results of this examination, the above mentioned items were found to contain no relevant indications and is acceptable to the above mentioned standard **except** the West head outer circumference weld between WHT3 and WHT4.

West Head Crack In - Between WHT3 and WHT4

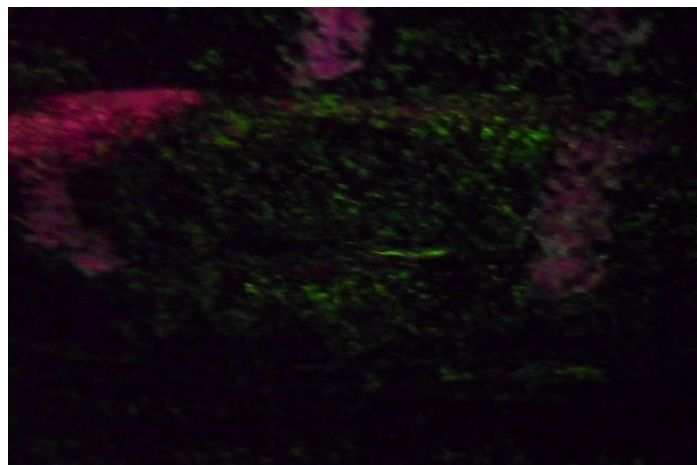
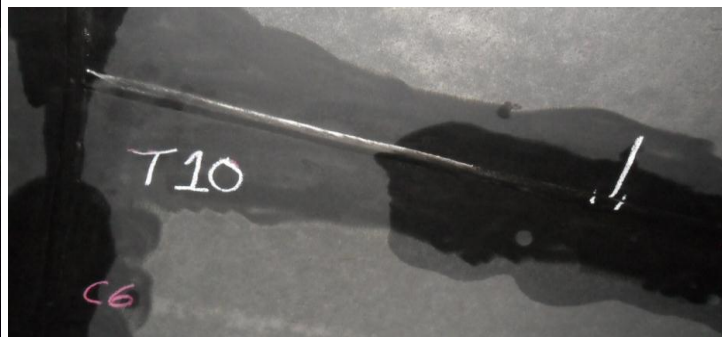
T10 / C6 Tee Weld - Start / Stop of the Weld
