EQUIPMENT INTERNAL INSPECTION REPORT

Customer:	TAQA North	ITS Job No.:	1829
District:	Northern	Date:	18-Jul-2012
Facility:	Chinchaga Gas Plant	LSD:	C-32-H/94-H-08
Equip. Description:	Propane Bullet	Serial No.:	393508
Equip./OIP No.:	603VP005	PRN:	A601541
Equip. Type: <input type="checkbox"/> Column <input type="checkbox"/> Cooler <input type="checkbox"/> Exchanger <input type="checkbox"/> Furnace <input type="checkbox"/> Heater <input type="checkbox"/> Plate Exchanger <input type="checkbox"/> Reboiler <input checked="" type="checkbox"/> Vessel <input type="checkbox"/> Other:

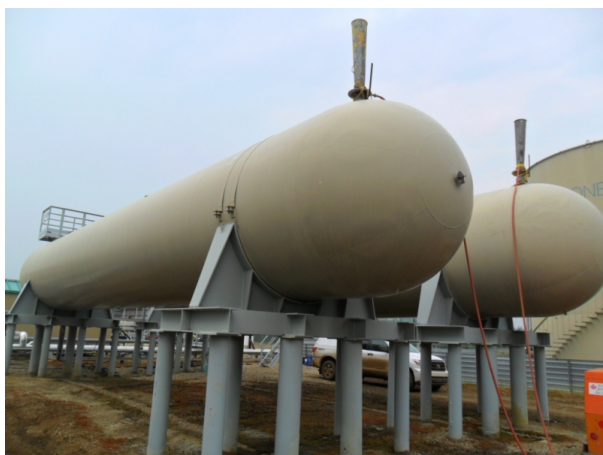
Photo 1: Overview

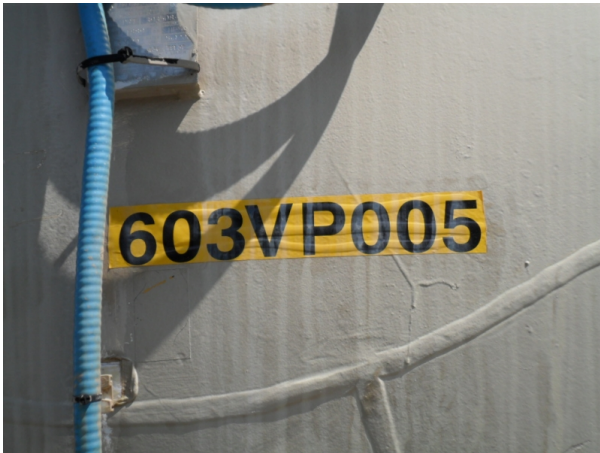
Photo 3: OIP Number

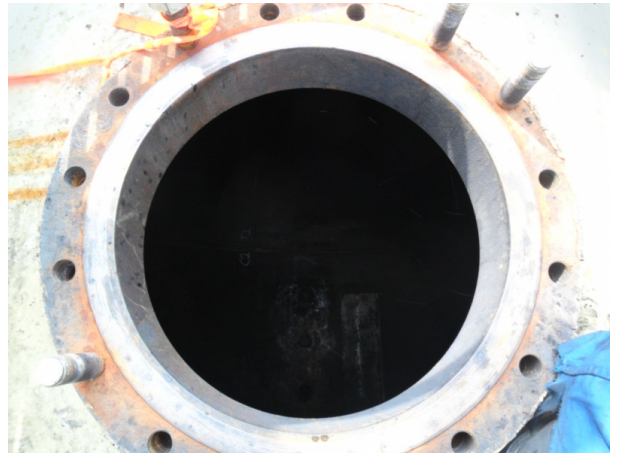
- Manway and manway sealing areas have no corrosion, erosion or mechanical damage, or issues.
- Both heads have mill scale still present and have a slight product residue.

Photo 4: Manway

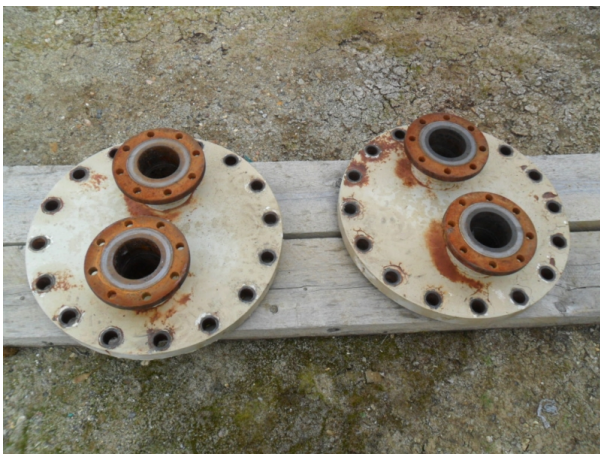
Photo 5: Manway Cover

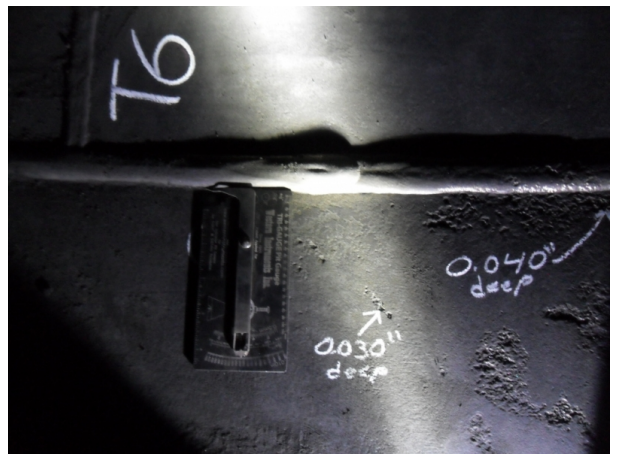
- On the East end of the vessel, there is corrosion noted on the shell floor. The corrosion is out 9" from the C7 weld and is 7" parallel with C7 weld. The deepest area noted in this corrosion on the shell side is 0.040".

- There is minor corrosion noted on the head side which is 1" out from the C7 weld and 6" long that runs parallel with the C7 weld and the deepest area found is 0.010".

Photo 6: Corrosion on East End

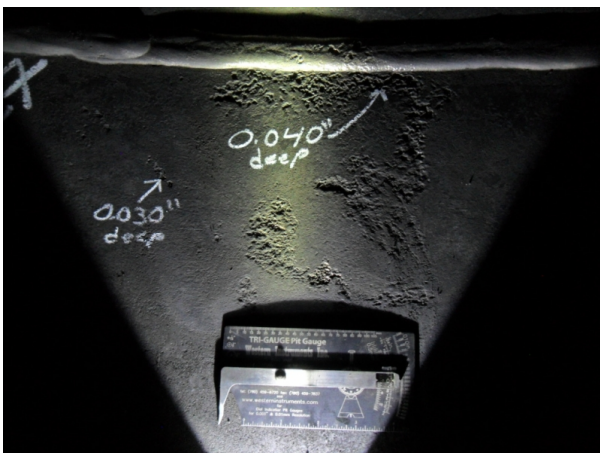
Photo 7: Corrosion on East End (2)

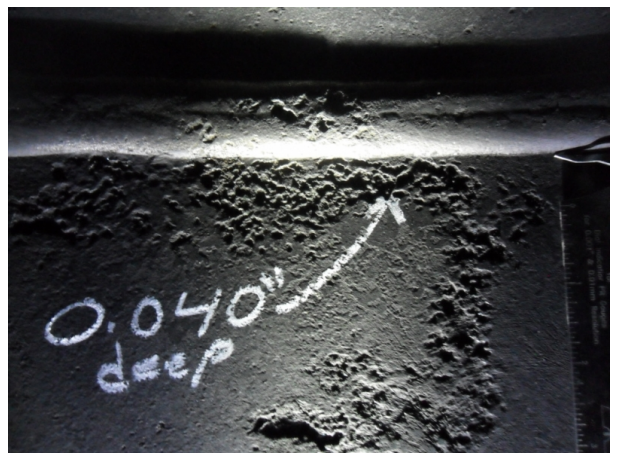
Photo 8: Corrosion on East End (3)

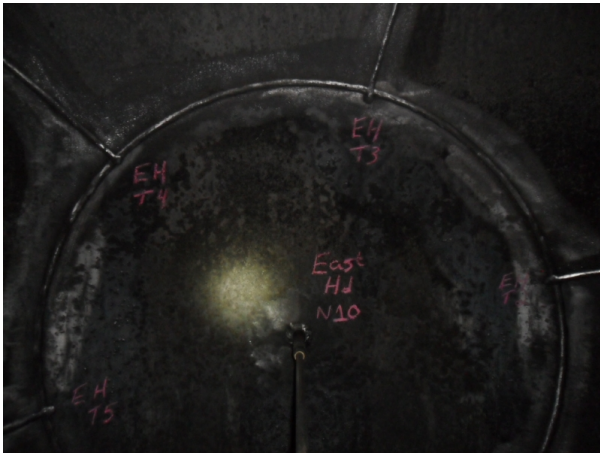
Photo 9: East Head Overview

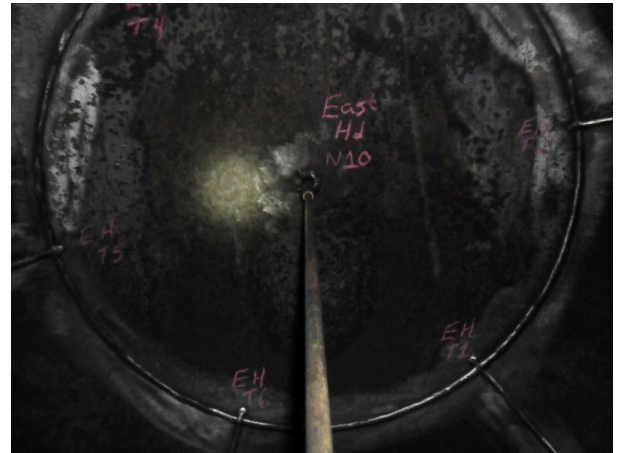
Photo 10: East Head Overview (2)

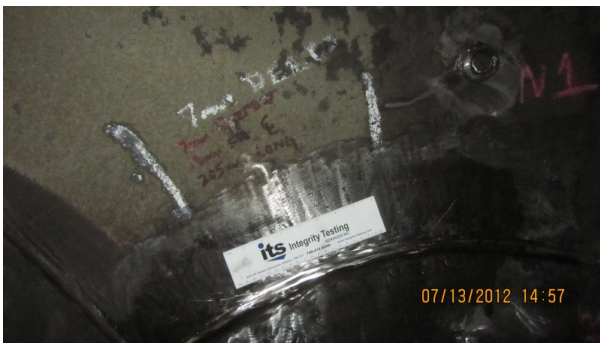
- The west head between T3 and T4 was an indication found on the outer diameter of the weld profile. This was Shear-wave UT'd (see UT-1828-01-MAJ) for the shear-wave results on the West Head.

Photo 11: Indication on West Head

- Have the indication repaired on the west head prior to putting back into service.
- Review TOFD results from 3rd party (FOCUS) NDE company.
- Label PSV (with serial number 15541) 603SVVP005 and reattach the nameplate.

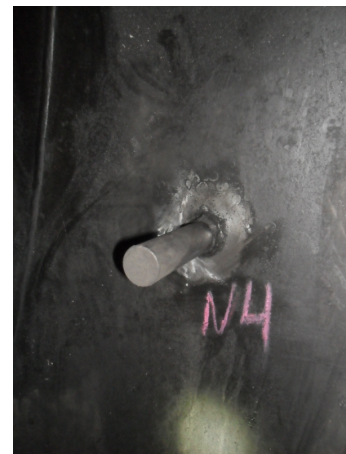
Photo 12: Nozzles

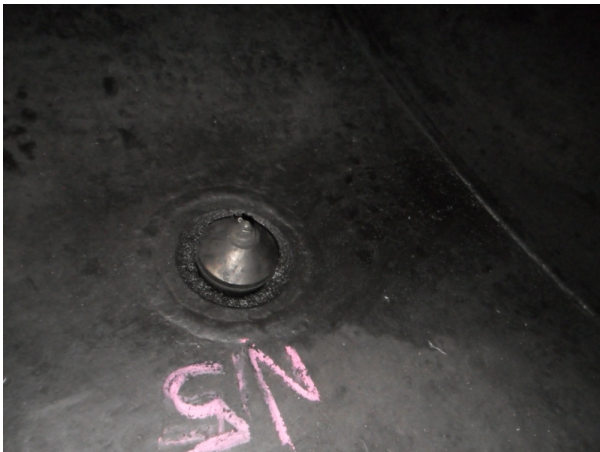
Photo 13: Nozzles (2)

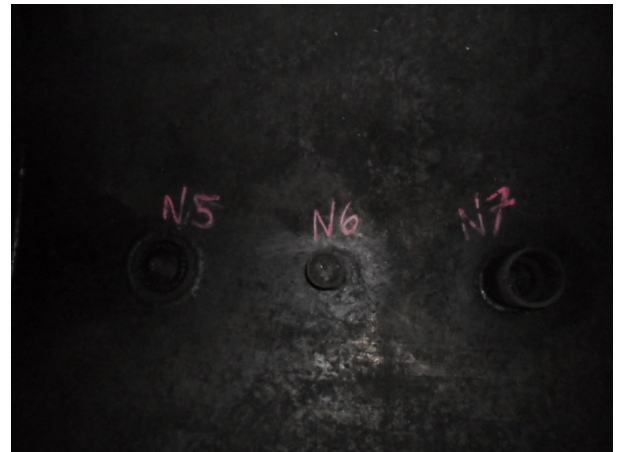
Photo 14: Nozzles (3)

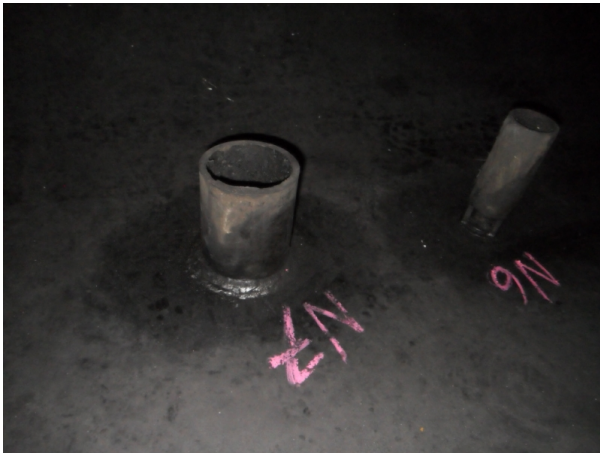
Photo 15: Nozzles (4)

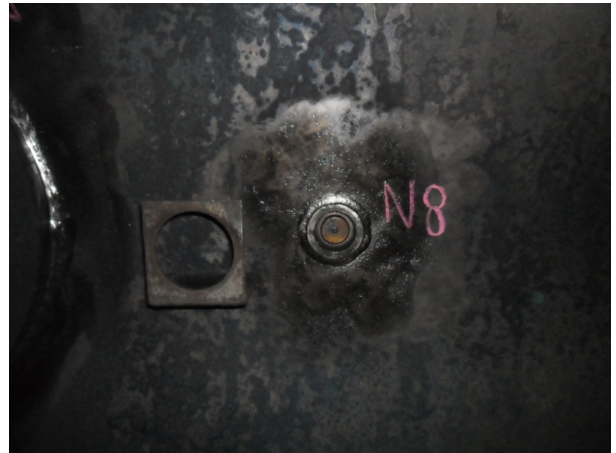
Photo 16: Nozzles (5)

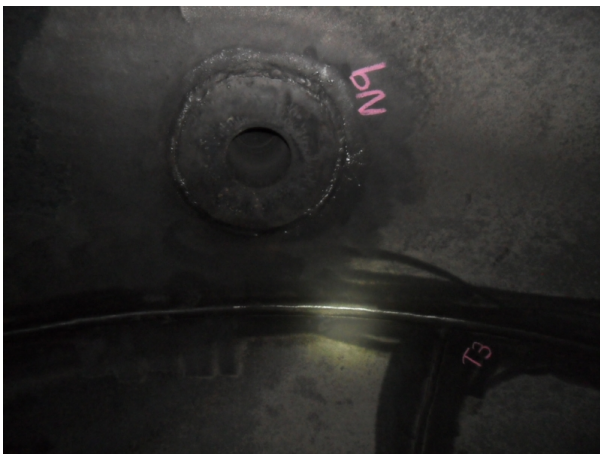
Photo 17: Nozzles (6)

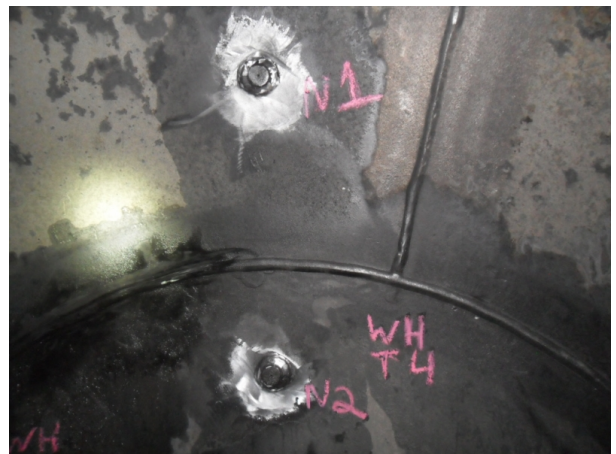
Photo 18: Nozzles (7)

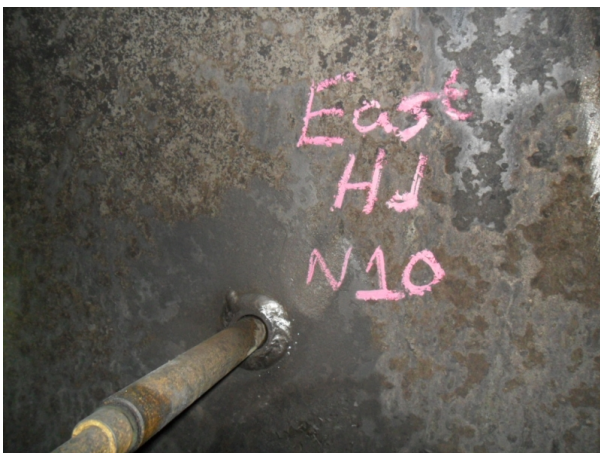
Photo 19: Nozzles (8)

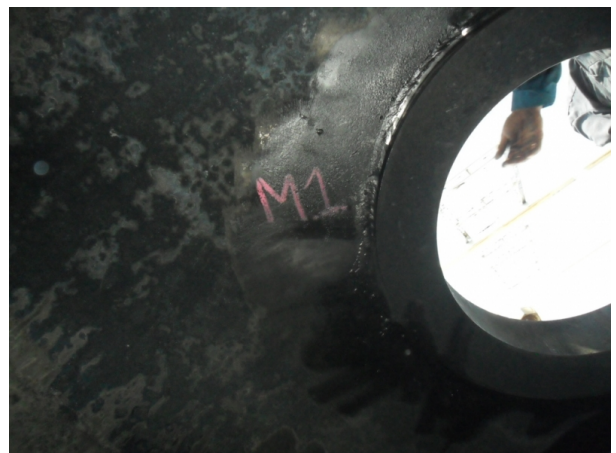
Photo 20: Nozzles (9)

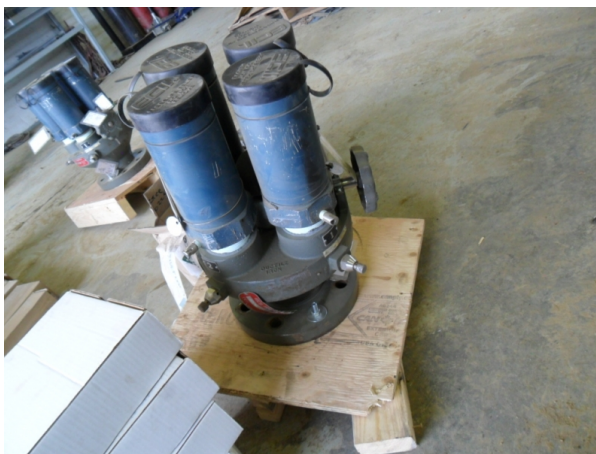
- N1, N2, N3, N4 are on the West Head. N5, N6, N7 are on shell floor in Can 1. M1 and N8 are in Can 1 on top of the shell at the 12 O'clock position. N9 is in Can 6 at 12 O'clock position. This is where the multi-port PSV is mounted. N10 is on the East Head.

Photo 21: Multi Port PSV
