EQUIPMENT EXTERNAL INSPECTION REPORT

Customer:	TAQA North	ITS Job No.:	1-4012
District:	North Area	Date:	09-Jul-2018
Facility:	Chinchaga Gas Plant	LSD:	C-032-H/094-H-08
Equip. Description:	BC #1 Inlet Separator	Serial No.:	7723-03
Equip./OIP No.:	603VS006	PRN:	Not Stated

Report No.: VE-1-4012-03-CRE

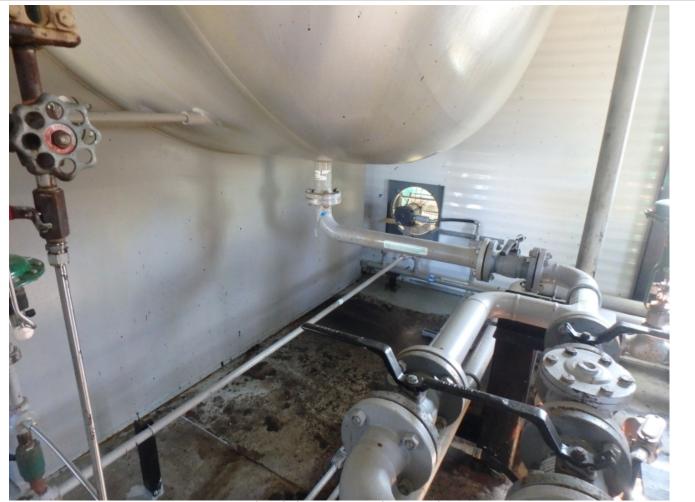
- Paint is in good condition.
- No access to the North head due to external insulation.
- Saran wrap noted on associated flanged connections.
- Weep noted on the South bridle top flanged head. (Appears old)
- Low UT reading found on CML 34 (3" 90 degree drain elbow) nominal thickness 5.5mm / 4.8mm.

Associated Flange connection overview

- Monitor the low UT reading found on CML 34 (3" 90 degree drain elbow).
- Remove the saran wrap from the associated flanged connections.
