Facility:	Chinchaga C-32-H/94-H-8	PRN:	PV69P8804 (BC)	Date of Inspection:	June 7, 2017
Equipment Type:	Inlet Separator (BC# 1)	Field Tag #:	603VS006		
Service:	<input type="checkbox"/> Sour <input checked="" type="checkbox"/> Sweet <input type="checkbox"/> Cryogenic <input type="checkbox"/> Air <input type="checkbox"/> Steam	MAWP:	275 PSI @ 120F		
Fluid:	Emulsion	Manway	<input checked="" type="checkbox"/> Yes <input type="checkbox"/> No	Size of Manway	
Scope of Inspection:		Type of Inspection:		Cleaning:	Access:
<input type="checkbox"/> Pre-commissioning		<input type="checkbox"/> AE	<input type="checkbox"/> MT	<input type="checkbox"/> RT	<input checked="" type="checkbox"/> Good
<input type="checkbox"/> Initial		<input type="checkbox"/> ET	<input type="checkbox"/> MFL	<input type="checkbox"/> UT	<input type="checkbox"/> Fair
<input checked="" type="checkbox"/> Re-inspection		<input type="checkbox"/> LT	<input type="checkbox"/> PT	<input checked="" type="checkbox"/> VT	<input type="checkbox"/> Inadequate

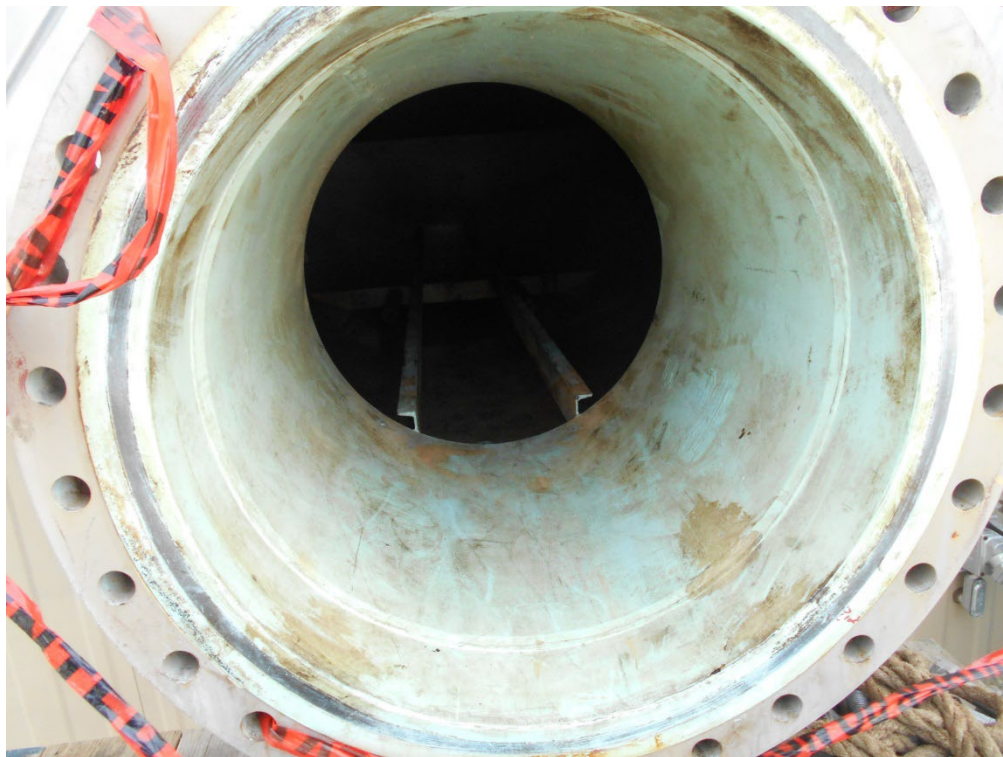
Figure 1 Manway Access

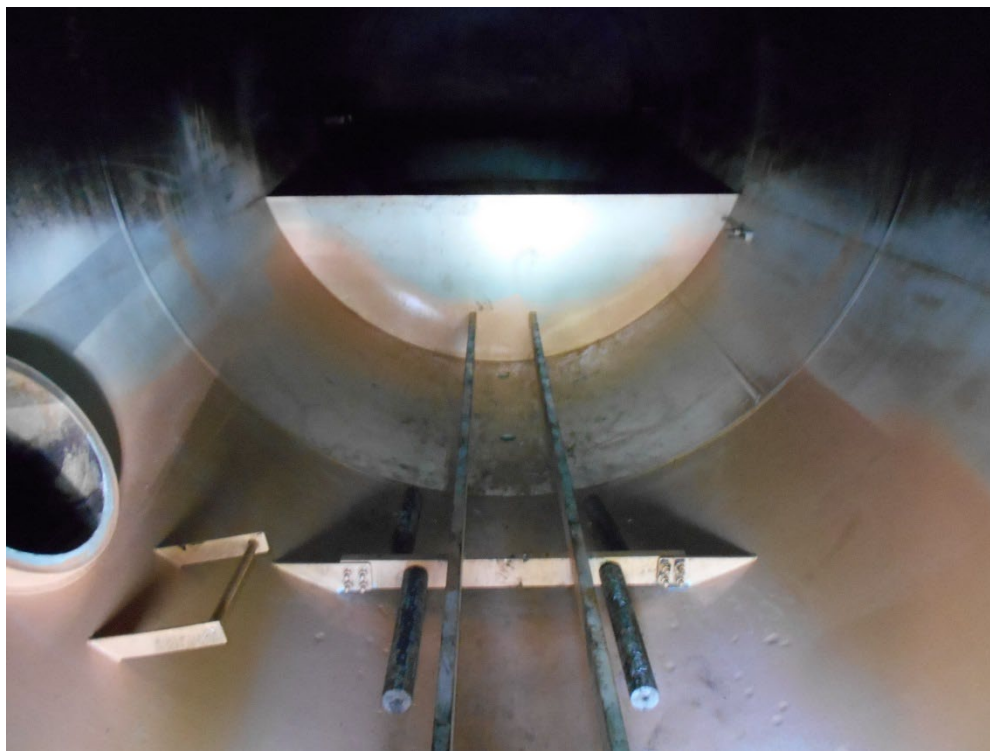
Figure 2 Anodes and 3rd Stage Weir near Manway

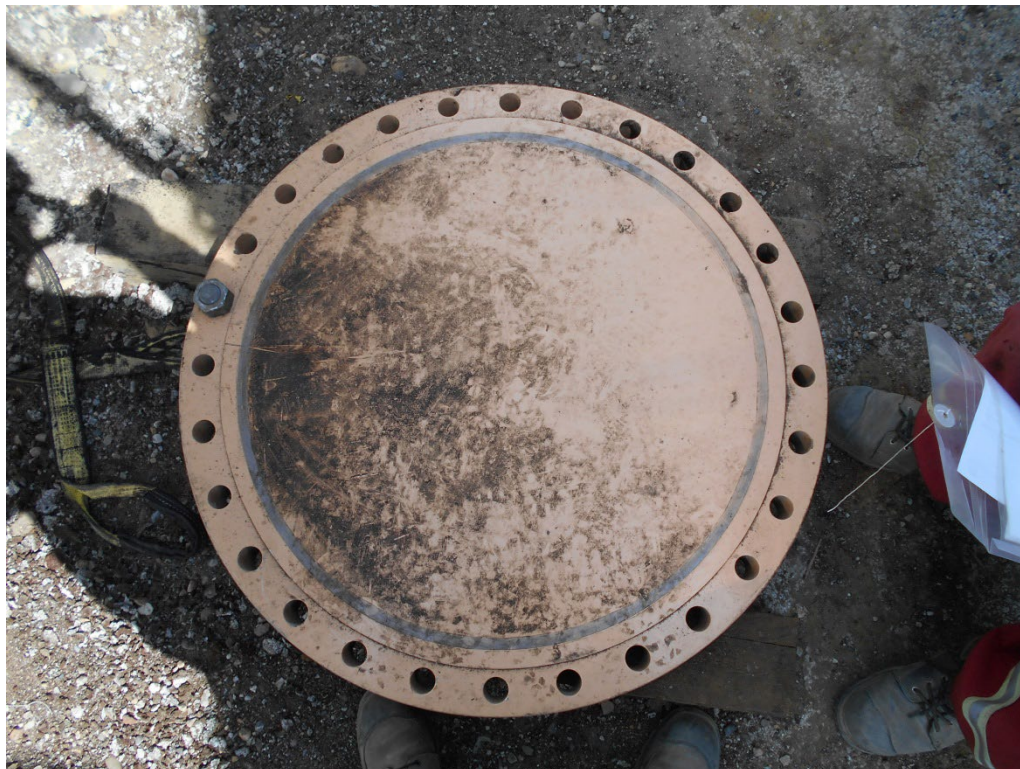
Figure 3 Manway Access Door

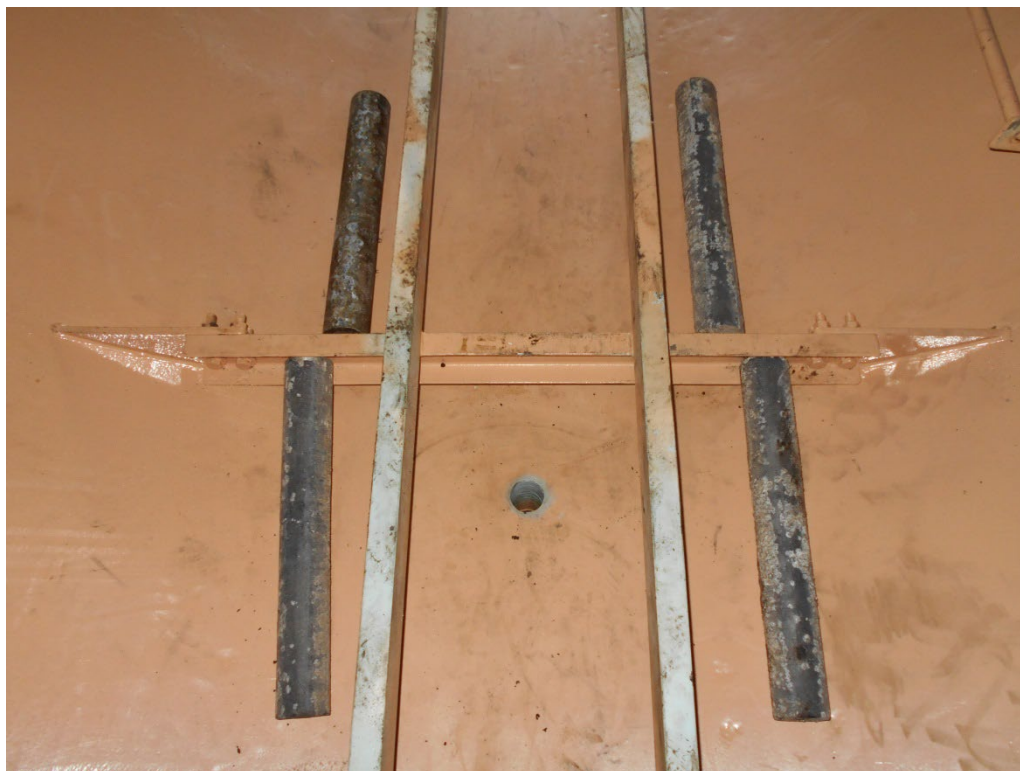
Figure 4 Anodes

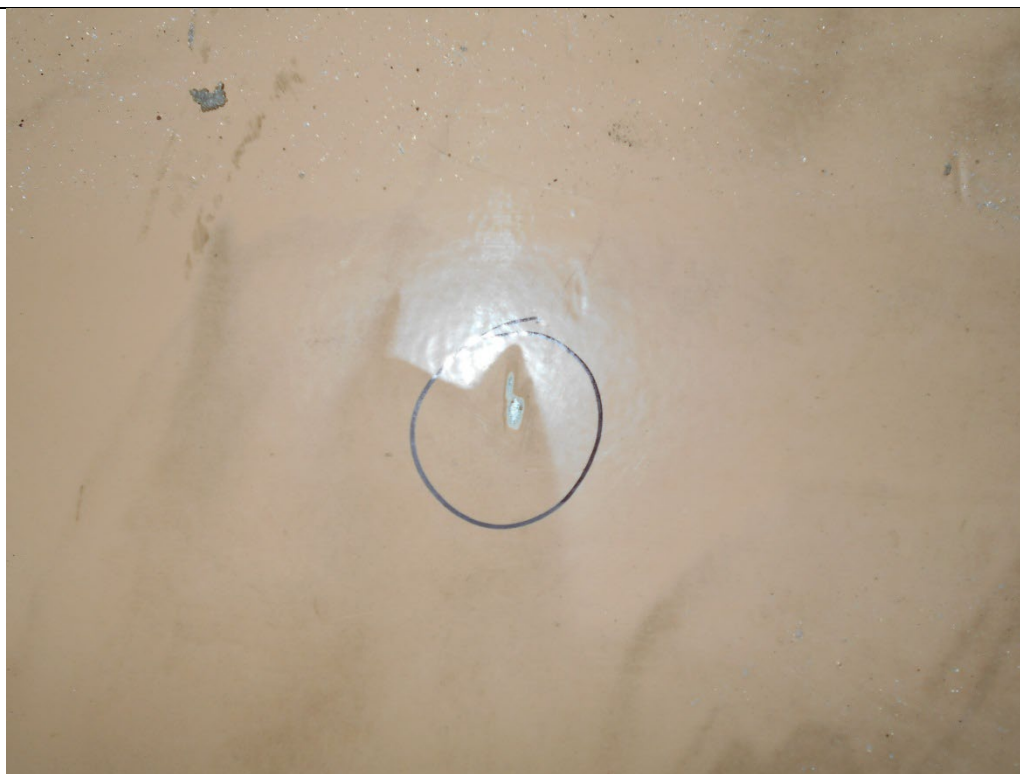
Figure 5 Example of Chip in Coating

<input type="checkbox"/> HT	<input type="checkbox"/> Other		
Note: Add pages and sketches as needed					
Observations:		<input checked="" type="checkbox"/> External		<input checked="" type="checkbox"/> Internal	
Internal: <ul style="list-style-type: none"> • 3 staged separator divided by 2 weirs. • Bottom half of the vessel is coated. • The vessel was about 30-50% full with sand upon opening for cleaning and inspection. • Coating was well intact and had a total of 8 chips or imperfections requiring repair. • Total of 4 anodes of which all were only 5% consumed • Nozzles are in good condition with no cracks or pitting observed 					
External: <ul style="list-style-type: none"> • Vessel is externally coated and is in near perfect condition. • No visible cracks on exposed welds. 					
Recommendations: Repair chips on coating with epoxy spot repair. Anodes can be left in place and monitored next outage.

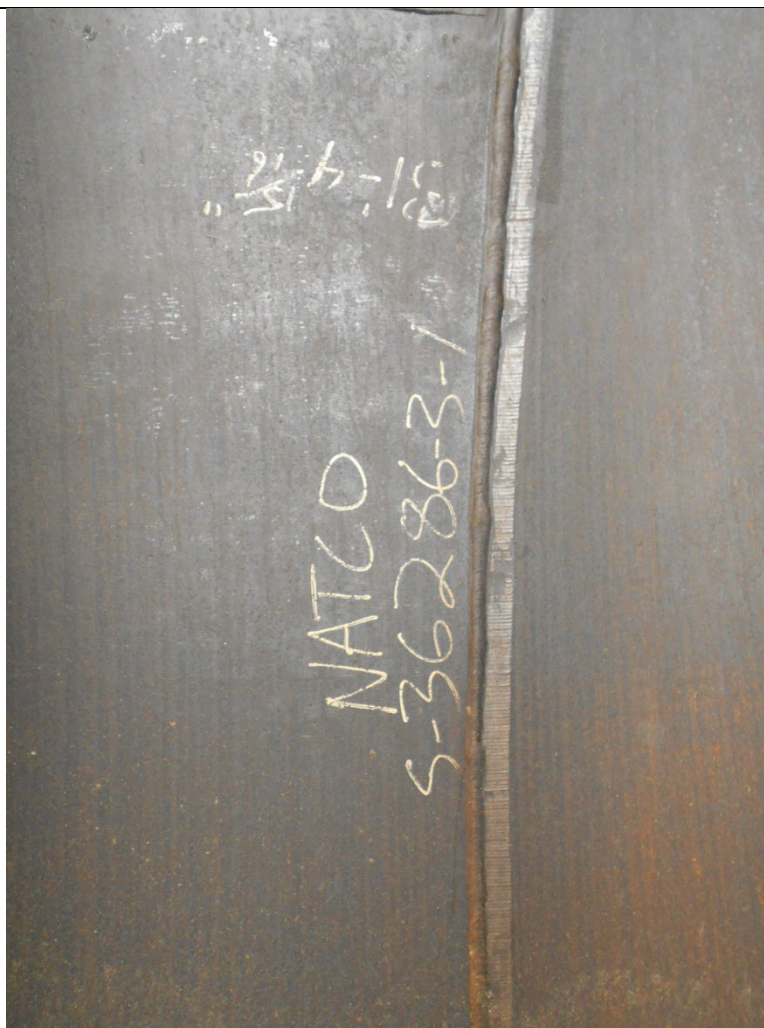
Figure 6 Stenciling on Weld seam

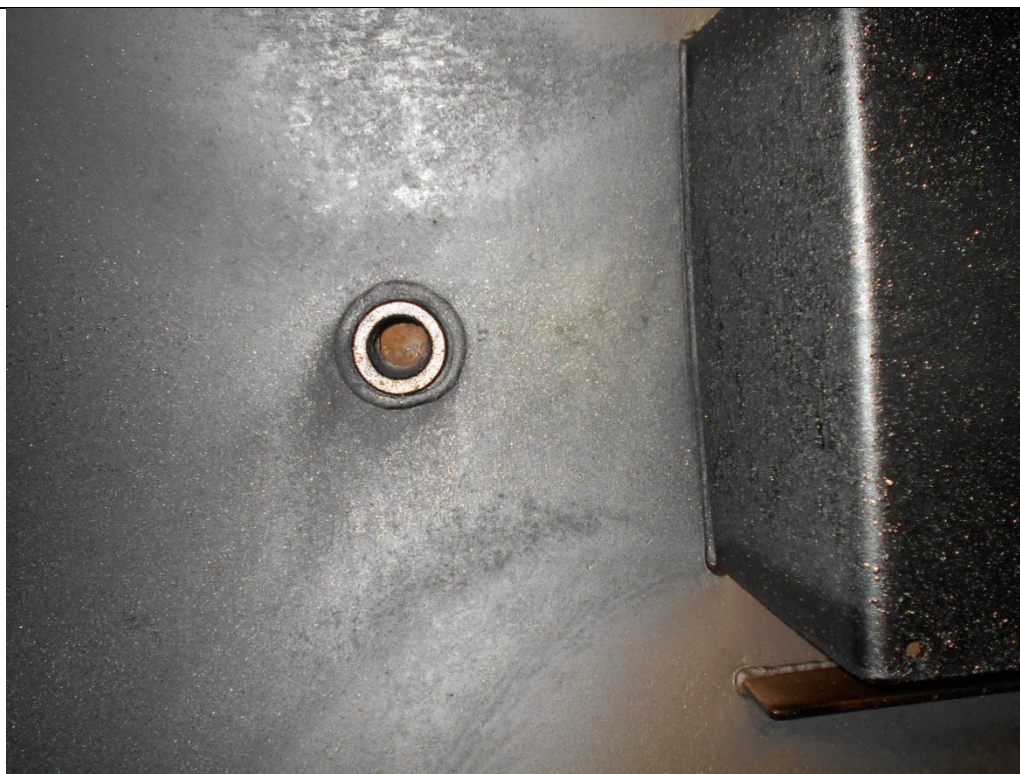
Figure 7 Nozzle

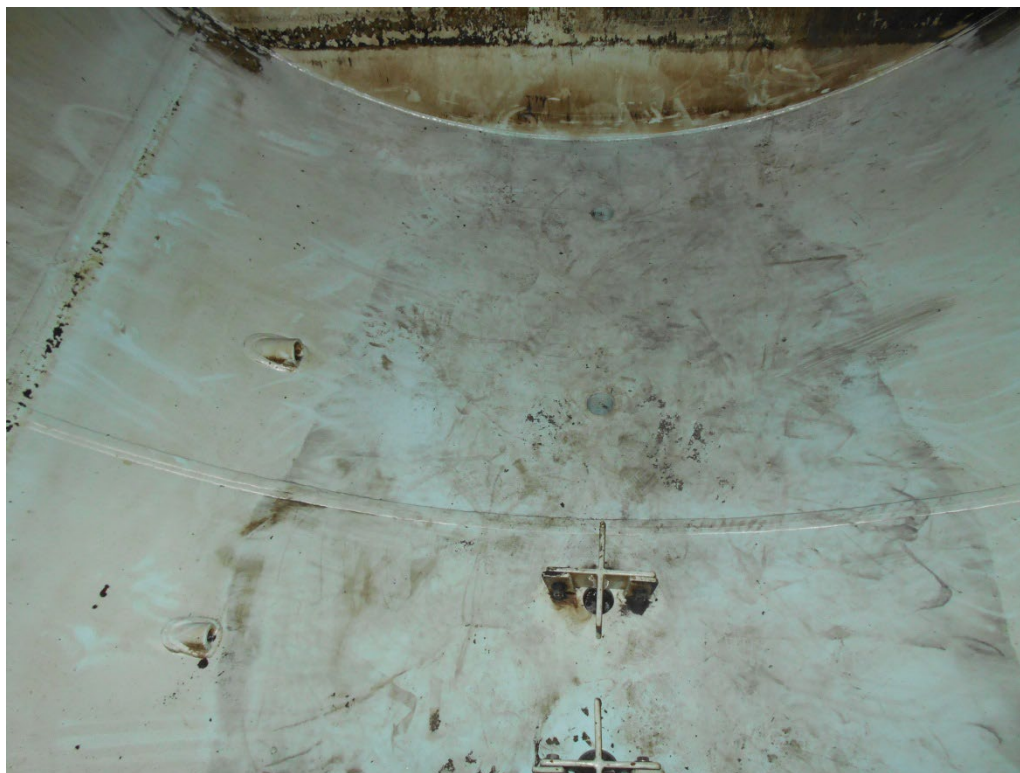
Figure 8 Vessel Bottom 2nd Stage

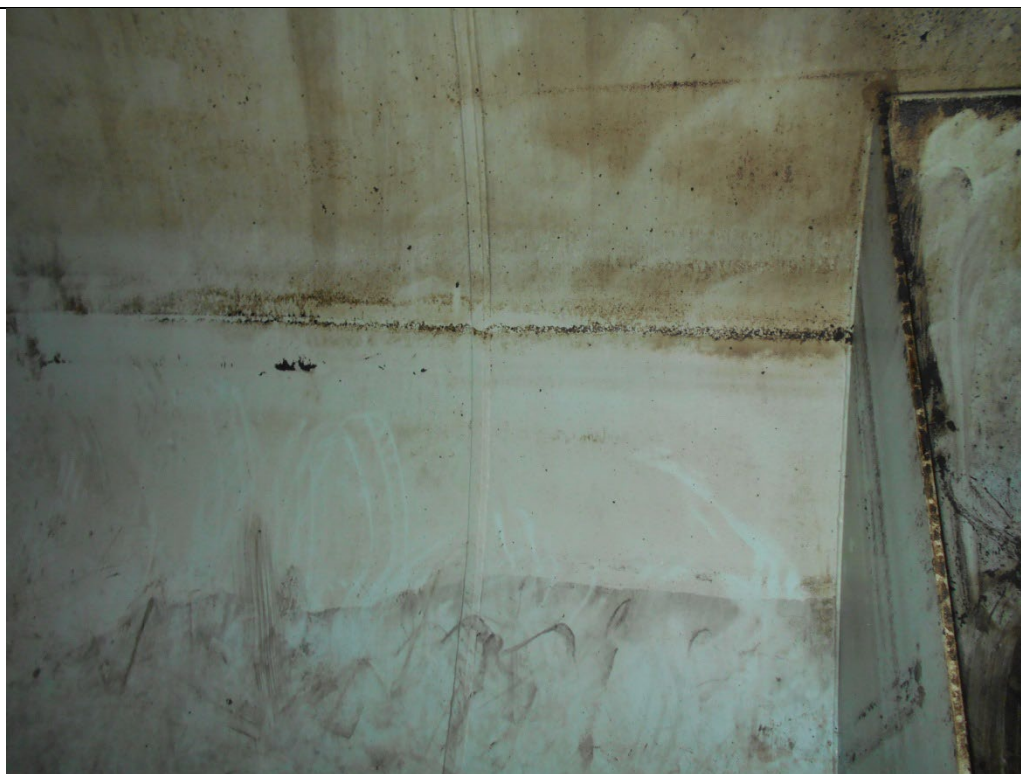
Figure 9 Wall Coating 2nd Stage

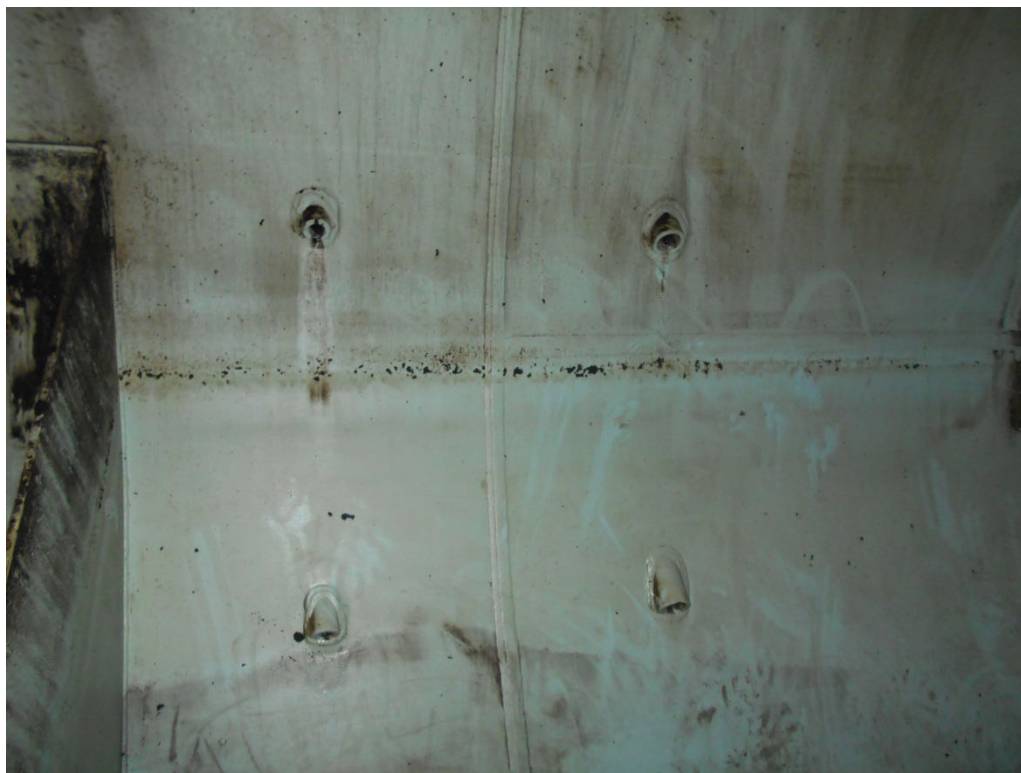
Figure 10 2nd Stage Nozzles

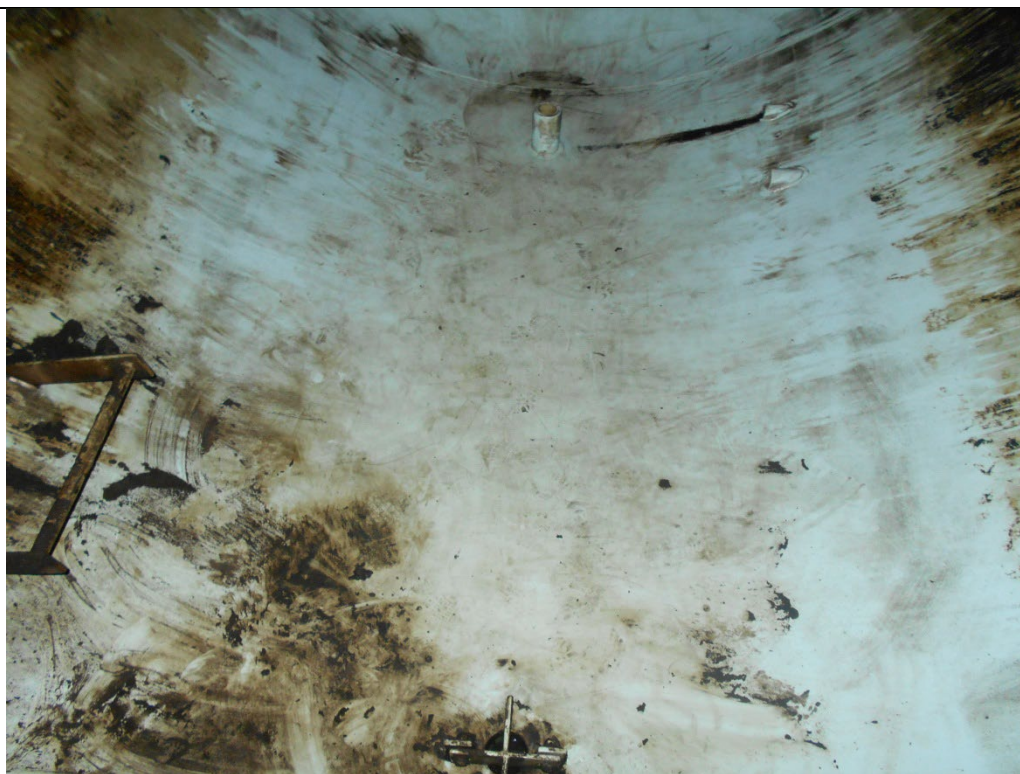
Figure 11 3rd Stage Bottom

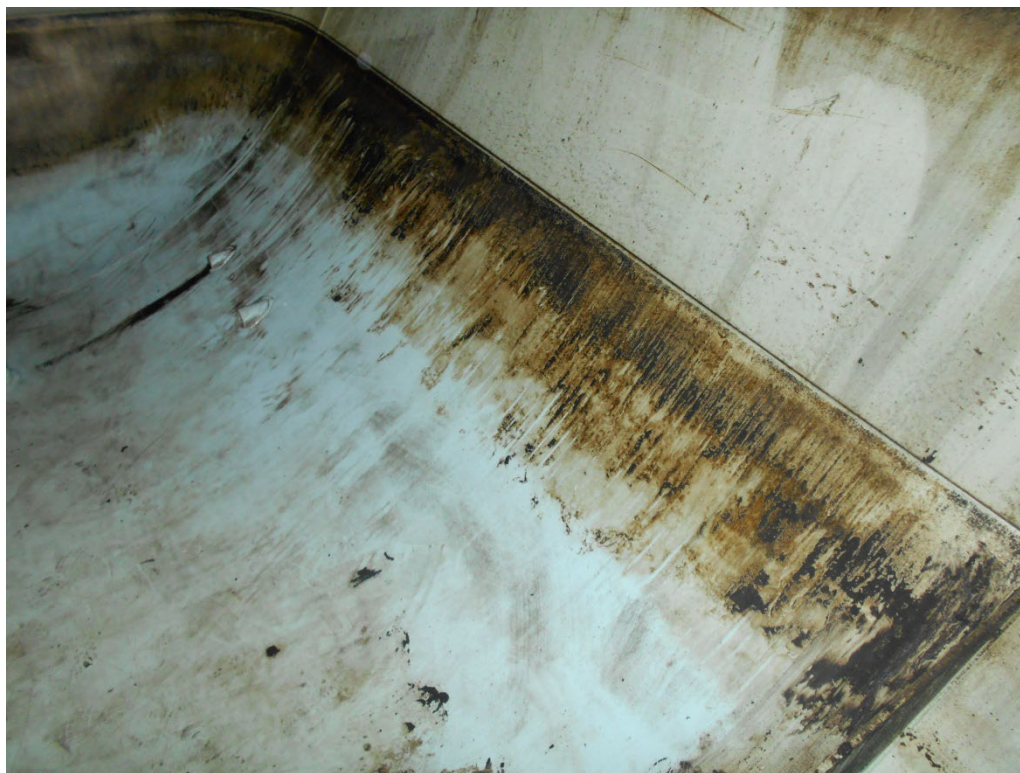
Figure 12 3rd Stage Walls

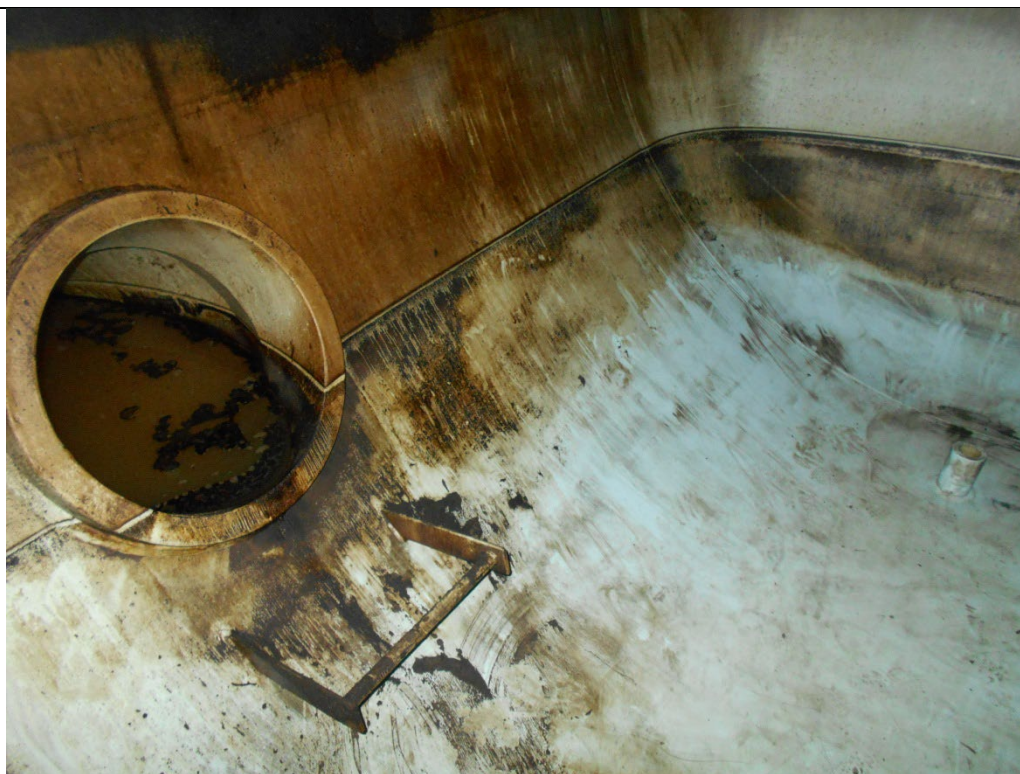
Figure 13 3rd Stage Wall with Manway

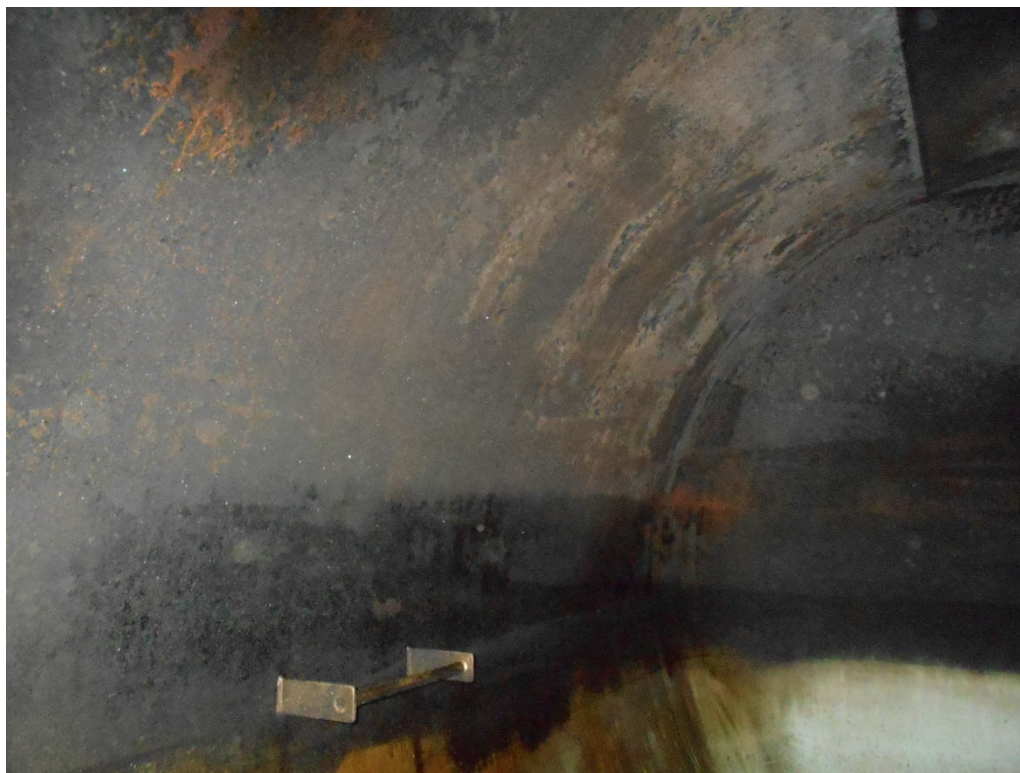
Figure 14 3rd Stage Uncoated Upper Wall

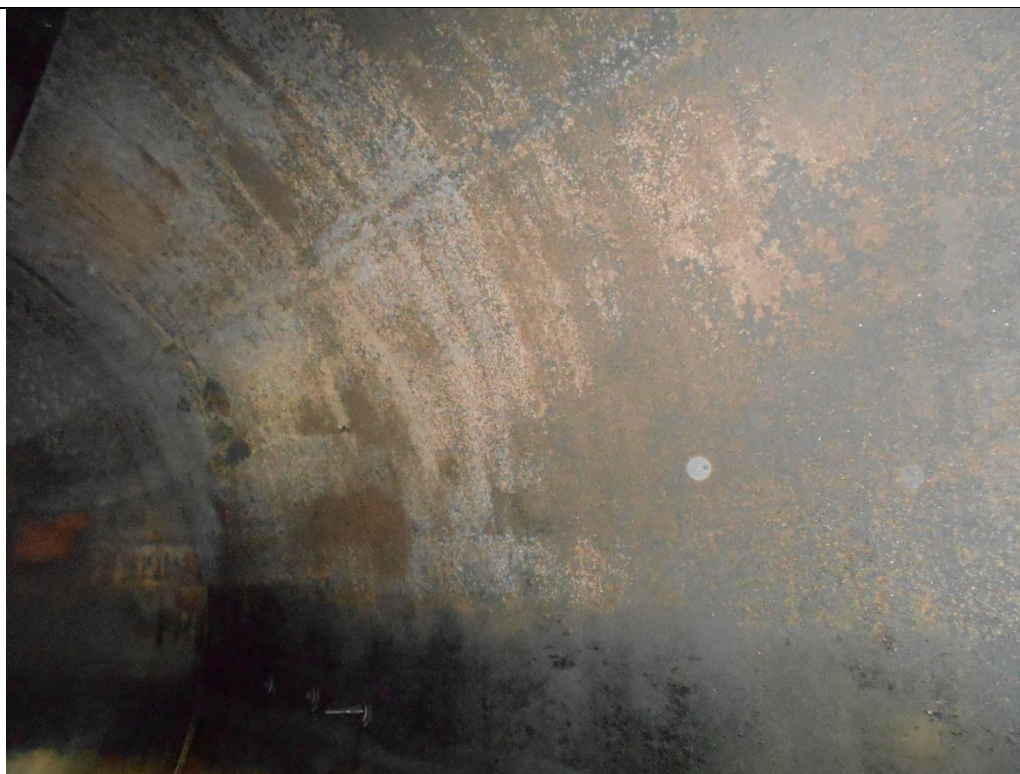
Figure 15 3rd Stage Uncoated Wall
