Encana Corporation Tank Inspection Report

District: Clearwater	Date: May 7, 2013					
Facility: Rockyford	Location (LSD): 14-09-025-23					
Serial Number: 50A11D008	Manufacturer: Tanksafe					
Orientation: Vertical	Tag No.					
Status: Operating	Regulatory Inspection <input type="checkbox"/> Yes <input checked="" type="checkbox"/> No					
NAMEPLATE DATA						
Capacity: 50 bbls	Size (diameter x length- estimate if necessary): 7'10" X 6' primary					
Shell thickness: 3/16"	Deck Thickness: 3/16"					
Floor thickness: 1/4"	Design Pressure: atmospheric					
Interstitial gauge: Yes	Pressure Relief Valve: N/A					
Internal Coating: ? <input type="checkbox"/> Yes <input checked="" type="checkbox"/> No	Double or Single-Wall: <input checked="" type="checkbox"/> Double <input type="checkbox"/> Single					
Type of Coating:						
Manufacturer:	Year built: 2011					
Insulated? <input type="checkbox"/> Yes <input type="checkbox"/> No	Manway? <input checked="" type="checkbox"/> Yes <input type="checkbox"/> No

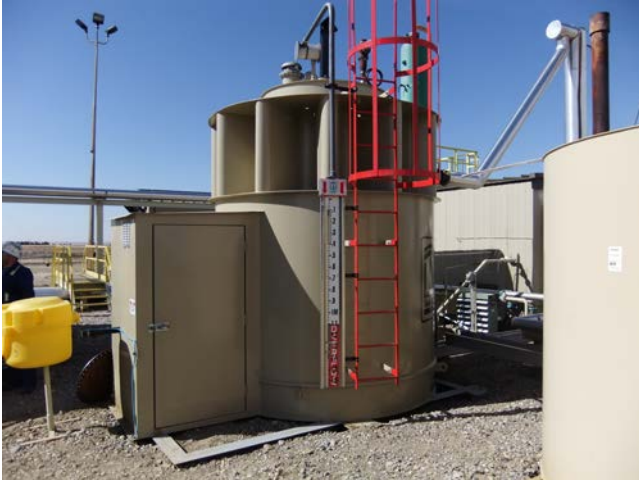
Photo 1 Description: External View

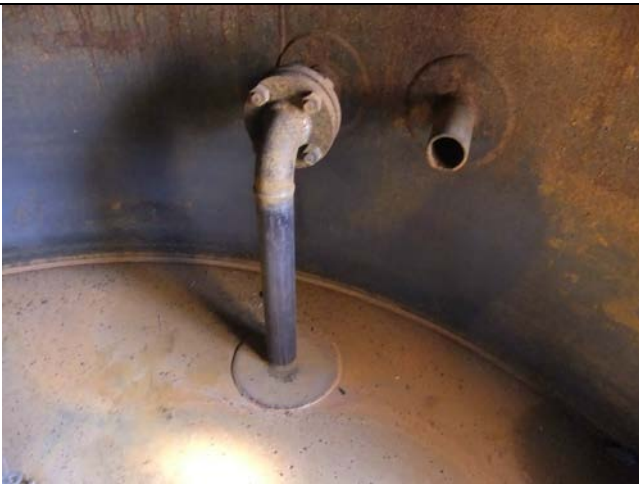
Photo 3 Description: Inlet and Outlet lines

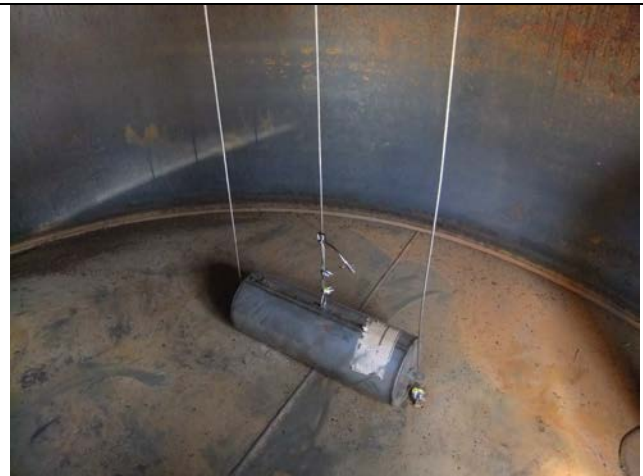
Internal Inspection Items	G	F	P	N/A	Comments
Float	X				Cables replaced immediately before inspection due to fraying
Drain Line	X				Like New, reinforcing plate welded to floor
Roof vent downcomer	X				Like New
Floor	X				No evidence of corrosion
Walls	X				No evidence of corrosion
Repairs Required.				X	
NDE Was any NDE done. (MI coordinator to review results)				X	
Recommendations or corrective actions : Tank is Fit for Service					
Other Observations:					
Recommendations:					
Continue normal surveillance of the interstitial space, internal inspection only if opening for operational purposes					
Summary: Tank is in as-new condition

Photo 4 Description: Float with new cables

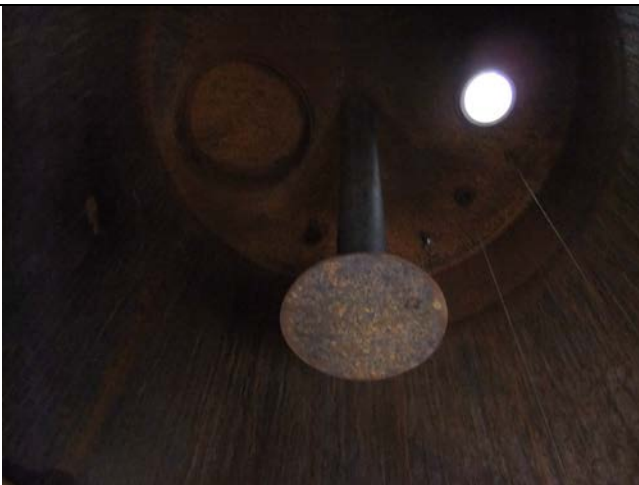
Photo 5 Description: Roof vent downcomer

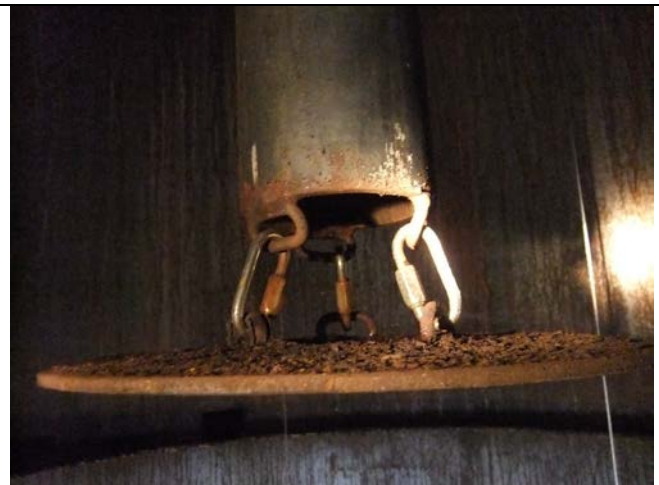
Photo 6 Description: Links holding baffle in place on roof vent downcomer
