VESSEL INSPECTION SUMMARY

Report #: **d34K-173502-01**
 Inspect Date: 30-Oct-15
 Page: 1 of 10
 IRISNDT #: 173502

Client: CHEVRON District: Liard Field: Liard
 Facility: d-34-K Unit / Skid #: N/A LSD: D-34-K/94-O-05
 Jurisdiction #: A573595 Equip Tag #: H-500 Serial #: NWP-2631-01
 CRN #: P0417.213 Nat'l Bd #: N/A Year Built: 2010
 Manufacturer: NWP Equipment Description: LINEHEATER
 Status: In Service - Date Removed From Service: N/A Service: Sour
 MAWP Shell: Atmos @ 200 °F Height/Length: Unknown Code Stamp: Y N
 MAWP Tube: 4503 Psi @ 200 °F Size/Diameter.: Unkno Insulated: Y N
 MDMT: -20 °F RT: RT-1 Volume: Unknown PWHT: Y N
 Support Type: Saddle Manway: Y N
 C.A.: _____ Coated: Y N Clad: Y N J.E.: N/A (No Remote Access) - _____

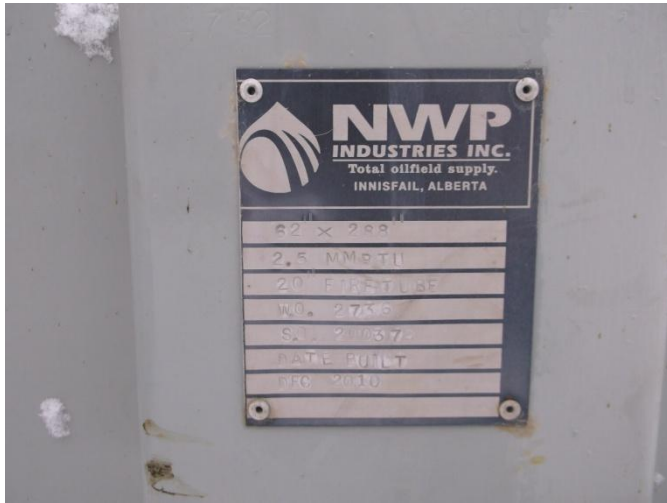
01 - H-500 LINEHEATER DATA PLATE

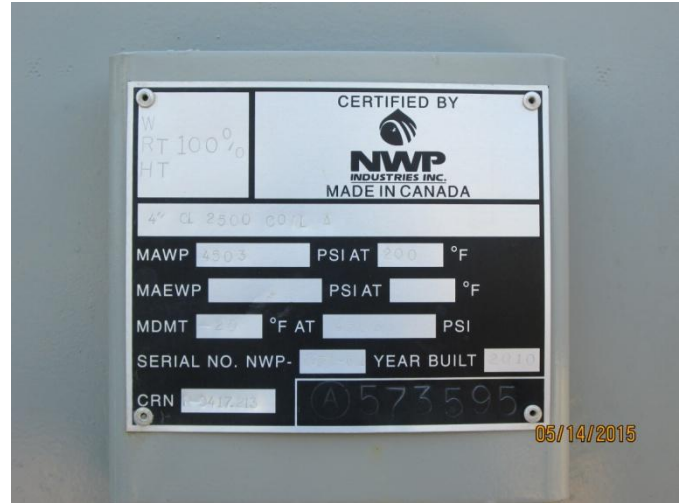
02 - H-500 LINEHEATER DATA PLATE

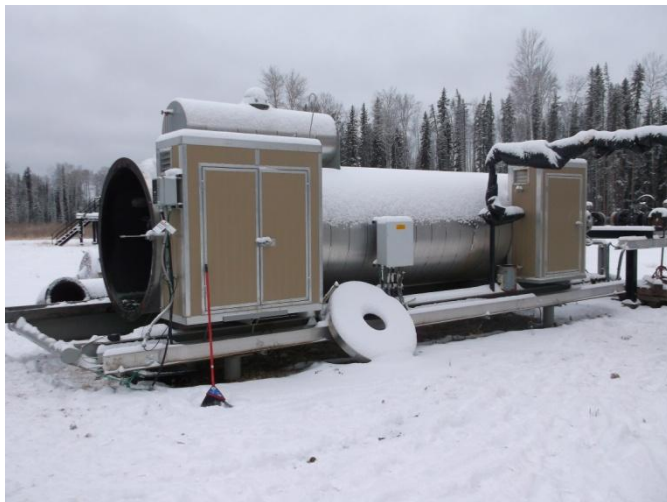
03 - H-500 LINEHEATER OVERVIEW

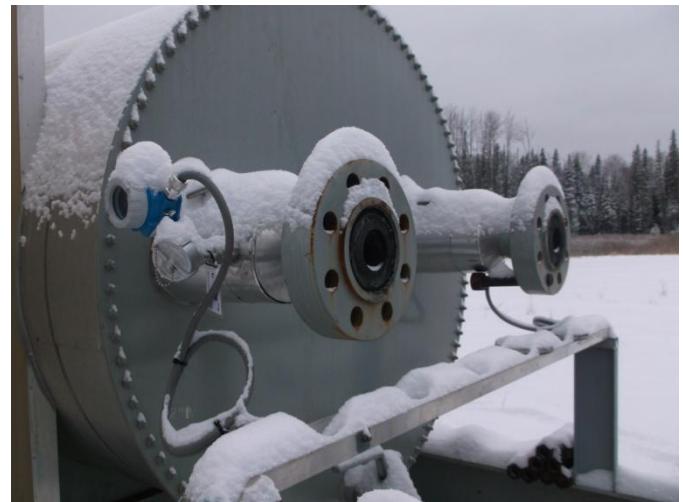
Vessel was dismantled for internal inspection.
 Firetube was removed.
 Piping was dismantled at inlet & outlet.
 UT survet of inlet/outlet elbows showed no issues.

04 - H-500 LINEHEATER INLET & OUTLET DISMANTLED

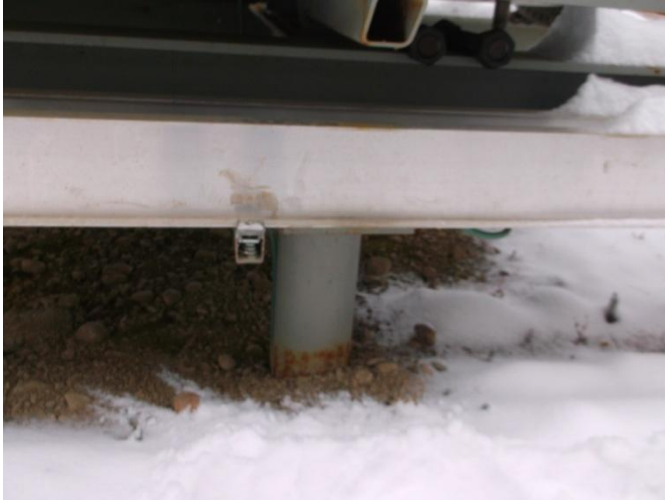
05 - H-500 LINEHEATER SKID 7 PILINGS

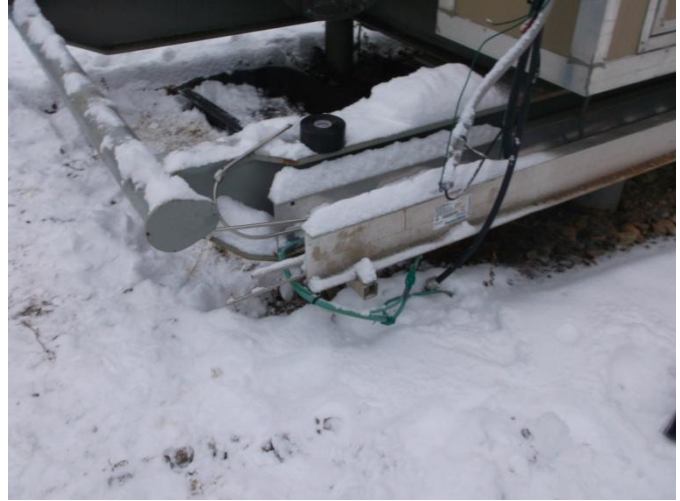
06 - H-500 LINEHEATER SKID 7 GROUND CABLE

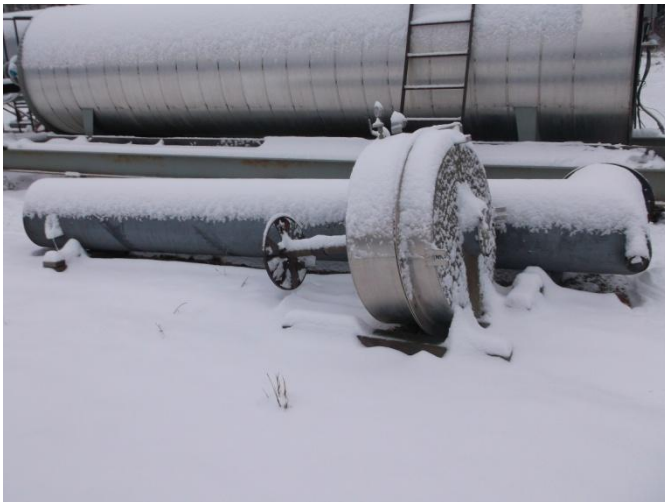
07 - H-500 LINEHEATER BURNER

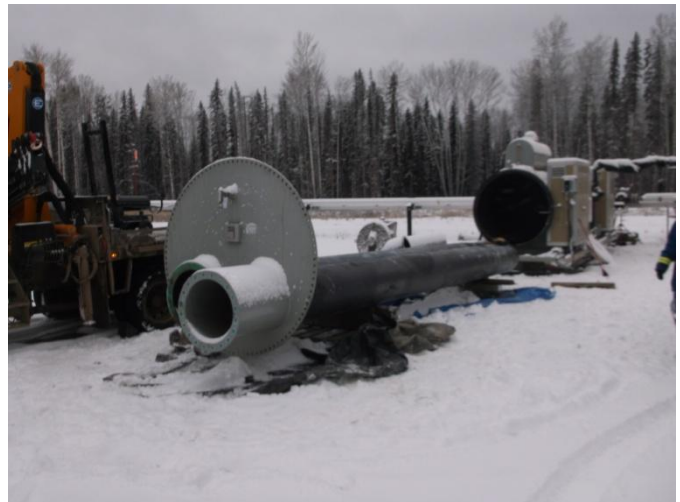
08 - H-500 LINEHEATER FIRETUBE OVERVIEW

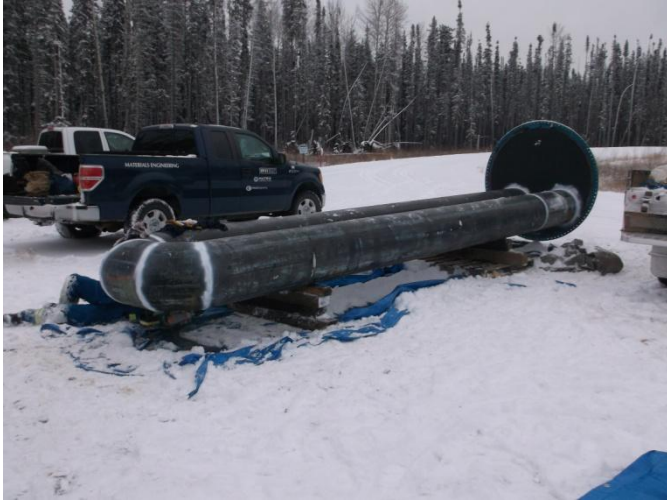
09 - H-500 LINEHEATER FIRETUBE OVERVIEW

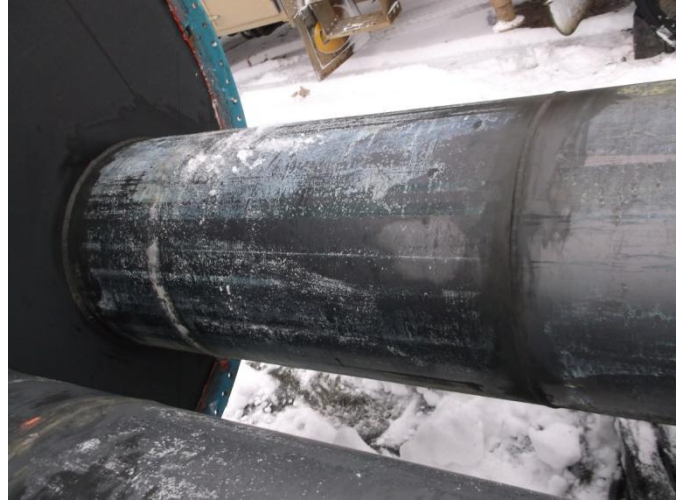
10 - H-500 LINEHEATER FIRETUBE BURNER SIDE

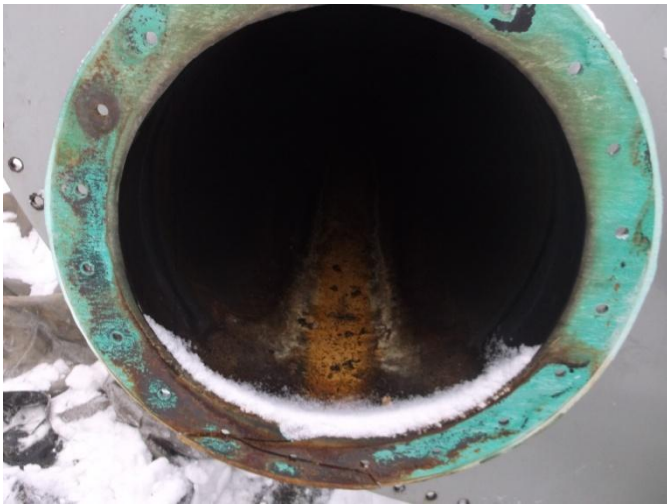
Firetube showed typical discoloration at burner side for first few feet. Some scale build up. Fire tube to tubesheet welds & mitered return bend welds were MPI tested for cracking. No relevant indications were observed. A UT CML survey was conducted on the firetube. No issues were observed.

11 - H-500 LINEHEATER FIRETUBE BURNER SIDE DISCOLORATION

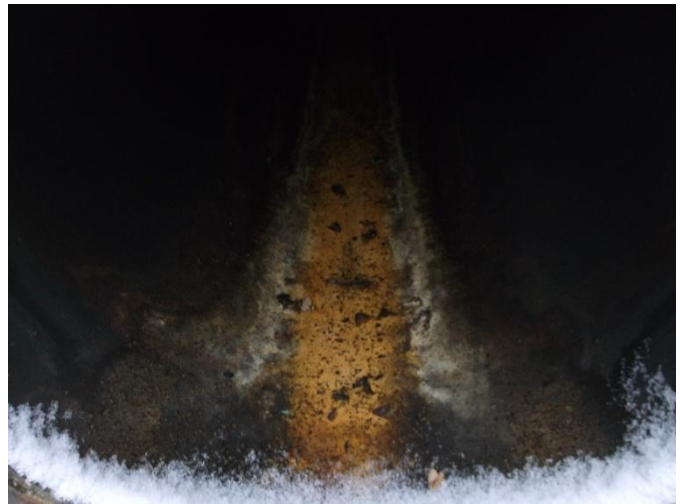
12 - H-500 LINEHEATER FIRETUBE BURNER SIDE DISCOLORATION

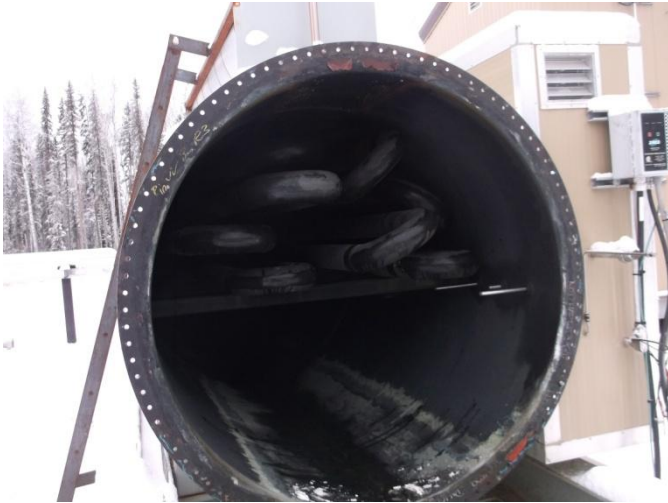
13 - H-500 LINEHEATER OPEN SHELL

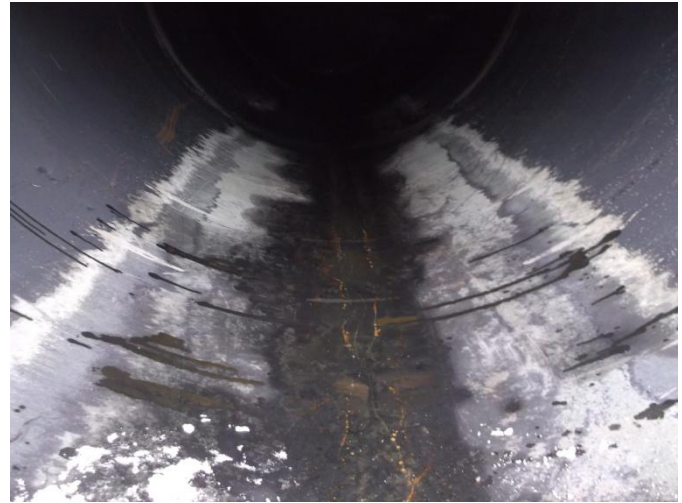
14 - H-500 LINEHEATER SHELL BOTTOM

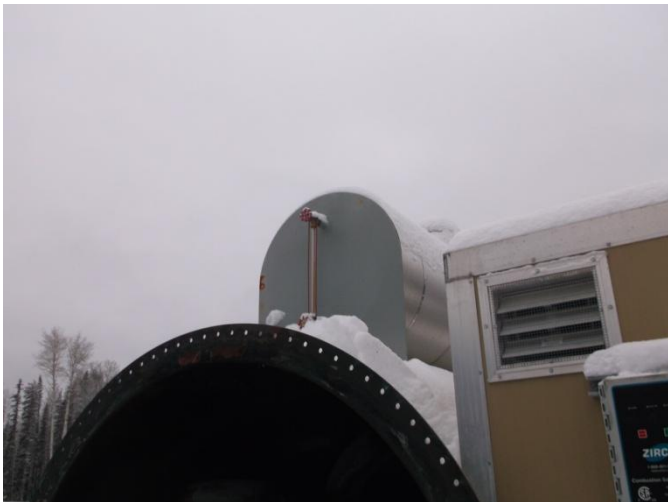
15 - H-500 LINEHEATER EXPANSION TANK & LEVEL GAUGE

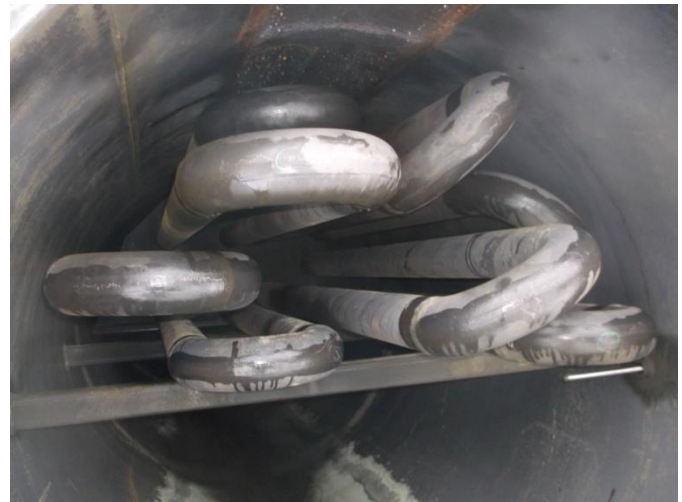
Coil tube bundle was inspected from the open firetube side of vessel. Entry to the vessel was not permitted. No damage, deformation or suspicious deposits were identified. Tube baffle plate appeared in good condition. A UT CML survey was performed on coil return bends accessible from open end. Some general wall loss not below minimum thickness was identified on individual return bend elbows. See UT CML spreadsheet for specific locations.

16 - H-500 LINEHEATER COIL

Continue to monitor general wall loss in coil return bund 180 deg elbows.
 Maintain inspection intervals to ensure safe operation.

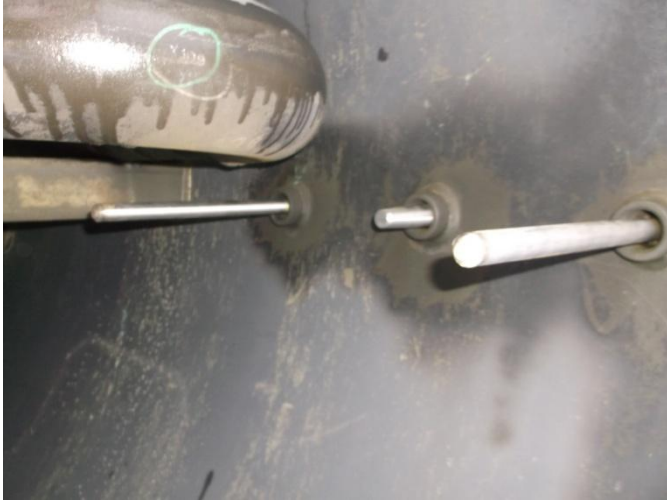
17 - H-500 LINEHEATER PROBES

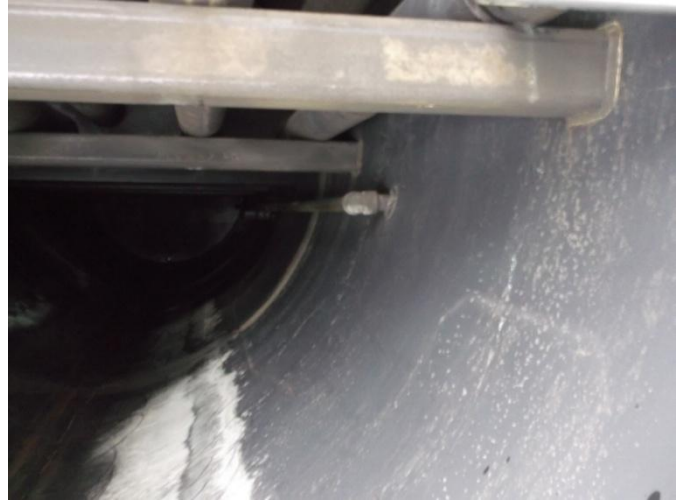
18 - H-500 LINEHEATER PRE-HEAT LINE

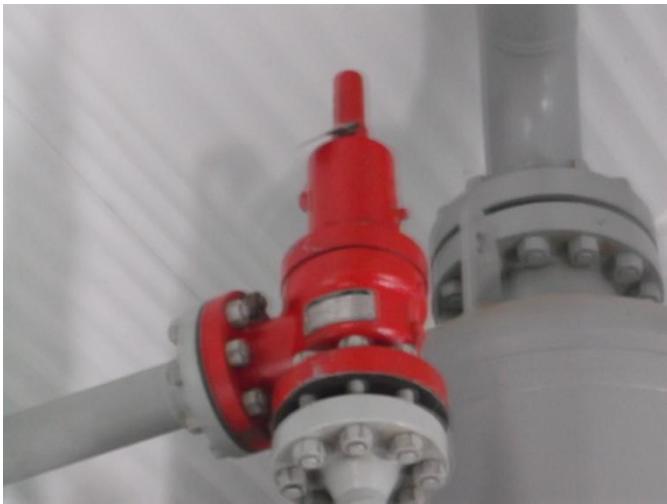
PSV is located on inlet separator.
 Static data & service tag were not verified.

19 - H-500 LINEHEATER PSV OVERVIEW
