## Observation and Findings Report

**PIM Work Order # CS-01**

Client: Encana Corporation

Project Name: 16-06-81-17 Tower Nodal Gas Lift Station (TNGL) Tower Lake

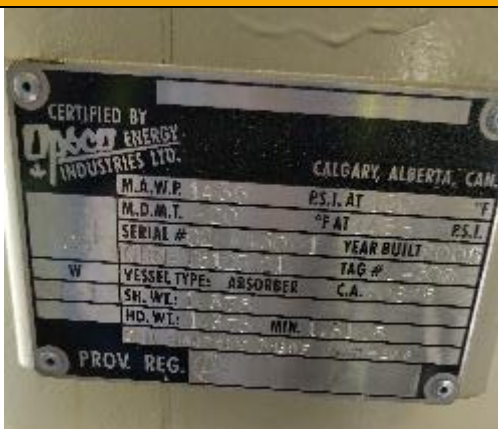
Photo 1 Description: Absorber tower nameplate.

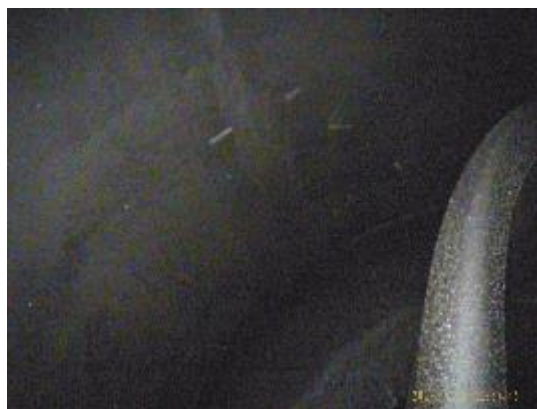
- The inside was extremely black, with only the camera lighting some pictures of the coil and the inside of the lower tower shell. The coil and shell did not appear to have any pitting or corrosion.

Photo 2 Description: Absorber bottom coil, inside the bottom section of the tower.

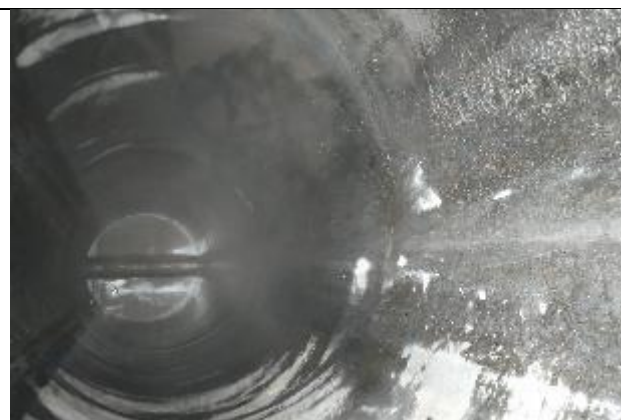
- The reboiler had been taken apart, a steam and vacuum truck had cleaned up the reboiler and fire tube section only.
- Both the inside shell section and the fire tube were found to be in extremely good shape and deemed acceptable for further use.

Photo 4 Description: Reboiler after clean up.

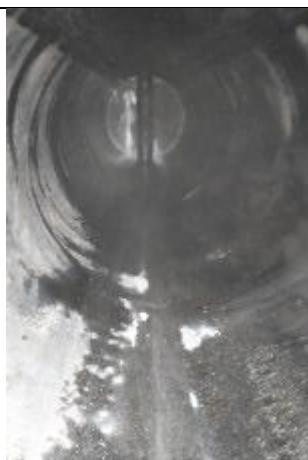
Photo 5 Description: No corrosion.

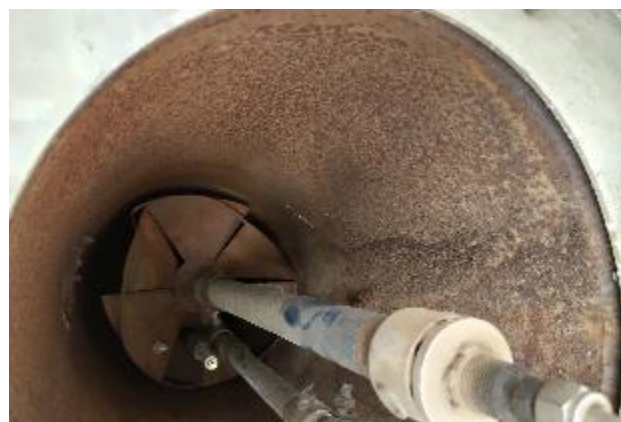
Photo 6 Description: Fire tube burner assembly.

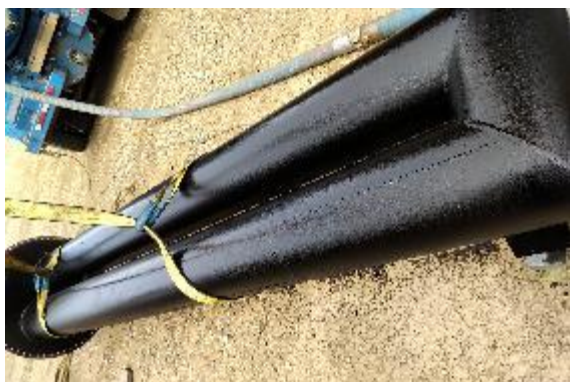
Photo 7 Description: Fire tube external.

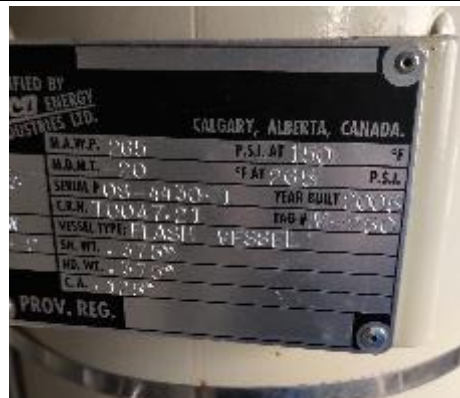
Photo 8 Description: Reboiler nameplate.

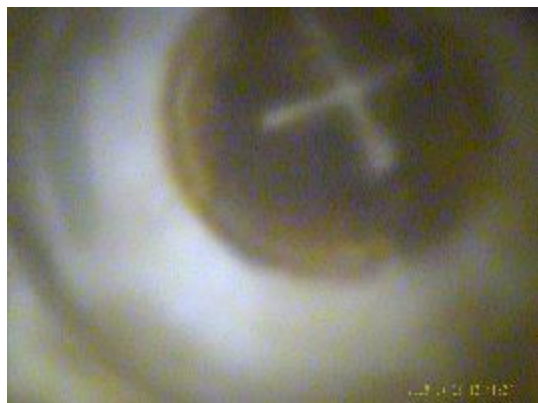
- A borescope review was performed on the inside of the internally coated vessel.
- The vessel weir was located and photos were taken. The boot section was accessed and some photos were taken. Based on the limited lighting it appeared to be free from major solid build up and in extremely good shape. The rest of the equipment on the separator package was also in good shape.

Photo 9 Description: Separator boot vortex breaker inside.

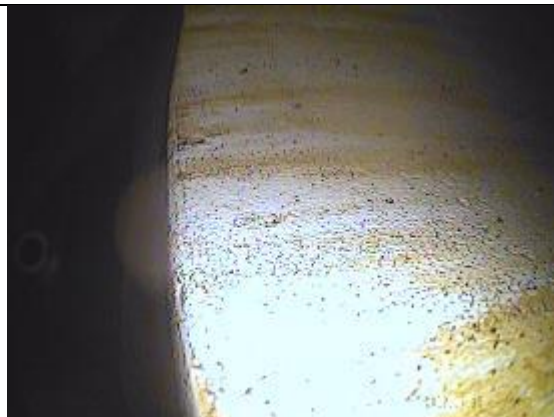
Photo 10 Description: Separator boot and drain.

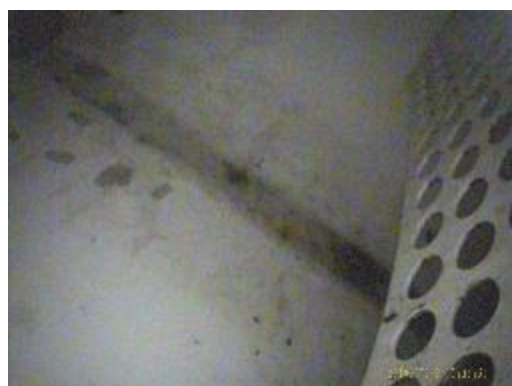
Photo 11 Description: Separator bottom weir located right of boot.

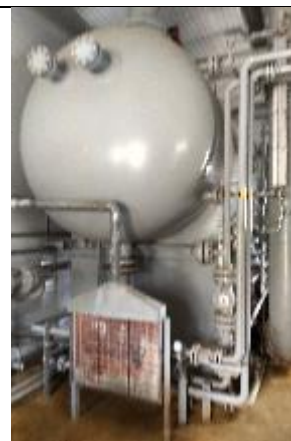
Photo 12 Description: Separator assembly.

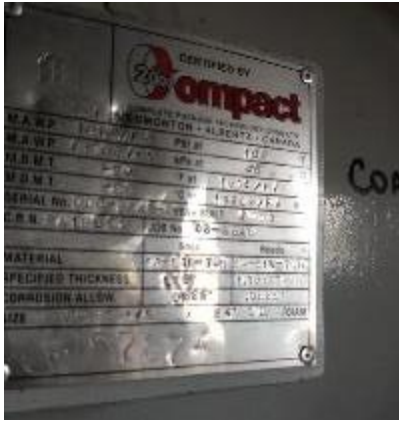
Photo 13 Description: Separator nameplate.
