Pressure Vessel Thorough Inspection Report

Client Work Order:		Report Number: 12212A	Date: October 18, 2020	Page 1 of 8
PRN Number: A 0126332	Description: 25,300 Gal. Western Rock Bit vessel CRN C-4936.23		Location: Dalemead, AB	
Max. Allowable Working Pressure: 225 PSI	Max. Allowable Working Temperature: 150°F	Inspection Spec: ASME V, API 510

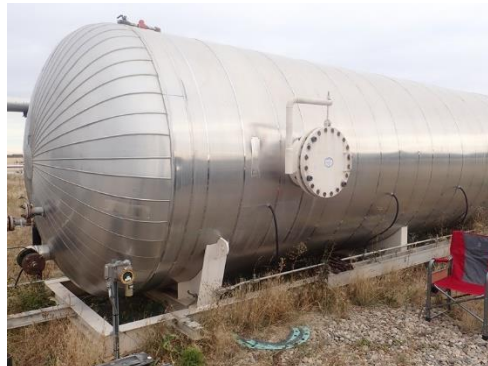
Inspection Points	In Order	N/A	Comments
1. Have all safety precautions been undertaken?	√		
2. Do previous inspection reports indicate any areas of concern?	X		Vessel has manway addition and de-rated to 225 psi
3. Did any abnormal process conditions or disturbances occur since the last inspection? If yes, specify.	√

Manway addition alteration

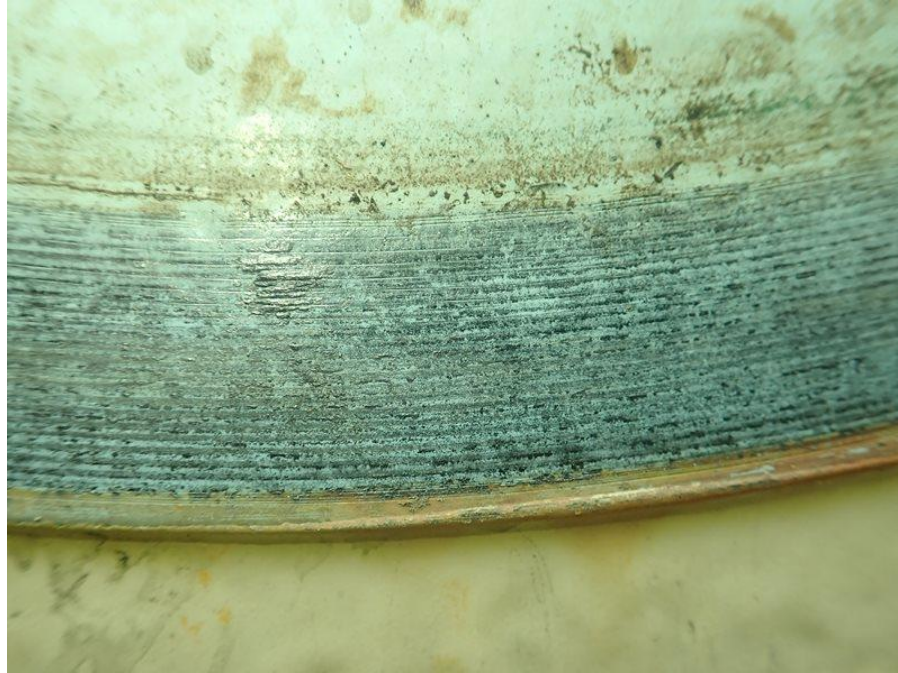
7. If possible, check gasket seats on all flanges. Check for signs of corrosion and/or mechanical damage?	✓		Gasket seating surface on both manways in good condition	
Internal Equipment/Piping/Supports				
Inspection Points	In Order	N/A	Comments

Gasket seating surface 16 in. manway

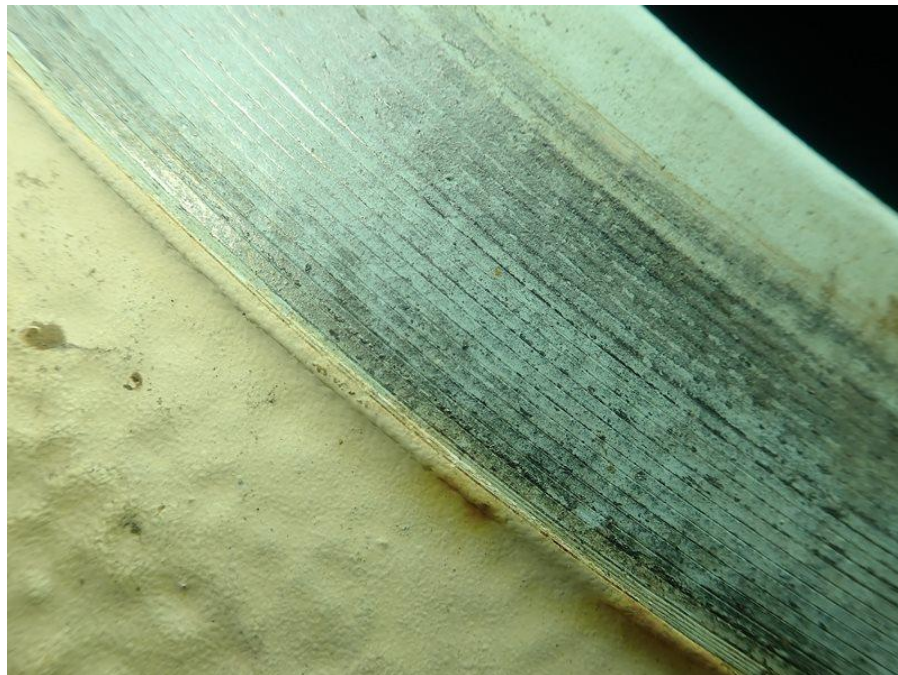
Gasket seating surface 20 in. manway

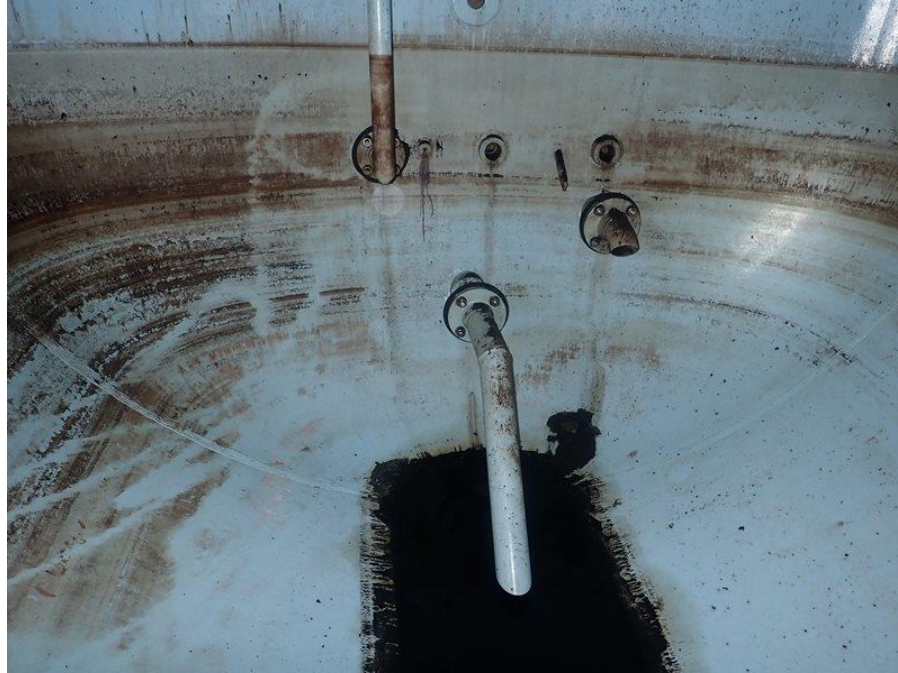
Internal view Head A

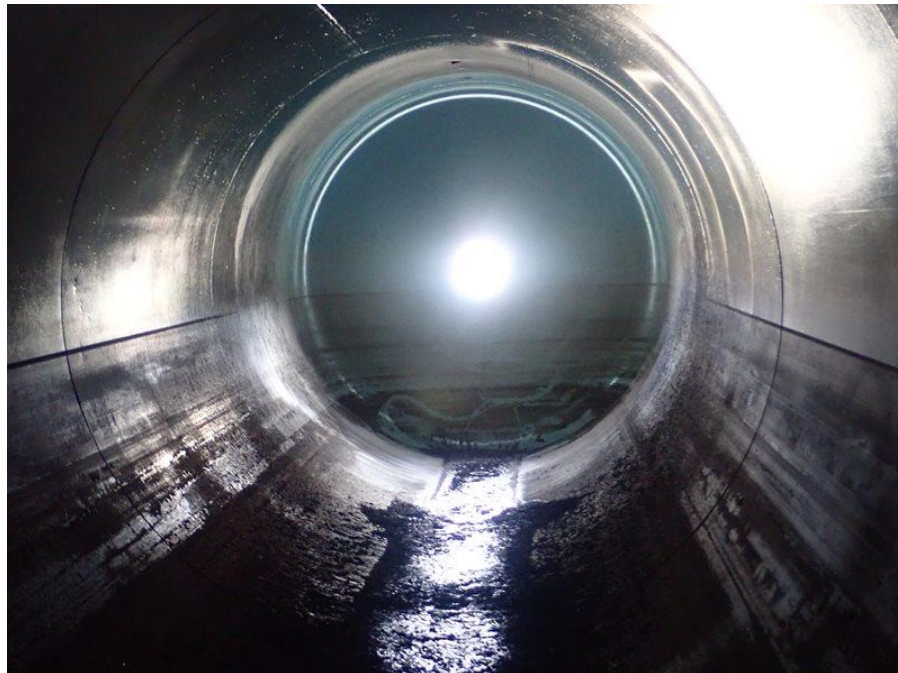
Internal view Head B

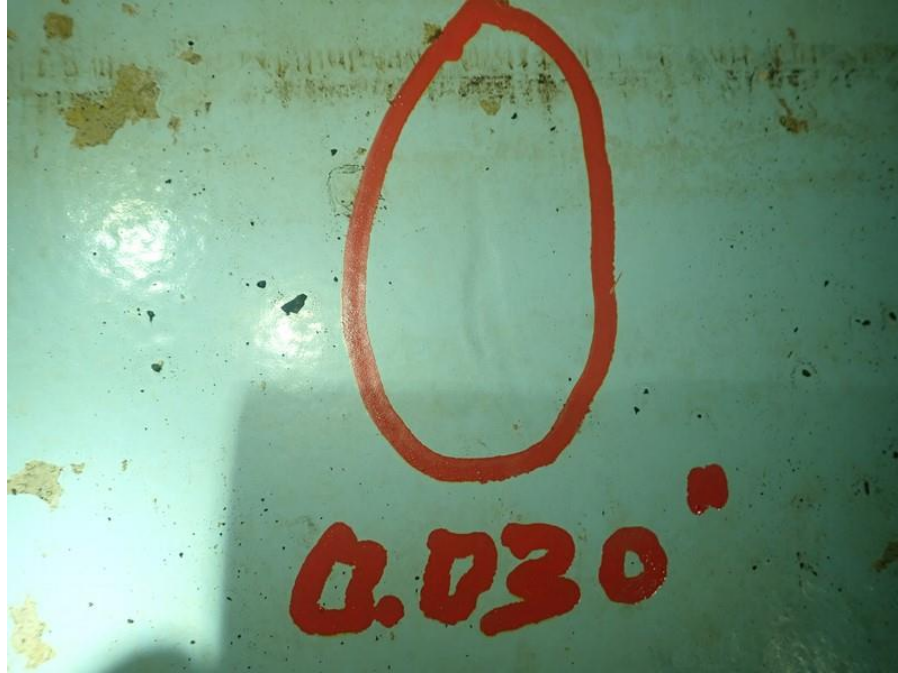
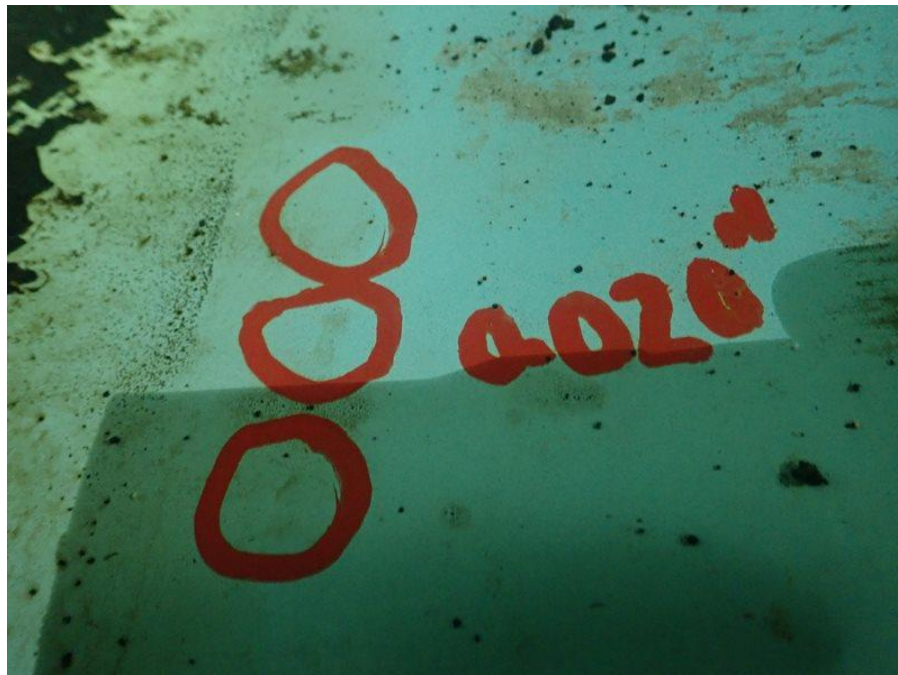
1. Check for signs of corrosion, erosion, cracks, blisters, pitting, distortion, or other forms of deterioration on the internal vessel surfaces? If so, specify type, location and extent.	✓		Vessel has internal coating over all surfaces. Some minor scattered corrosion evident. Less than 0.040 in. depth visible beneath coating

Pitting on shell

Vessel appears to have had a pitting corrosion issue prior to coating. All pits measured were below 0.050 in. and are soundly coated with epoxy type coating over entire internal vessel surface, including attachments. There is no visible instance of corrosion currently.

Vessel is suitable for continued service.

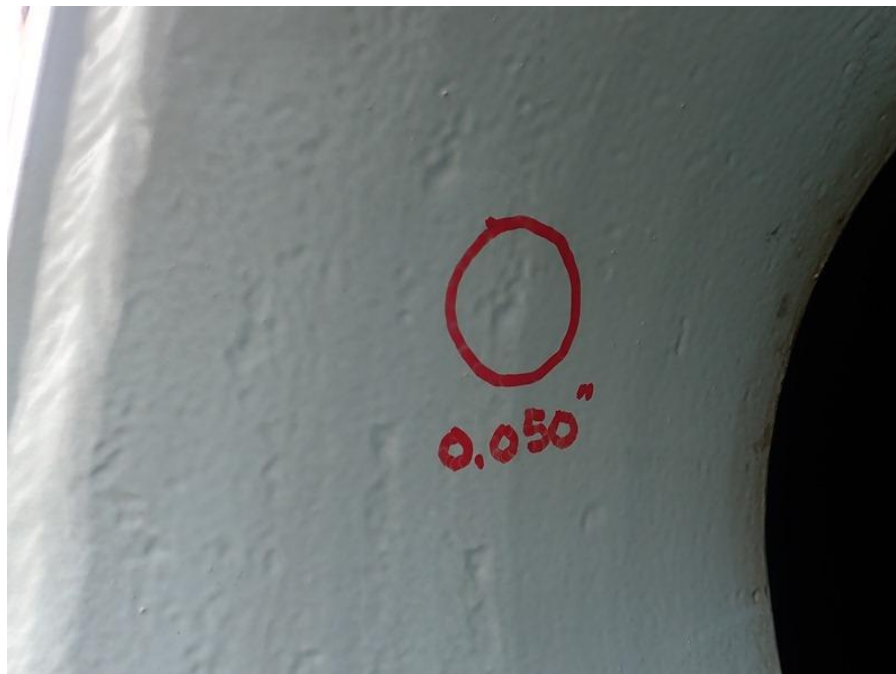
3. Check all manways, nozzles and connections for distortion, cracks, corrosion, wall loss, and other kind of defects or failures. If any defects are noted, specify type, extent and location.	✓		Manway nozzle shows some corrosion on nozzle less than 0.050 in. depth.

Pitting on 16 in. manway
