**PEYTO EXPLORATION & DEVELOPMENT CORP. PRESSURE VESSEL
ABACUS # 9468**

Peyto Exploration & Development Corp.
Galloway Plant 9-34-53-20 W5M

August 16, 2016
LPG Storage Tank
A 0578666, Sn S0700021, CRN L5670.51234
Internal Inspection,
Wet Fluorescent Magnetic Particle Inspection
& Partial Ultrasonic Inspection

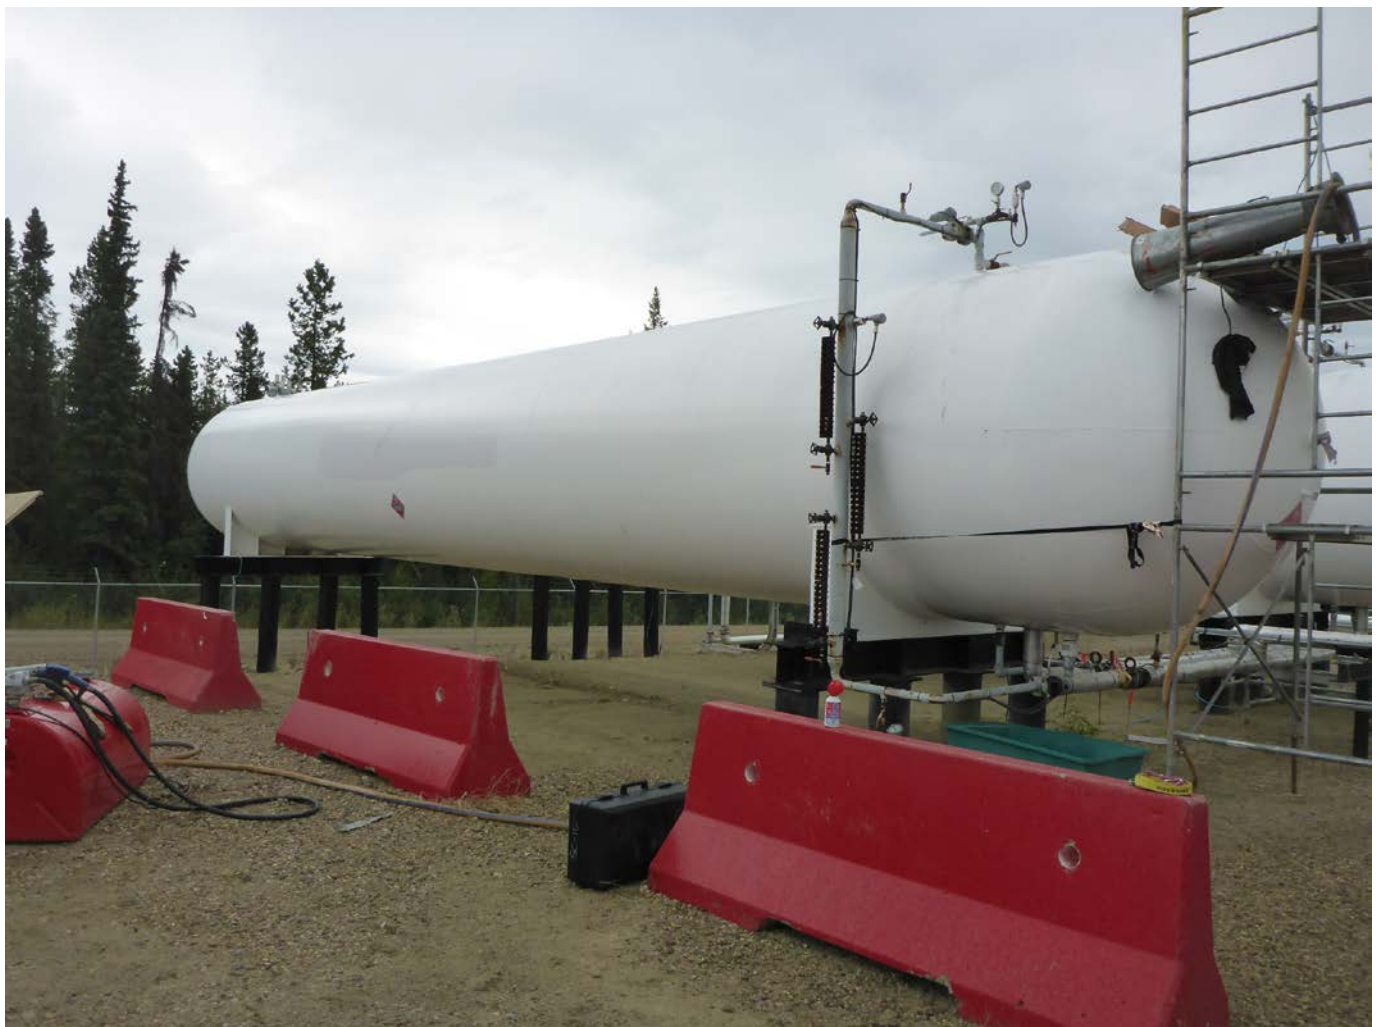
External View

Day Consulting Inc.		External Visual Inspection			63-33 Donlevy Avenue, Red Deer, AB, Phone 403-396-2127	
Location: 9 - 34 - 53 - 20 W 5 M		(A) 0578666			Date: August 16, 2016	
Sub Facility: LPG Bullet		Manufacturer's Serial Number: S0700021		Year Built: 2007	Client: Peyto Exploration and Development Corp. Galloway	
MAWP@Temp / MDMT / RT/HT: 250 psi @ 125F 2F		Equipment: LPG Bullet			CRN: L5670.51234	
G=Good F=Fair P=Poor N/A=Not Applicable		G	F	P	N/A	Comments
Insulation - Verify sealed around manways, nozzles, no damage present, and there is no egress of moisture. Are straps secure?		<input type="checkbox"/>	<input type="checkbox"/>	<input type="checkbox"/>	<input checked="" type="checkbox"/>	
Vessel Extends through the building roof?		Yes <input type="checkbox"/>	No <input type="checkbox"/>	NA <input checked="" type="checkbox"/>		
External Condition - Assess paint condition, areas peeling, record any corrosion, damage, distortion etc. (record location, size and depth of corrosion or damage)		<input checked="" type="checkbox"/>	<input type="checkbox"/>	<input type="checkbox"/>	<input type="checkbox"/>	Paint is 98%.

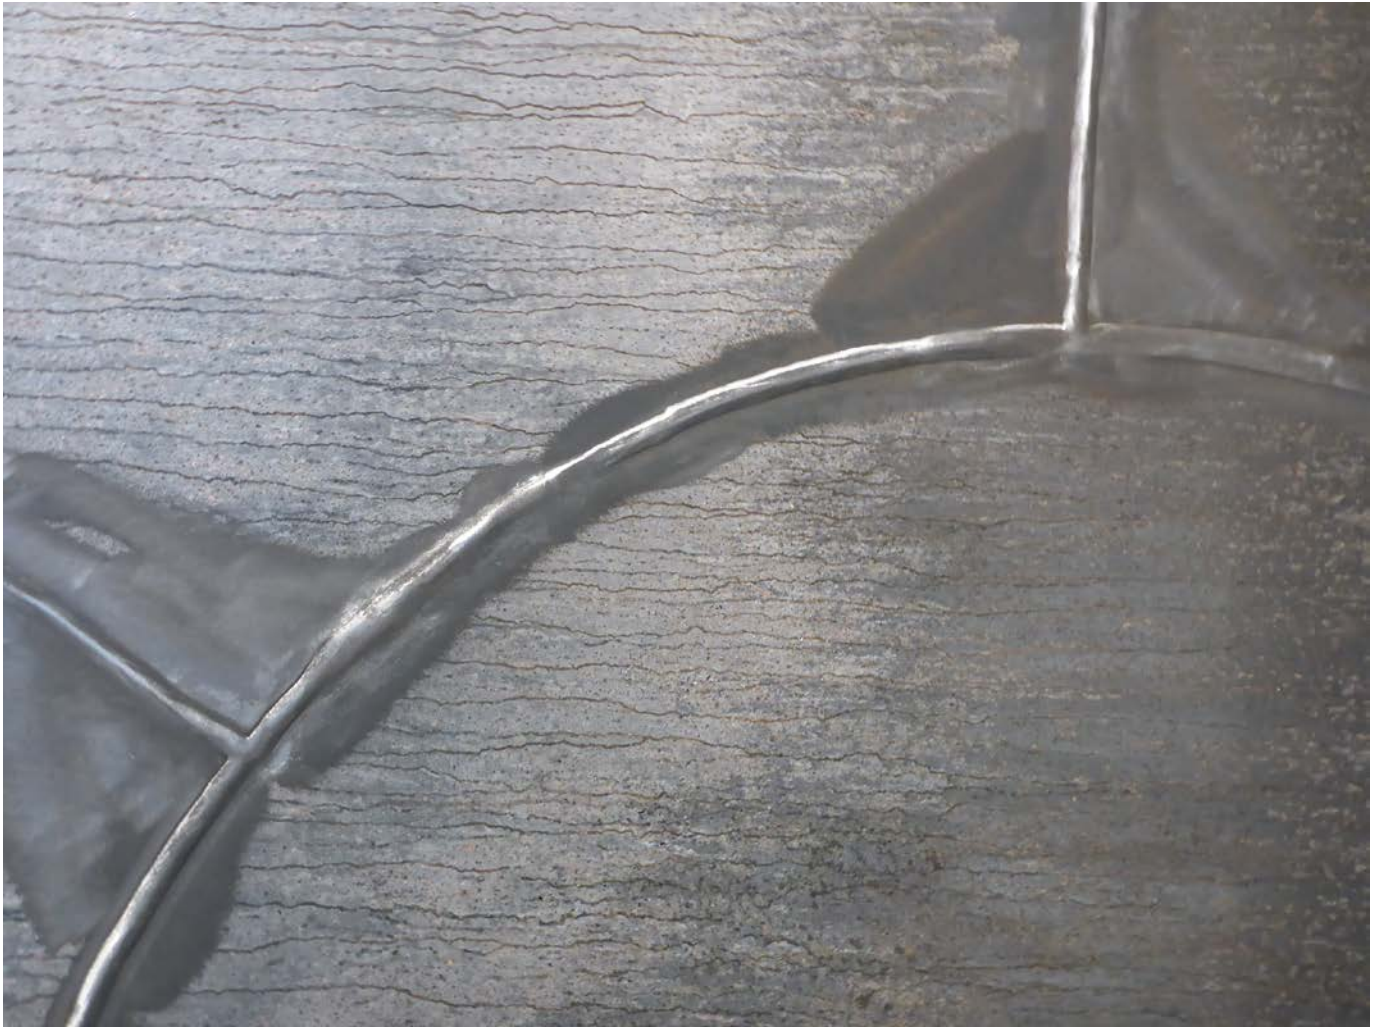
North Head

Rear Head (East) Note all corrosion, erosion or mechanical damage. (If vessel is horizontal identify "Right" or "Left" are oriented while facing the Nameplate.					<input checked="" type="checkbox"/>	<input type="checkbox"/>	<input type="checkbox"/>	<input type="checkbox"/>	Only superficial corrosion not exceeding 0.005". No Erosion or Mechanical Damage
Shell Sections Record location, size and depth of all erosion, corrosion or mechanical damage. Describe general condition. If any corrosion greater than corrosion allowance is observed in either shell or head, discuss with Chief Inspector before closing vessel.					<input checked="" type="checkbox"/>	<input type="checkbox"/>	<input type="checkbox"/>	<input type="checkbox"/>	Only superficial corrosion not exceeding 0.005". No Erosion or Mechanical Damage
Demister Pad Is it in place? Is it clean? If any corrosion is apparent in vessel, lift pad and check top head for corrosion.					<input type="checkbox"/>	<input type="checkbox"/>	<input type="checkbox"/>	<input checked="" type="checkbox"/>	No demister.

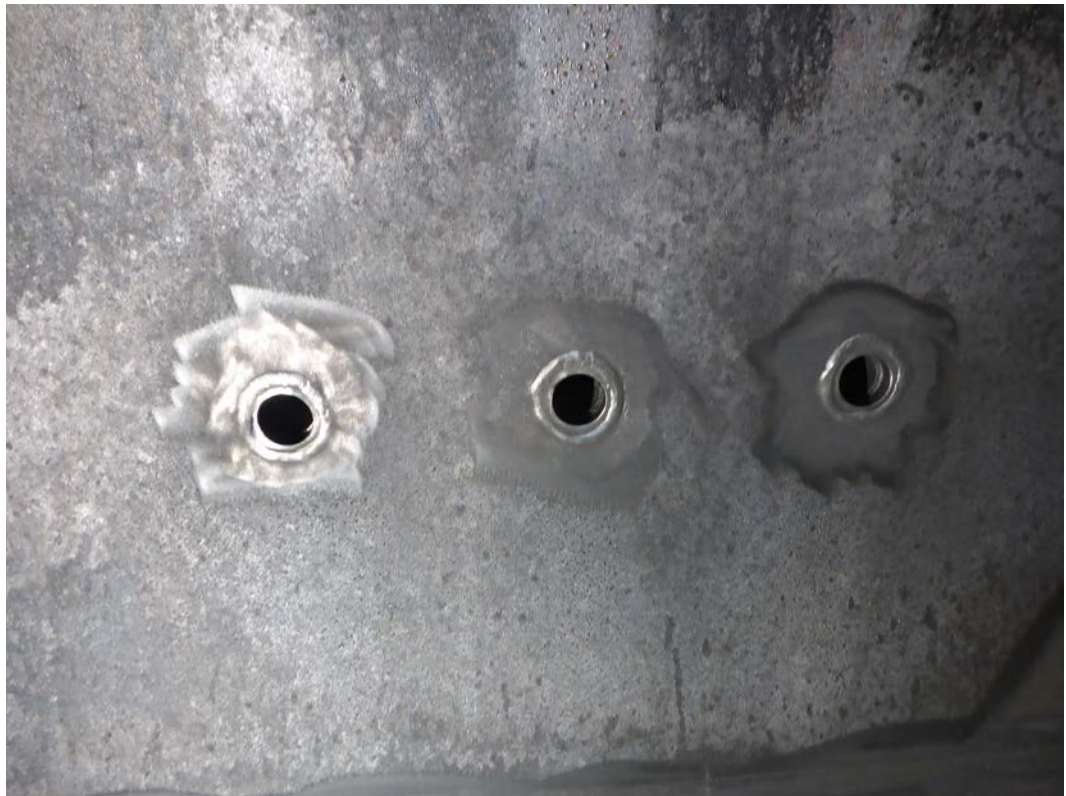
PSV Nozzles at 12 o'clock

Nozzle - Assess paint, look for leakage, and ensure stud threads are fully engaged. Record any damage, deflection, etc. Are nozzles gusseted? Inspect gussets for cracking. Any leaks or seepage from weep holes on repads.		<input checked="" type="checkbox"/>	<input type="checkbox"/>	<input type="checkbox"/>	<input type="checkbox"/>	
Weep Hole(s) are clear on repad(s)?		Yes <input type="checkbox"/>	No <input checked="" type="checkbox"/>	NA <input type="checkbox"/>		
Gauges - Ensure gauges are visible, working, no leakage, and suitable for range of MAWP/Temp. Upright ? Vertical?		<input checked="" type="checkbox"/>	<input type="checkbox"/>	<input type="checkbox"/>	<input type="checkbox"/>	Vessel was not in service.
Temperature ←	Pressure ←	PI Yes <input type="checkbox"/>	TI Yes <input type="checkbox"/>	No <input checked="" type="checkbox"/>		
External Piping - Ensure pipe is well supported. All clamps, supports, shoes, etc. in place. Look for evidence of structural overload, deflection, etc. Paint condition, external corrosion?		<input checked="" type="checkbox"/>	<input type="checkbox"/>	<input type="checkbox"/>	<input type="checkbox"/>

PRD - Are PRD seals in place? Ensure no block valves between PRD and vessel, or if there are that they are locked/sealed open. Any PRD Non-conformances?		<input checked="" type="checkbox"/>	<input type="checkbox"/>	<input type="checkbox"/>	<input type="checkbox"/>	PSVs were all serviced in December of 2015.
PRD - Is the outlet piping the same size or larger than PRD outlet on the valve? Is properly supported and routed to a safe location?		Yes <input type="checkbox"/>	No <input checked="" type="checkbox"/>	NA <input type="checkbox"/>		
PRD - Is the PRD set at pressure at or below that of the MAWP?		Yes <input type="checkbox"/>	No <input checked="" type="checkbox"/>	NA <input type="checkbox"/>		
Serial # 4 - SEE ABADATA PAGES		PRD Manufacturer Squibb-Taylor		Capacity 5795 SCFM		CRN OG 0515.9C
Inlet Size 1.25"		Last Service December 14, 2015		Next Service		Set Pressure 250 psi
HLSD <input type="checkbox"/>		LLSD <input type="checkbox"/>		HPSD <input type="checkbox"/>		Model/Part Number A1310A
