**PEYTO EXPLORATION & DEVELOPMENT CORP. PRESSURE VESSEL
ABACUS # 9469**

Peyto Exploration & Development Corp.
Galloway Plant 9-34-53-20 W5M

August 18, 2016
LPG Storage Tank
A 0578667, Sn S0700020, CRN L5670.51234
Internal Inspection,
Wet Fluorescent Magnetic Particle Inspection
& Partial Ultrasonic Inspection

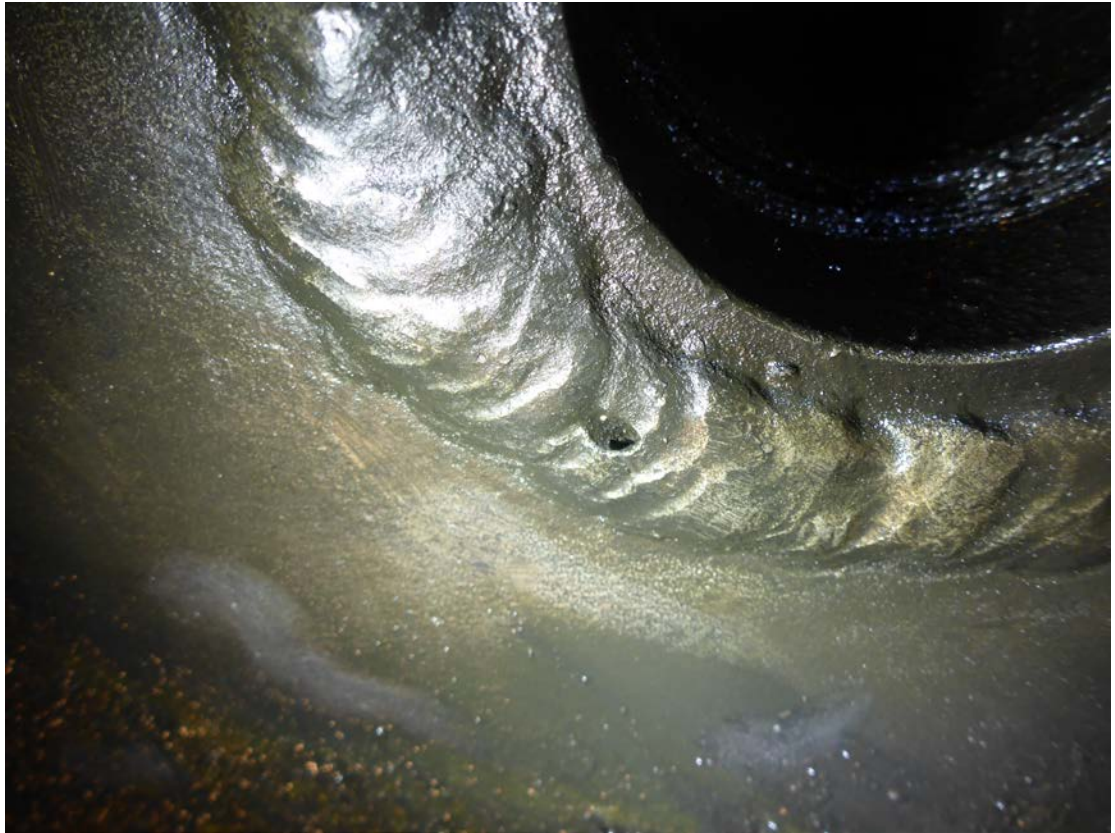
Manway					<input checked="" type="checkbox"/>	<input type="checkbox"/>	<input type="checkbox"/>	<input type="checkbox"/>	No corrosion, erosion or mechanical damage.
Summary MT Inspection identified pitting of a PSV nozzle welds. This vessel was repaired in August 2016. See the repair report. In consultation with the Facilities Engineer the inspection interval remains at 5 years under current operating conditions. This vessel is acceptable for continued use under current service conditions for 5 years. (Repair completed)									
Inspector (print) Bill Day					API or IPVI Certification Number 000232			Sign

Pit found in a PSV Nozzle weld exceeding the minimum thickness allowed.

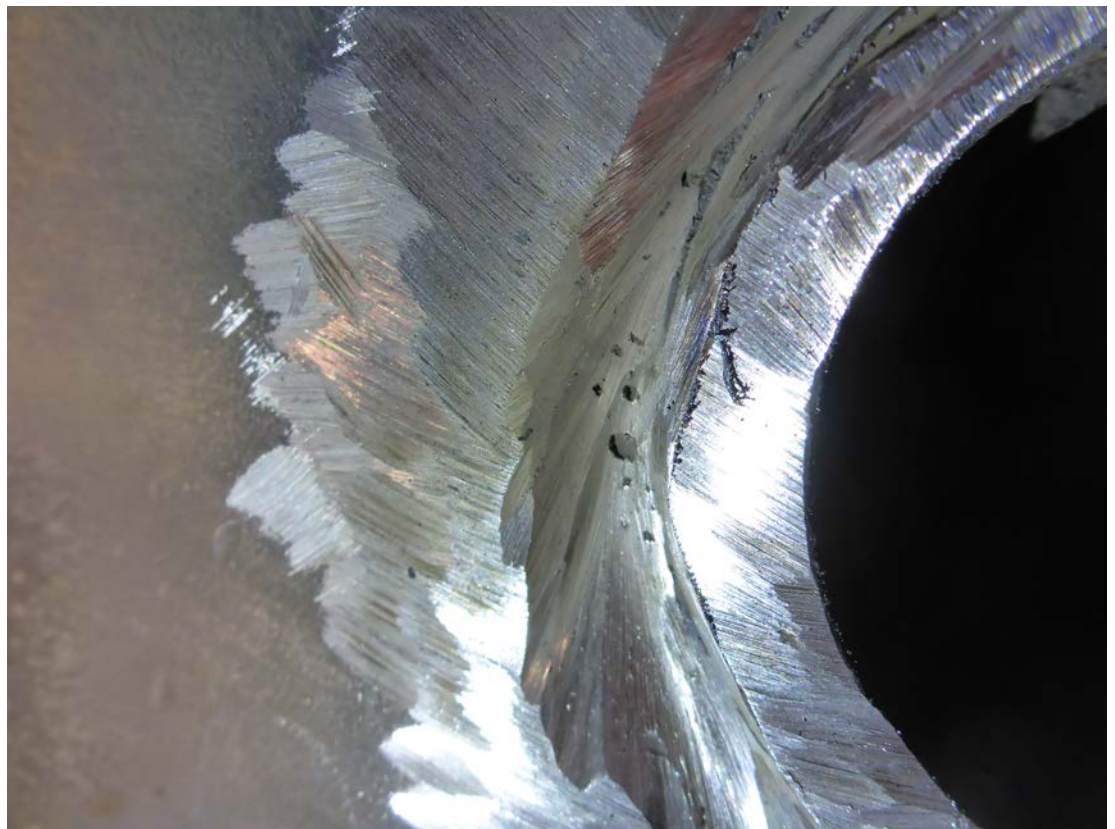
Porosity was found throughout the nozzle weld as the pit was excavated.
