Tank: RAET28494

Client	Tervita Corporation			Client Tank No.	Cond. Prod. Tank #930		
Province/LSD	AB 02-18-052-11W5			Inspection Date	Jun 4, 2012		
Location	Granada			Inspection Type	VI / VE / UT / MFL		
Service				Interim Insp'n			
Manufacturer	Argo Sales Ltd.			Interim Type			
Serial Number	8316			Next Inspection	2017		
Type				Next Type	VI / VE / UT / MFL		
Foundation	Raised gravel pad			Ext.Cathodic	No		
Ext. Coating	White coating			Anodes	No		
Int. Lining	Devoe 253			Status			
Insulation	None			Volume	1000 bbl		
Manway	2'x3' rectangular manway			Diameter	17.3 ft		
Vapour Rec.	None			Height	24 ft		
MAWP				Year Built	2004		
MAWV				RAE Job #	2878		
Max. Temp				D55	No		
Min. Temp							
Fill Height							
Secondary Containment	Rectangular - Concrete	Height	1.5 ft	Width	55 ft	Length	250 ft
History Log

This was one of nine tanks on the Granada site. All tanks were sharing the same secondary containment. This tank was labeled as "Cond. Prod. Tank #930" and was the furthest south of the tanks.

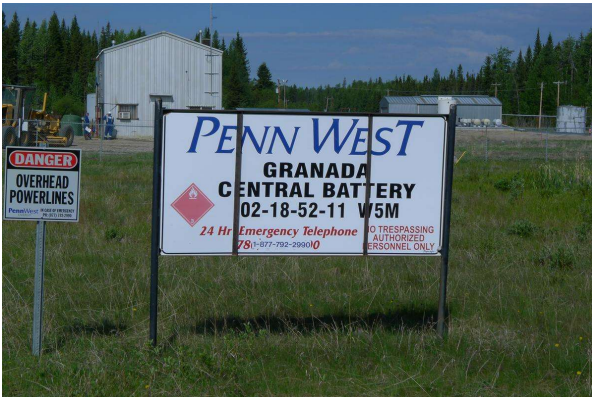
Figure: 1

Plant Lease Sign

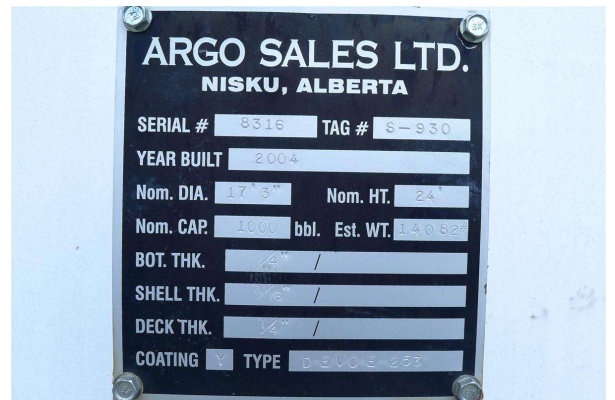
Figure: 2

Nameplate

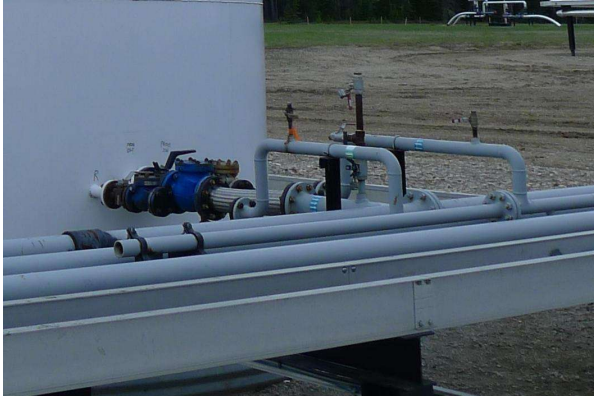
Figure: 3

The piping appeared to be in good condition.

The piping connections to the tank were equipped with bellows. One of the bellows was removed at the time of inspection, possibly for isolation purposes.

Piping

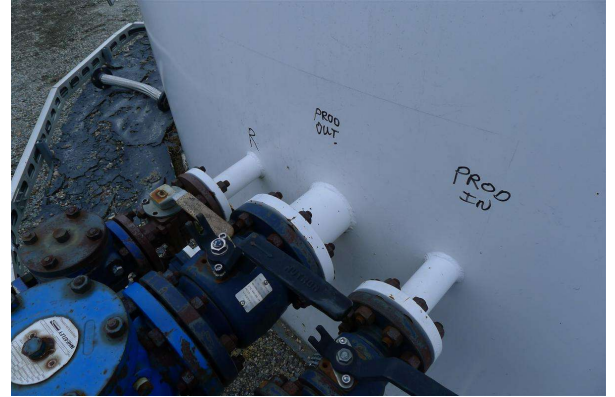
Figure: 4

The nozzles in this tank were not reinforced. According to API 650/653, all nozzles greater than NPS 2 in size must be equipped with repads.

Nozzles - note lack of repads

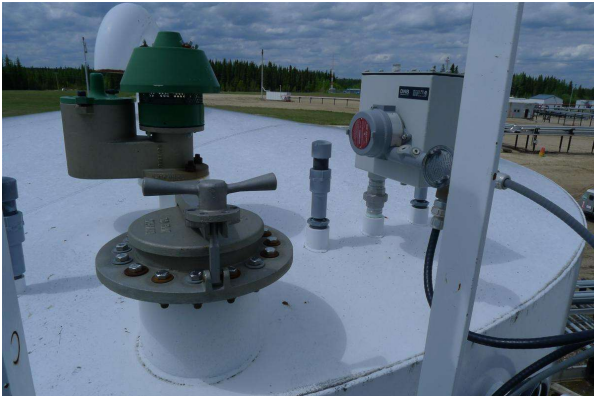
Figure: 5

The thief hatch on the roof was not designed for pressure relief.

A pressure and vacuum relief valve was installed on the roof beside the thief hatch.

There was a gooseneck nozzle in the centre of the roof, making the tank open to atmospheric pressure.

Thief hatch, PVRV, and gooseneck

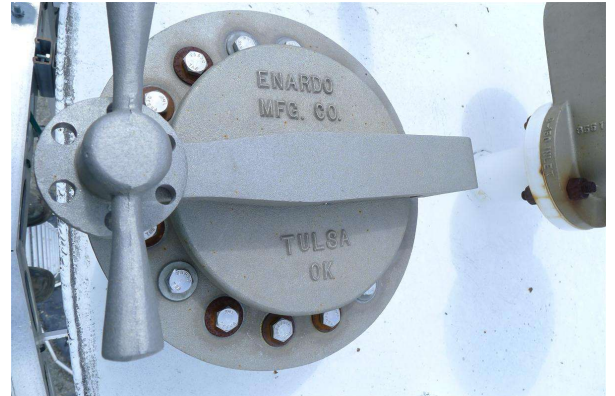
Figure: 6

Top of thief hatch

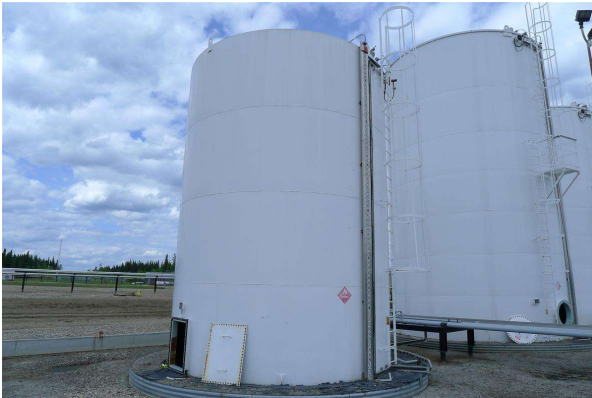
Figure: 7

The level gauge was in good condition.

The ladder was in good condition.

Overall view - note ladder and level gauge

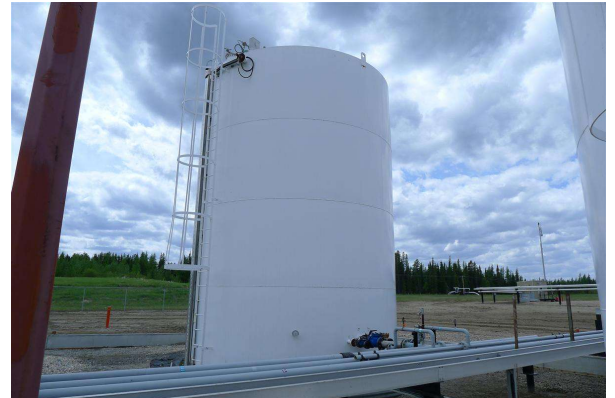
Figure: 8

Overall view 2

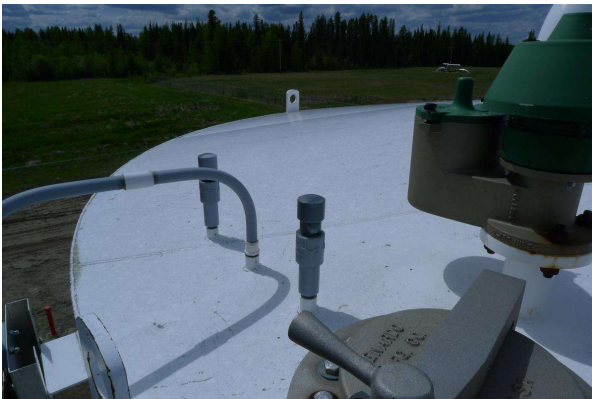
Figure: 9

External roof

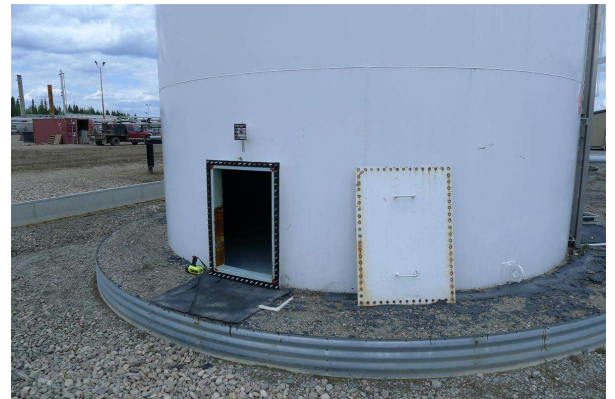
Figure: 10

The tank was sitting on a raised gravel pad. The gravel pad was contained by a metal ring. Leak detection tubes were in place beneath the tank floor.

Manway and door - note foundation and leak detection

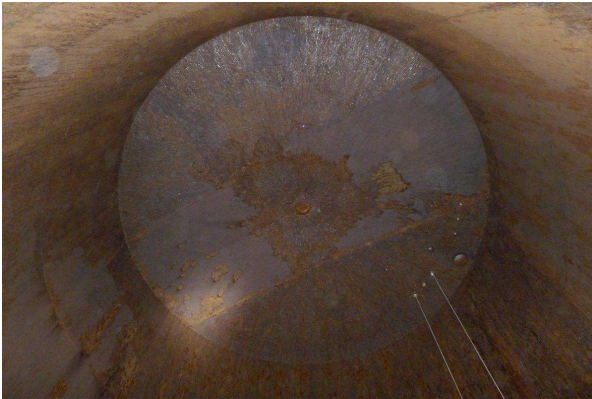
Figure: 11

Internal roof/shell

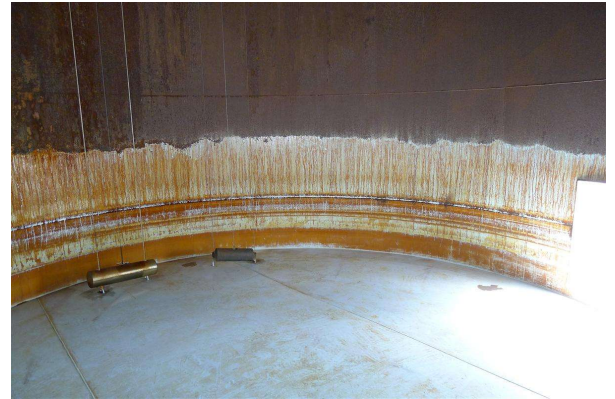
Figure: 12

There were two level floats installed in the tank. One float was black and the other was bare metal. The black float appeared to be the active level float as it was the only one attached to a level gauge board on the outside of the tank.

Internal shell/floor - note two level floats

1. Remove inactive level float

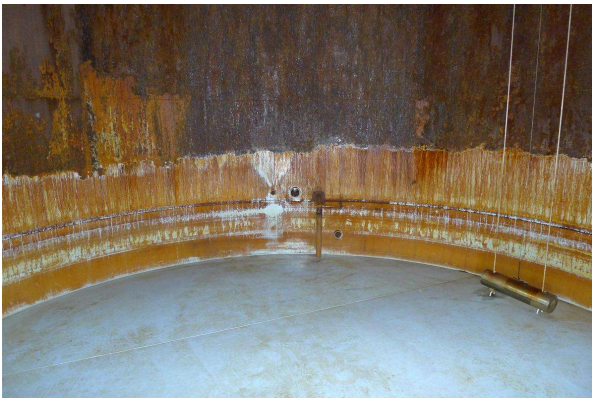
Figure: 13

An orange-brown layer of corrosion/product covered the internal surfaces of the shell.

Internal shell/floor - note nozzles and orange layer on shell

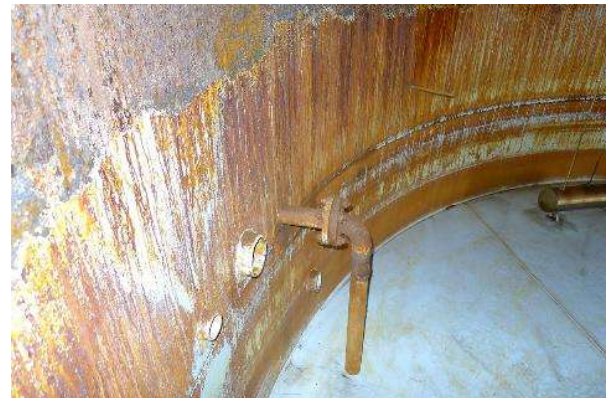
Figure: 14

Close up of nozzles
