Tank: RAET28493

Client	Tervita Corporation			Client Tank No.	GF-700 Prod. Tank #925		
Province/LSD	AB 02-18-052-11W5			Inspection Date	Jun 4, 2012		
Location	Granada			Inspection Type	VI / VE / UT / MFL		
Service	Frac Oil			Interim Insp'n			
Manufacturer	GLM			Interim Type			
Serial Number	J-04-087-5			Next Inspection	2017		
Type	API 650 Modified			Next Type	VI / VE / UT / MFL		
Foundation	Raised gravel pad			Ext.Cathodic	No		
Ext. Coating	White coating			Anodes	No		
Int. Lining	Light blue epoxy			Status			
Insulation	None			Volume	3000 bbl		
Manway	30" Circular manway			Diameter	23.5 ft		
Vapour Rec.	None			Height	39 ft		
MAWP	ATM			Year Built	2004		
MAWV				RAE Job #	2878		
Max. Temp				D55	No		
Min. Temp							
Fill Height							
Secondary Containment	Rectangular - Concrete	Height	1.5 ft	Width	55 ft	Length	250 ft
History Log

This was one of nine tanks on the Granada site. All tanks were sharing the same secondary containment. This tank was labeled as "GF-700 Prod. Tank #925".

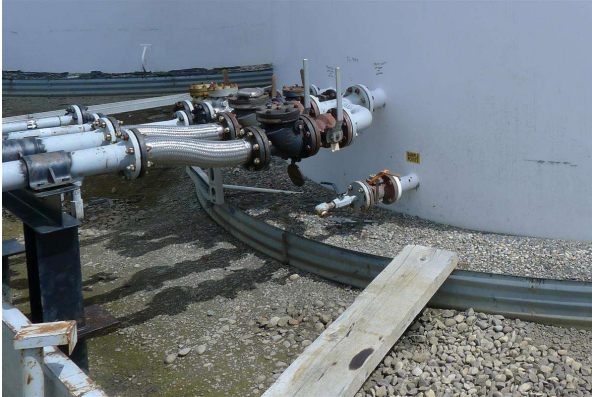
Figure: 3

Some of the piping connections to the tank were equipped with bellows. A couple of the bellows were removed at the time of inspection, possibly for isolation purposes.

Piping - note removed bellows

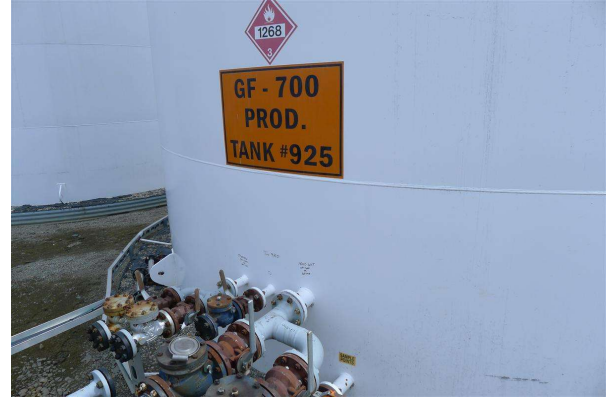
Figure: 4

The nozzles in this tank were not reinforced. According to API 650/653, all nozzles greater than NPS 2 in size must be equipped with repads.

Nozzles and tank labeling - note lack of repads

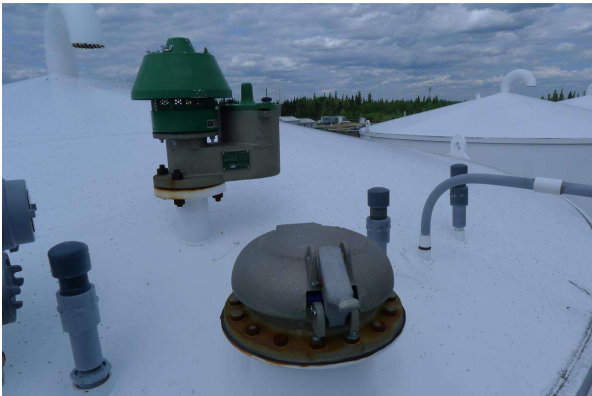
Figure: 5

The thief hatch was in good condition and was designed to provide pressure and vacuum relief.

A separate pressure and vacuum relief valve was installed on the roof beside the thief hatch.

There was a gooseneck nozzle in the centre of the roof, making the tank open to atmospheric pressure.

Thief hatch, PVRV, and gooseneck

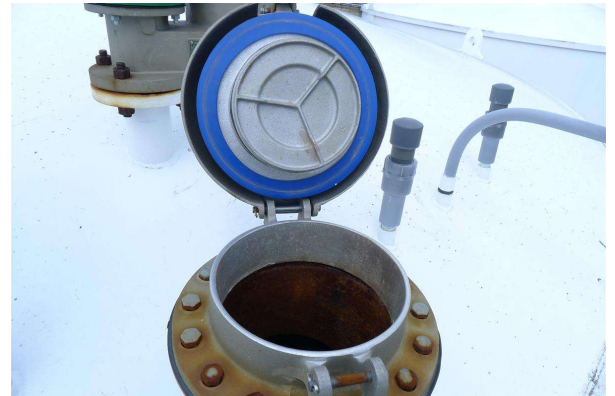
Figure: 6

Thief hatch open

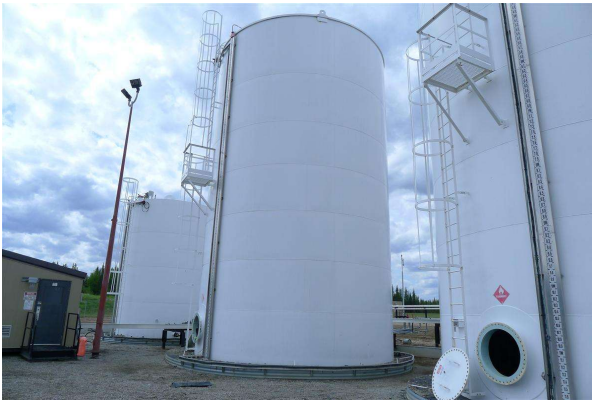
Figure: 7

The level gauge was in good condition.

The ladder was in good condition.

Overall view - note ladder and level gauge

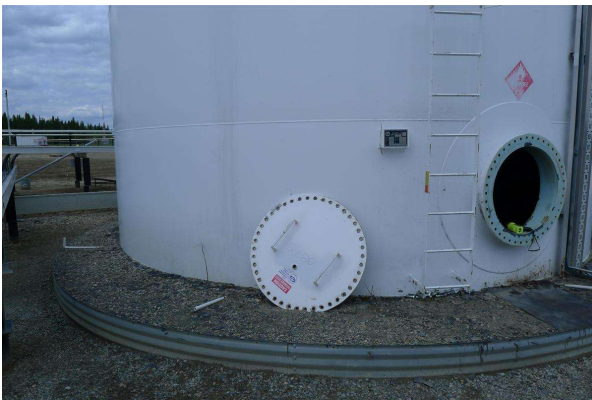
Figure: 9

The tank was sitting on a raised gravel pad. The gravel pad was contained by a metal ring. About half of the outer lip of the tank floor was covered by gravel. Remnants of a tar coating were visible on top of the gravel pad. Leak detection tubes were in place beneath the tank floor.

Manway and door - note foundation and leak detection

1. Clear gravel off of the outer floor lip (chime area)
2. Remove inactive level float

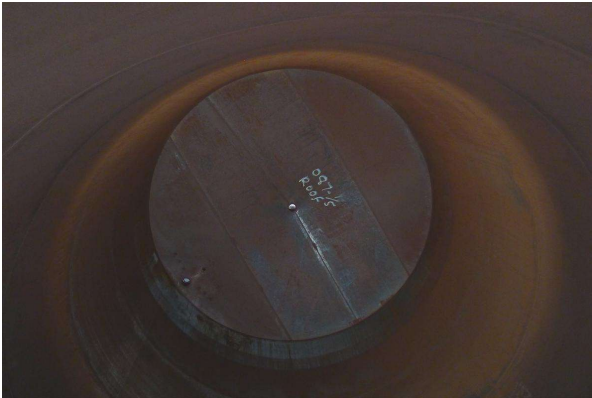
Figure: 11

Internal roof/shell - note good condition

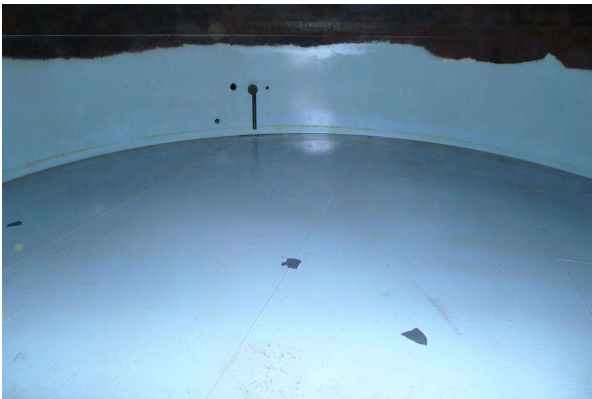
Figure: 13

The floor and the bottom ~4' of the shell was coated with light blue epoxy. The coating was mostly in good condition. The coating had been patched with black coating in a few places. The coating patches were in good condition.

Internal shell/floor - note nozzles and coating patches

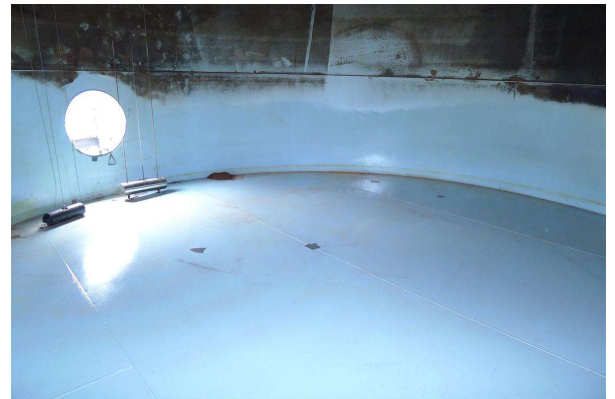
Figure: 14

There were two level floats installed in the tank. One float was black and the other was bare metal. The black float appeared to be the active level float as it was the only one attached to a level gauge board on the outside of the tank. The metal level float was installed in a location where it partially blocked the manway.

Internal shell/floor - note two level floats, one in front of manway
