Tank: RAET28492

Client	Tervita Corporation					Client Tank No.			GF-700 Prod. Tank #920		
Province/LSD	AB 02-18-052-11W5					Inspection Date			Jun 4, 2012		
Location	Granada					Inspection Type			VI / VE / UT / MFL		
Service	Frac Oil					Interim Insp'n					
Manufacturer	GLM					Interim Type					
Serial Number	J-04-087-4					Next Inspection			2017		
Type	API 650 Modified					Next Type			VI / VE / UT / MFL		
Foundation	Raised gravel pad					Ext.Cathodic			No		
Ext. Coating	White coating					Anodes			No		
Int. Lining	Light blue epoxy					Status					
Insulation	None					Volume			3000 bbl		
Manway	30" Circular manway					Diameter			23.5 ft		
Vapour Rec.	None					Height			39 ft		
MAWP	ATM					Year Built			2004		
MAWV						RAE Job #			2878		
Max. Temp						D55			No		
Min. Temp											
Fill Height											
Secondary Containment		Rectangular - Concrete	Height	1.5 ft		Width	55 ft		Length	250 ft	
History Log

Comments

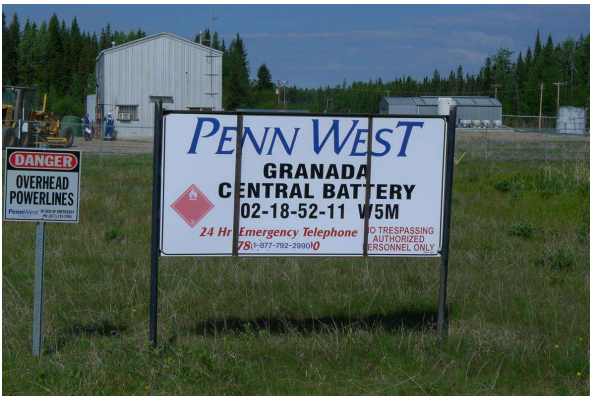
Figure: 1

Plant Lease Sign

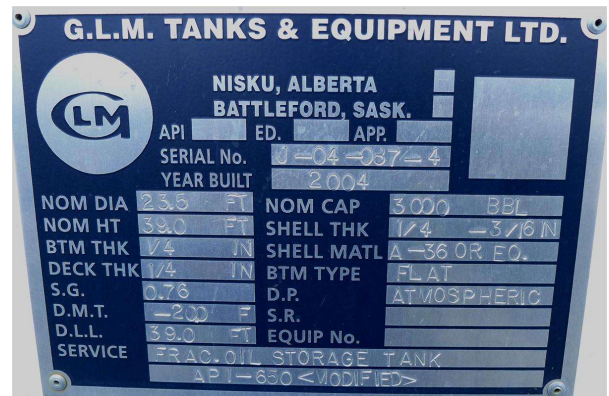
Figure: 2

Nameplate

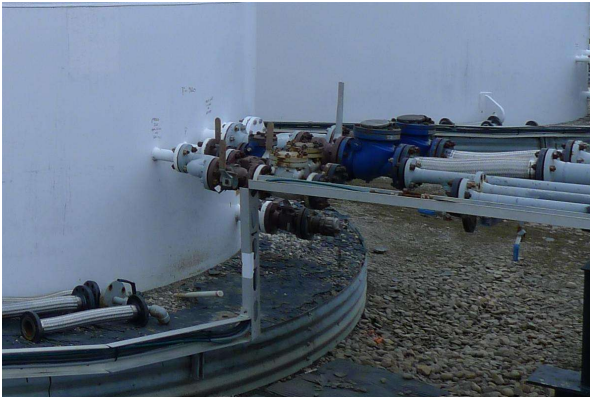
Figure: 3

Some of the piping connections to the tank were equipped with bellows. A couple of the bellows were removed at the time of inspection, possibly for isolation purposes.

Piping - note removed bellows

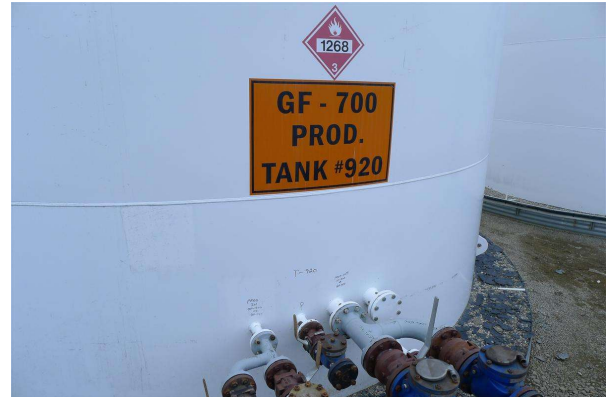
Figure: 4

The nozzles in this tank were not reinforced. According to API 650/653, all nozzles greater than NPS 2 in size must be equipped with repads.

Nozzles and tank labeling - note lack of repads

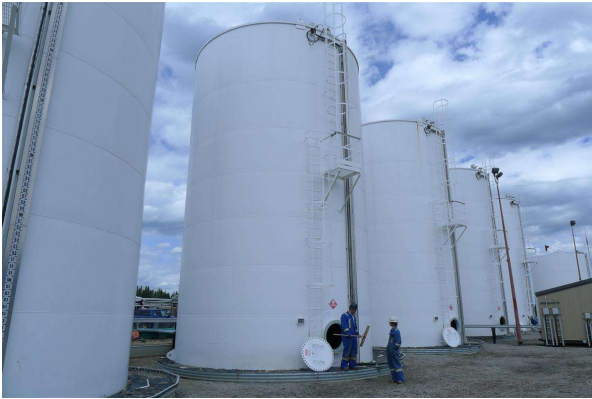
Figure: 5

The level gauge was in good condition.

The ladder was in good condition.

Overall view - note ladder and level gauge

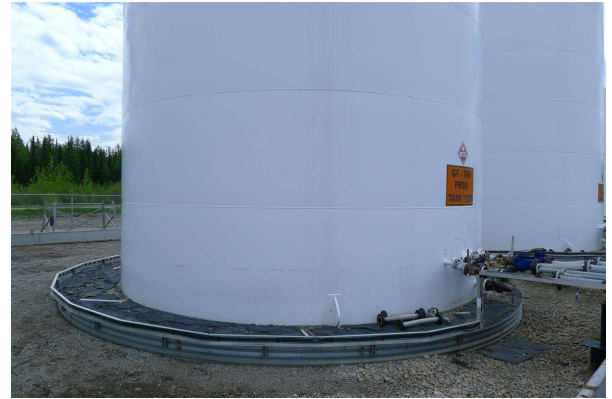
Figure: 6

The tank was sitting on a raised gravel pad. The gravel pad was contained by a metal ring. Most of the outer lip of the tank floor was covered by gravel. Remnants of a tar coating were visible on top of the gravel pad. Leak detection tubes were in place beneath the tank floor.

Lower tank - note foundation, leak detection, and layer of tar

1. Clear gravel off of the outer floor lip (chime area)
2. Remove inactive level float

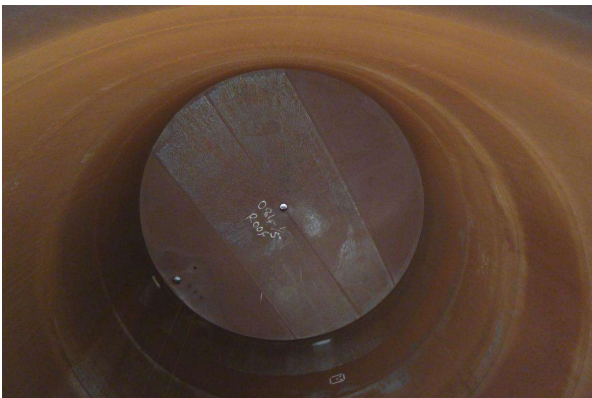
Figure: 7

Internal roof/shell

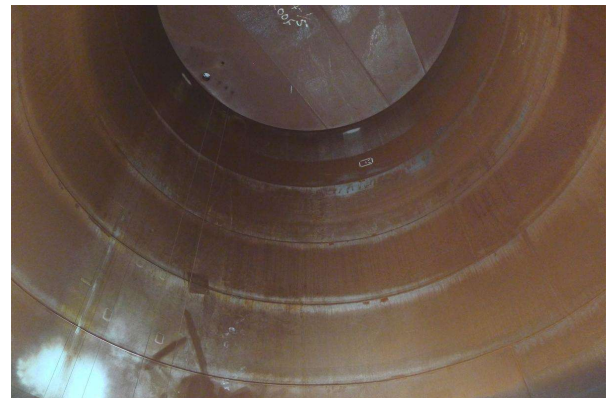
Figure: 8

Internal shell

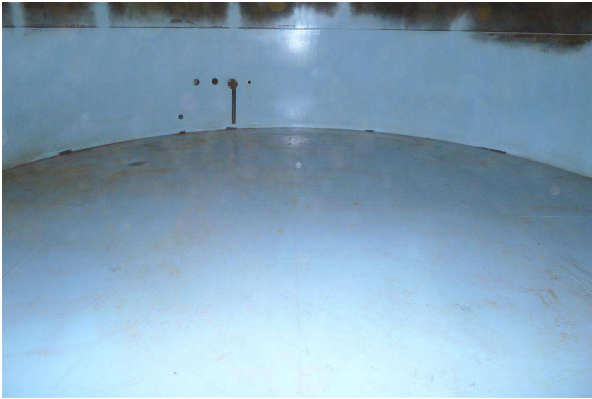
Figure: 9

Internal shell/floor - note nozzles

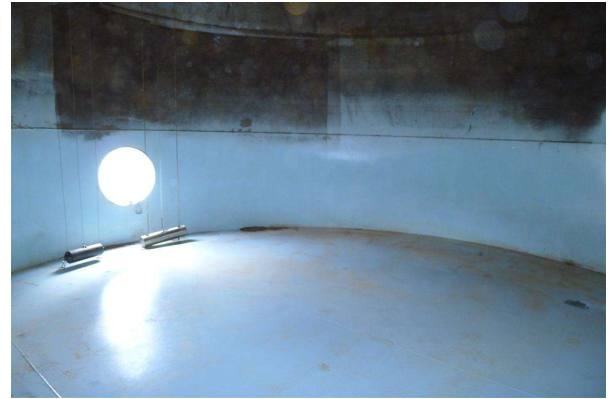
Figure: 10

There were two level floats installed in the tank. One float was black and the other was bare metal. The black float appeared to be the active level float as it was the only one attached to a level gauge board on the outside of the tank. The metal level float was installed in a location where it partially blocked the manway.

Internal shell/floor - note two level gauges, one in front of manway
