Tank: RAET28491

Client	Tervita Corporation					Client Tank No.		GF-700 Prod. Tank #915	
Province/LSD	AB 02-18-052-11W5					Inspection Date		Jun 4, 2012	
Location	Granada					Inspection Type		VI / VE / UT / MFL	
Service	Frac Oil					Interim Insp'n			
Manufacturer	GLM					Interim Type			
Serial Number	J-04-087-3					Next Inspection		2017	
Type	API 650 Modified					Next Type		VI / VE / UT / MFL	
Foundation	Raised gravel pad					Ext.Cathodic		No	
Ext. Coating	White coating					Anodes		No	
Int. Lining	Light blue epoxy					Status			
Insulation	None					Volume		3000 bbl	
Manway	30" Circular manway					Diameter		23.5 ft	
Vapour Rec.	None					Height		39 ft	
MAWP	ATM					Year Built		2004	
MAWV						RAE Job #		2878	
Max. Temp						D55		No	
Min. Temp									
Fill Height									
Secondary Containment		Rectangular - Concrete	Height	1.5 ft	Width	55 ft	Length	250 ft	
History Log

The inspection was performed using the RAE Tank Inspection procedure 604B rev. 8

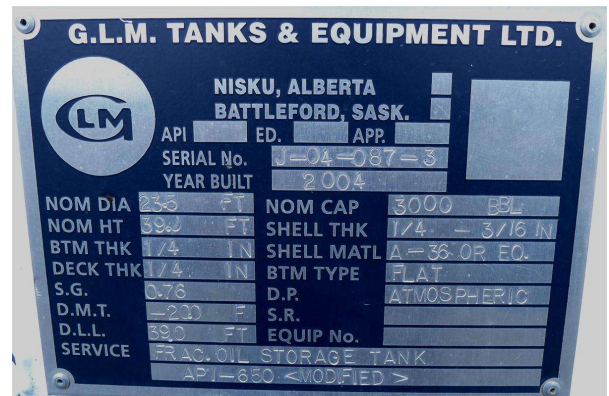
Figure: 2

Nameplate

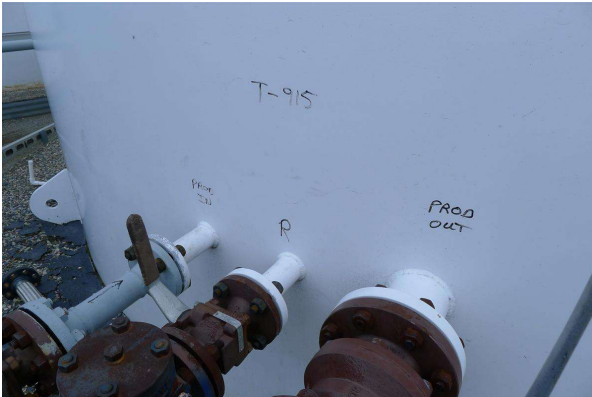
Figure: 3

The nozzles in this tank were not reinforced. According to API 650/653, all nozzles greater than NPS 2 in size must be equipped with repads.

Nozzles - note lack of repads

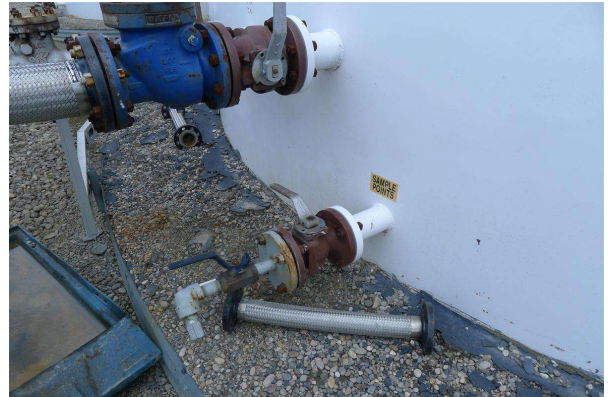
Figure: 4

Some of the piping connections to the tank were equipped with bellows. A couple of the bellows were removed at the time of inspection, possibly for isolation purposes.

Nozzles - note removed bellows beside tank

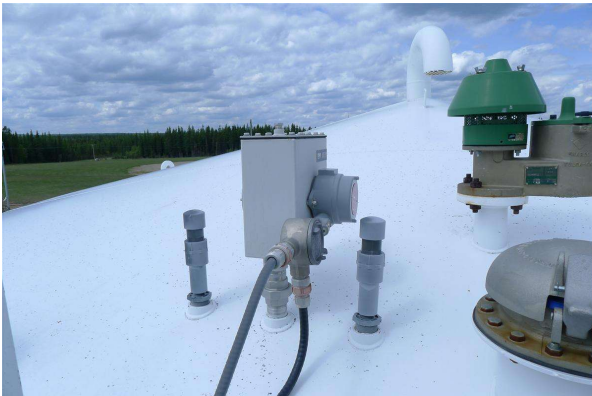
Figure: 5

The thief hatch was in good condition and was designed to provide pressure and vacuum relief.

A separate pressure and vacuum relief valve was installed on the roof beside the thief hatch.

There was a gooseneck nozzle in the centre of the roof, making the tank open to atmospheric pressure.

Thief hatch, PVRV, and gooseneck

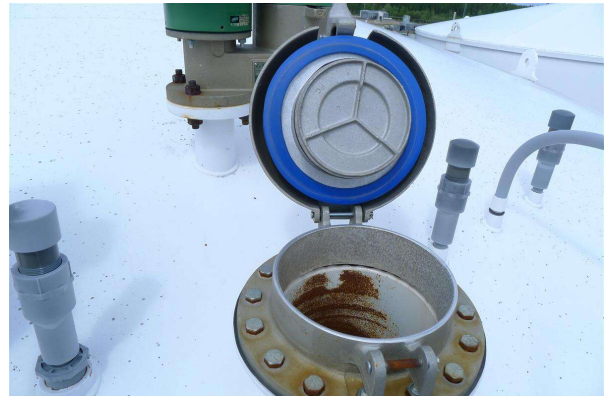
Figure: 6

Thief hatch open

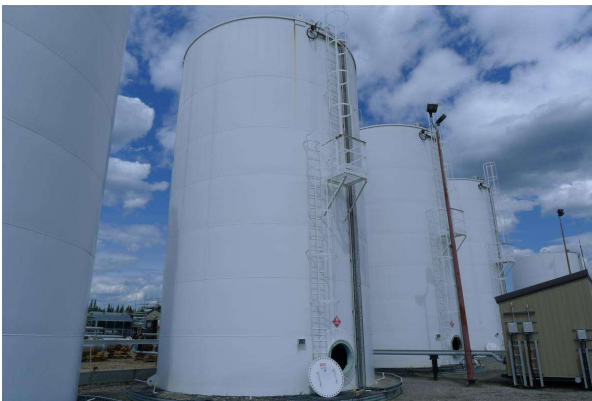
Figure: 7

The level gauge was in good condition.

The ladder was in good condition.

Overall view - note ladder and level gauge

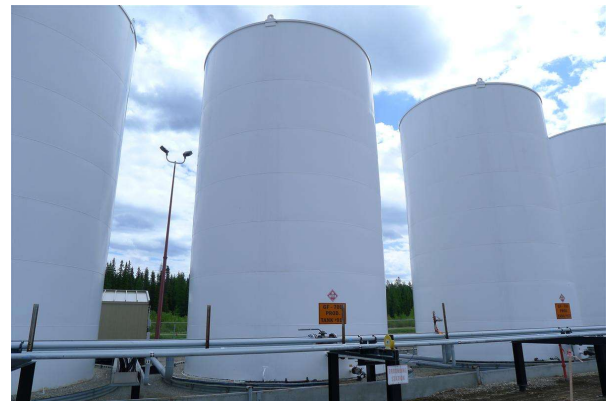
Figure: 8

Overall view 2 - note piping and labeling

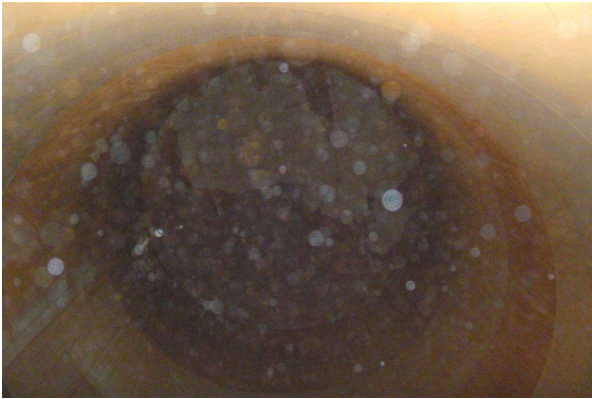
Figure: 9

Internal roof/shell

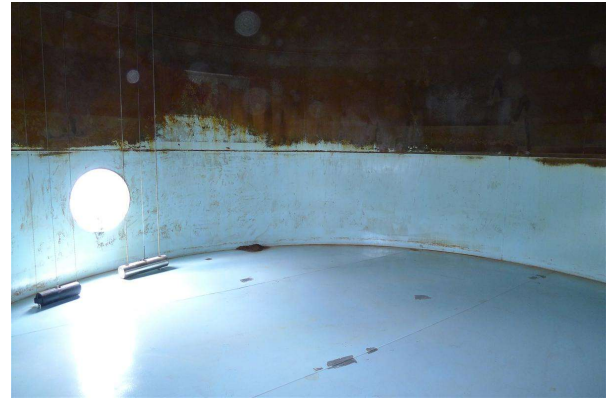
Figure: 10

There were two level floats installed in the tank. One float was black and the other was bare metal. The black float appeared to be the active level float as it was the only one attached to a level gauge board on the outside of the tank. The metal level float was installed in a location where it partially blocked the manway.

Internal shell/floor - note two level floats, one in front of manway

1. Clear gravel off of the outer floor lip (chime area)
2. Remove inactive level float

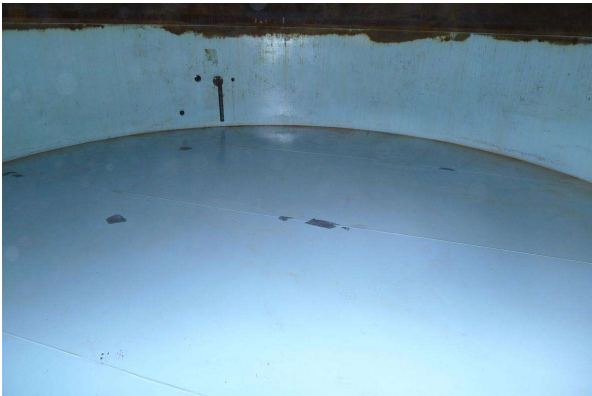
Figure: 11

The floor and the bottom ~5' of the shell was coated with light blue epoxy. The coating was mostly in good condition. The coating had been patched with black coating in a few places. The coating patches were in good condition.

Internal shell/floor - note nozzles and coating patches

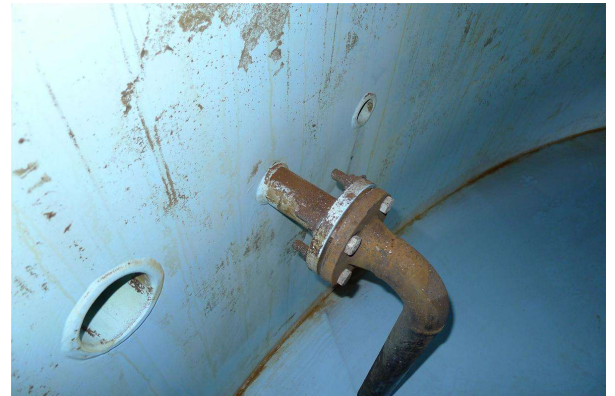
Figure: 12

Internal nozzles
