Tank: RAET28490

Client	Tervita Corporation			Client Tank No.	GF-700 Prod. Tank #910		
Province/LSD	AB 02-18-052-11W5			Inspection Date	Jun 4, 2012		
Location	Granada			Inspection Type	VI / VE / UT / MFL		
Service	Frac Oil			Interim Insp'n			
Manufacturer	GLM			Interim Type			
Serial Number	J-04-087-2			Next Inspection	2017		
Type	API 650 Modified			Next Type	VI / VE / UT / MFL		
Foundation	Raised gravel pad			Ext.Cathodic	No		
Ext. Coating	White coating			Anodes	No		
Int. Lining	Light blue epoxy			Status			
Insulation	None			Volume	3000 bbl		
Manway	30" Circular manway			Diameter	23.5 ft		
Vapour Rec.	None			Height	39 ft		
MAWP	ATM			Year Built	2004		
MAWV				RAE Job #	2878		
Max. Temp				D55	No		
Min. Temp							
Fill Height							
Secondary Containment	Rectangular - Concrete	Height	1.5 ft	Width	55 ft	Length	250 ft
History Log

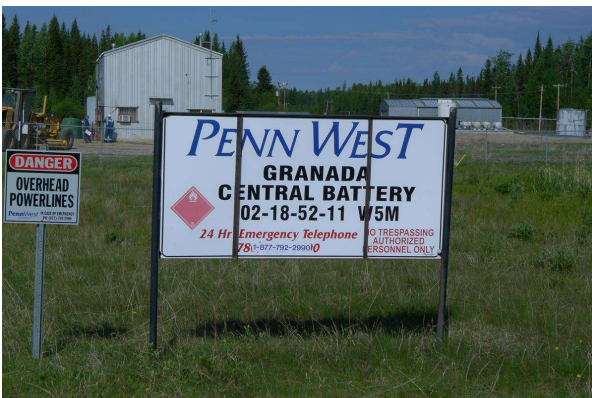
Figure: 1

Plant Lease Sign

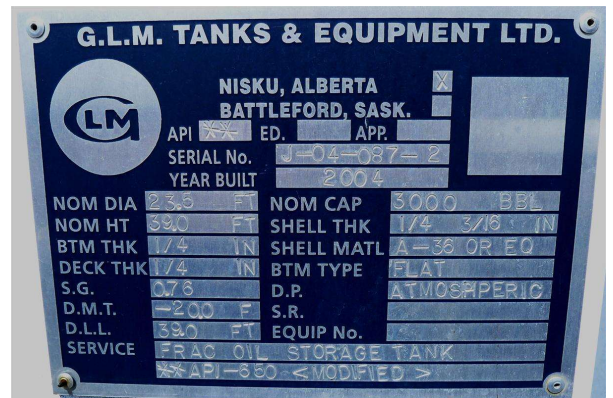
Figure: 2

Nameplate

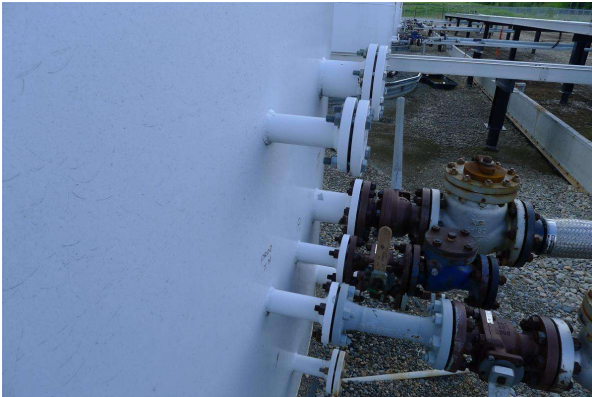
Figure: 3

The nozzles in this tank were not reinforced. According to API 650/653, all nozzles greater than NPS 2 in size must be equipped with repads.

Nozzles - note lack of repads

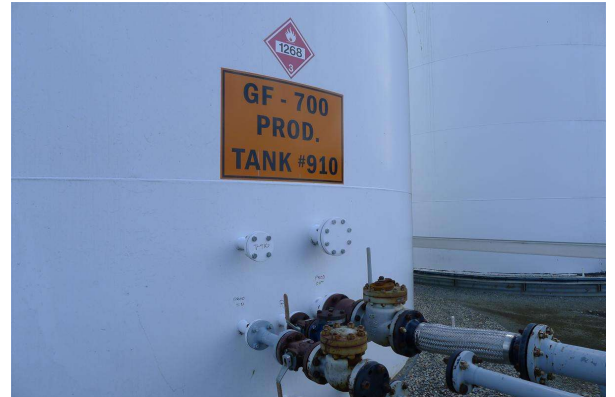
Figure: 4

Some of the piping connections to the tank were equipped with bellows. Two of the bellows were removed at the time of inspection, possibly for isolation purposes.

Piping and tank labeling - note disconnected bellows

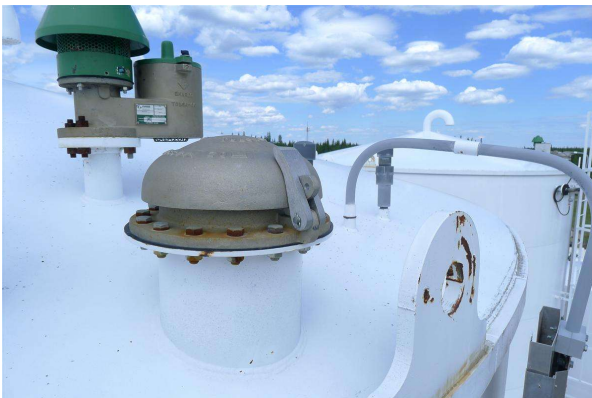
Figure: 5

The thief hatch was in good condition and was designed to provide pressure and vacuum relief.

A separate pressure and vacuum relief valve was installed on the roof beside the thief hatch.

Thief hatch and PVRV

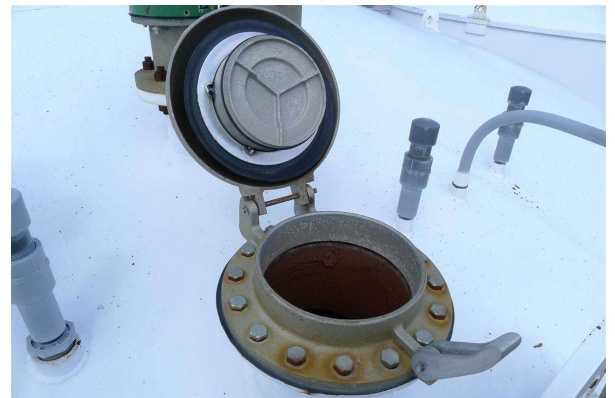
Figure: 6

Thief hatch open

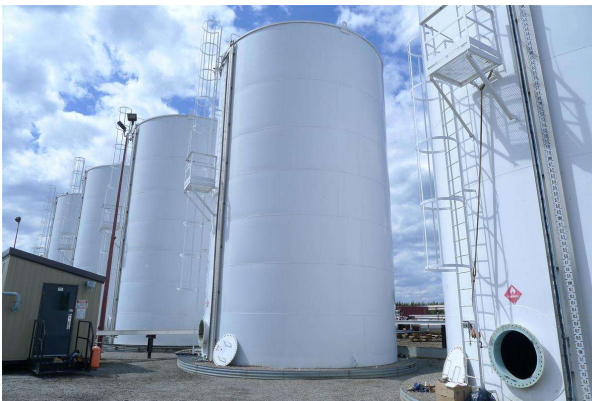
Figure: 7

The tank was un-insulated and was coated white. The external coating had a few small failures but was mostly in good condition.

Overall view

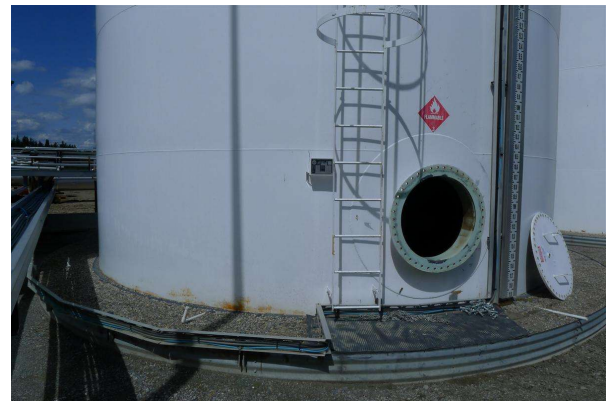
Figure: 8

The level gauge was in good condition.

The ladder was in good condition.

Manway and door - note ladder and level gauge

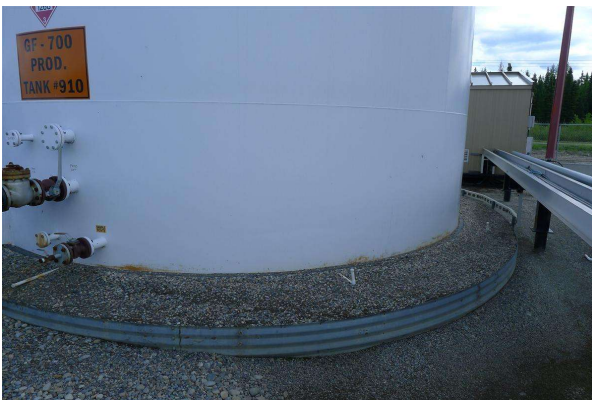
Figure: 9

The tank was sitting on a raised gravel pad. The gravel pad was contained by a metal ring. Some of the outer lip of the tank floor was covered by gravel. Leak detection tubes were in place beneath the tank floor.

Bottom of tank - note foundation and leak detection

1. Clear gravel off of the outer floor lip (chime area)
2. Remove inactive level float

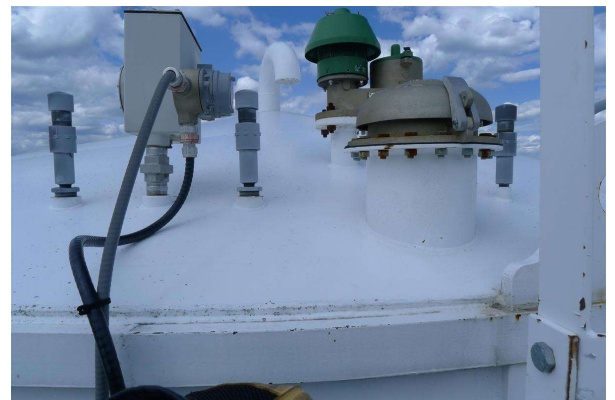
Figure: 10

There was a gooseneck nozzle in the centre of the roof, making the tank open to atmospheric pressure.

External roof

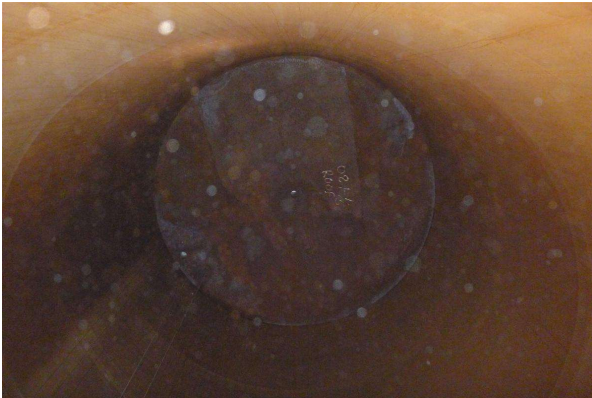
Figure: 11

Internal roof/shell

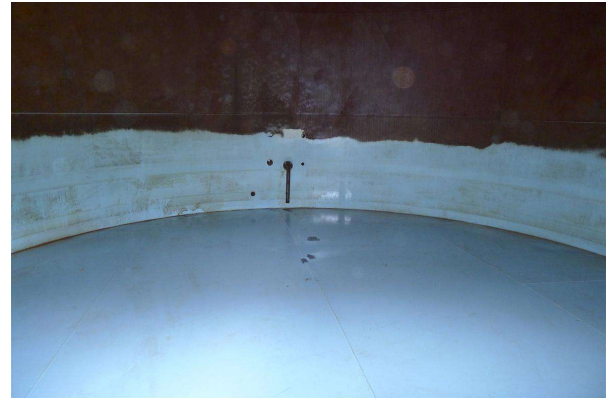
Figure: 12

Internal shell/floor - note nozzles

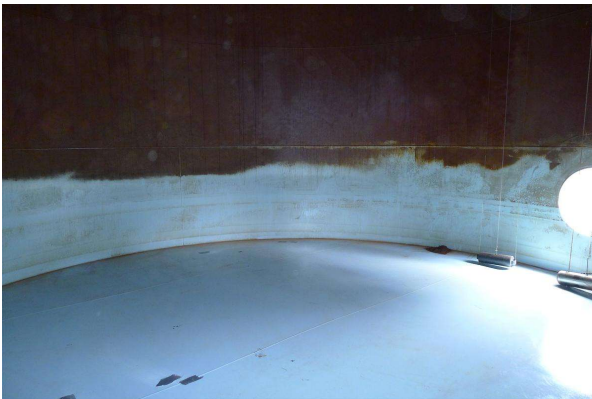
Figure: 13

There were two level floats installed in the tank. One float was black and the other was bare metal. The black float appeared to be the active level float as it was the only one attached to a level gauge board on the outside of the tank. The metal level float was installed in a location where it partially blocked the manway.

Internal shell/floor - note two level floats, one in front of manway

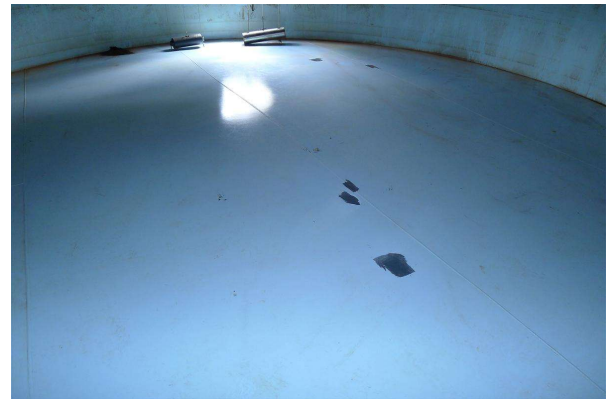
Figure: 14

The floor and the bottom ~4' of the shell was coated with light blue epoxy. The coating was mostly in good condition. The coating had been patched with black coating in a few places. The coating patches were in good condition.

Internal floor - note coating patches
