Tank: RAET28487

Client	Tervita Corporation			Client Tank No.	Feed Tank #900		
Province/LSD	AB 02-18-052-11W5			Inspection Date	Jun 4, 2012		
Location	Granada			Inspection Type	VI / VE / UT / MFL		
Service				Interim Insp'n			
Manufacturer	Argo Sales Ltd.			Interim Type			
Serial Number	8315			Next Inspection	2017		
Type				Next Type	VI / VE / UT / MFL		
Foundation	Raised gravel pad			Ext.Cathodic	No		
Ext. Coating	White coating			Anodes	No		
Int. Lining	Devoe 253			Status			
Insulation	None			Volume	1000 bbl		
Manway	2'x3' rectangular manway			Diameter	17.3 ft		
Vapour Rec.	None			Height	24 ft		
MAWP				Year Built	2004		
MAWV				RAE Job #	2878		
Max. Temp				D55	No		
Min. Temp							
Fill Height							
Secondary Containment	Rectangular - Concrete	Height	1.5 ft	Width	55 ft	Length	250 ft
History Log

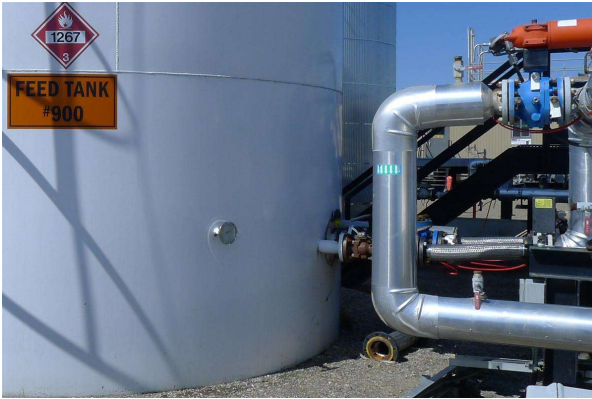
Figure: 3

The piping connections to the tank were equipped with bellows.

Piping - note removed bellows

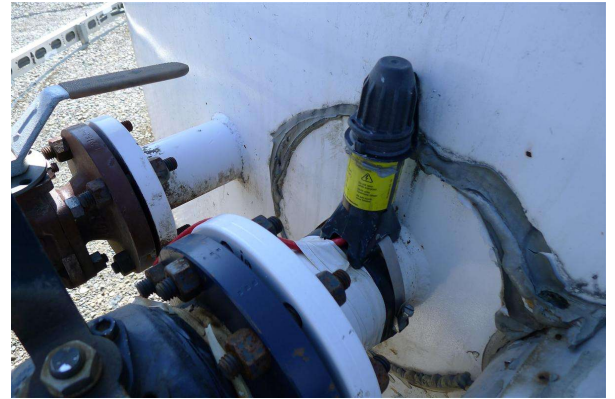
Figure: 4

The nozzles in this tank were not reinforced. According to API 650/653, all nozzles greater than NPS 2 in size must be equipped with repads.

Close up of nozzles - note lack of repairs

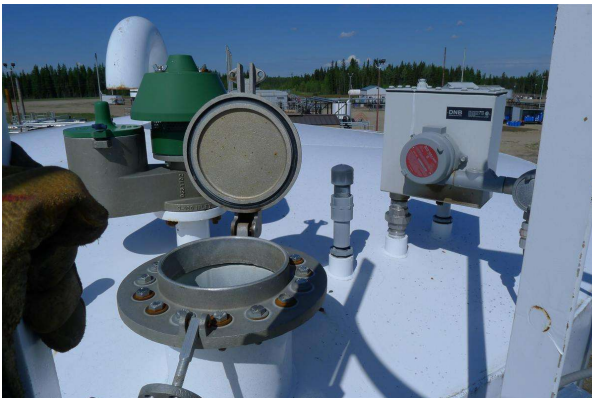
Figure: 5

The thief hatch on the roof was not designed for pressure relief.

A pressure and vacuum relief valve was installed on the roof beside the thief hatch.

There was a gooseneck nozzle in the centre of the roof, making the tank open to atmospheric pressure.

Thief hatch, PVRV and gooseneck

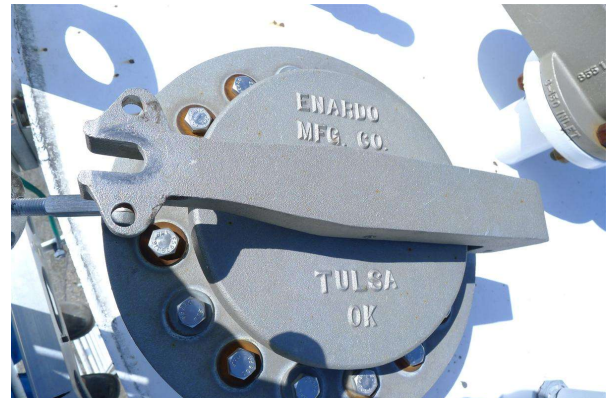
Figure: 6

Top of thief hatch (unfastened)

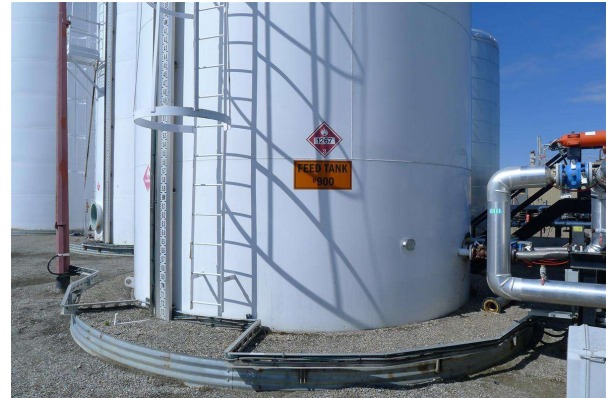
Figure: 8

The level gauge was in good condition.

The ladder was in good condition.

Lower tank - note ladder, level gauge, and labeling

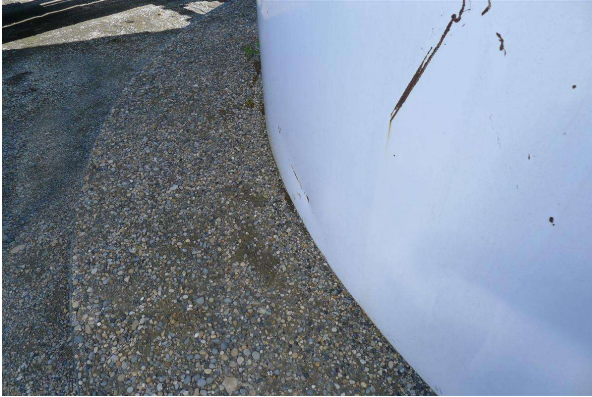
Figure: 11

The tank was un-insulated and was coated white. The external coating was mostly in good condition. A few large scrapes in the coating were found on the first and second course on the NW side of the shell.

There was a small dent in the lower shell on the NW side of the tank.

NW shell - note dent and scrapes in coating

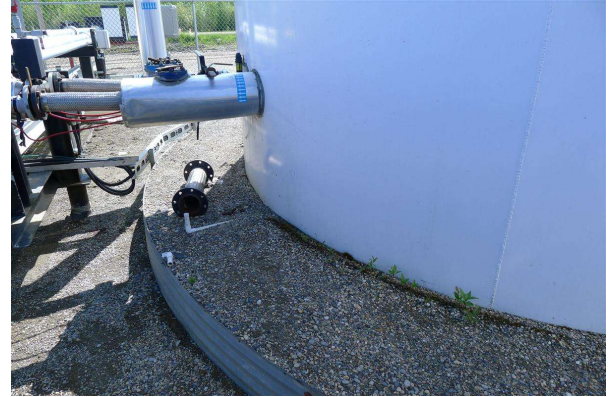
Figure: 12

The tank was sitting on a raised gravel pad. The gravel pad was contained by a metal ring. Some vegetation was found growing in the gravel around the tank. The outer lip of the tank floor was covered by gravel. Leak detection tubes were in place beneath the tank floor.

Lower shell - note leak detection and vegetation

1. Clear gravel off of the outer floor lip (chime area)
2. Remove inactive level float
3. Clear vegetation away from tank

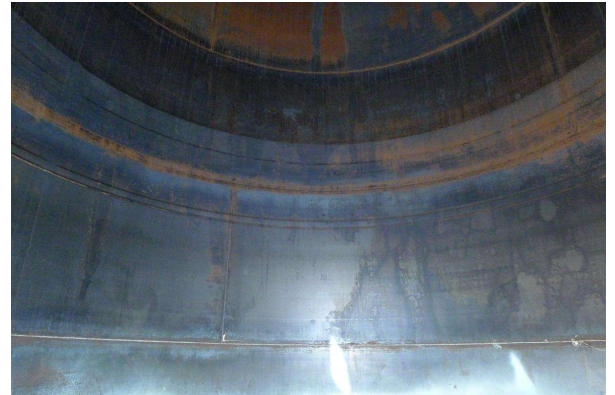
Figure: 14

Very little corrosion was visible on the uncoated surfaces of the tank.

Internal shell - note lack of corrosion

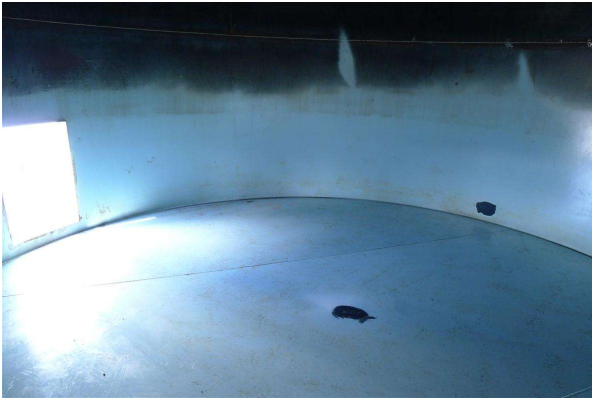
Figure: 15

The floor and the bottom ~4' of the shell was coated with light blue epoxy. The coating was mostly in good condition. A few isolated blisters and patches of blisters were found on the floor and shell. The coating had been patched with black coating in a few places. The coating patches were in good condition.

Internal shell/floor - note coating and coating patches

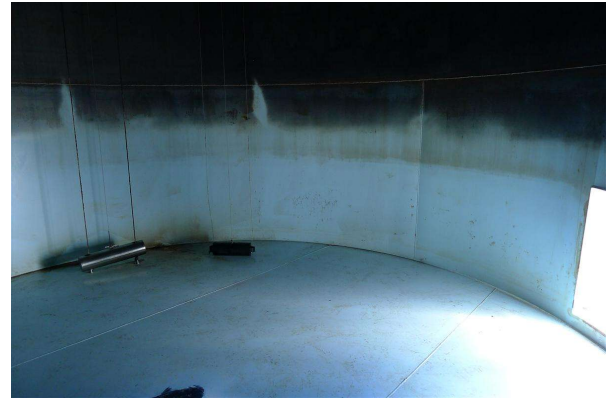
Figure: 16

There were two level floats installed in the tank. One float was black and the other was bare metal. The black float appeared to be the active level float as it was the only one attached to a level gauge board on the outside of the tank.

Internal shell/floor - note level floats
