Report No: VP000052

<b>Client</b>	Newalta Corporation	<b>Inspection Date</b>	Feb 13, 2015		
<b>Prov. Reg. #</b>	AB 0647153	<b>Inspection Type</b>	INSTALL		
<b>Equipment Type</b>	Vertical Blow Off Tank	<b>LSD</b>	AB 08-09-067-05W6		
<b>Tag/Equip.</b>		<b>Location</b>	Gold Creek Waste Management Facility		
<b>Status</b>	In Service	<b>Area</b>	Gold Creek		
<b>Manufacturer</b>	AT&S Advanced Tanks & Systems	<b>Year Built</b>	2014		
<b>Serial Number</b>	10434.3	<b>Service</b>	Hot Water		
<b>CRN #</b>	C2282.6527804913	<b>Manway</b>	Yes		
<b>Comp/Unit Id</b>		<b>Coating</b>	Yes		
<b>Nat.Board #</b>		<b>Owned By</b>	Newalta Corporation		
<b>Interim Insp'n</b>		<b>Interim Insp Type</b>			
<b>Next Inspection</b>	2020	<b>Next Insp Type</b>	VE / VI / UT		
<b>Length</b>		<b>Height</b>			
<b>Volume</b>		<b>RT</b>		<b>HT</b>	
<b>Job No.</b>	1435.024	<b>Client Reference</b>			
<b>Foreman</b>	Bryan Wagner	<b>DownholdLSD</b>			
<b>ABSA</b>	<b>Plant:</b> O <b>Vessel:</b> B <b>Process:</b> I	<b>Special:</b> 0	<b>ASME</b>	Sec. VIII div. 1

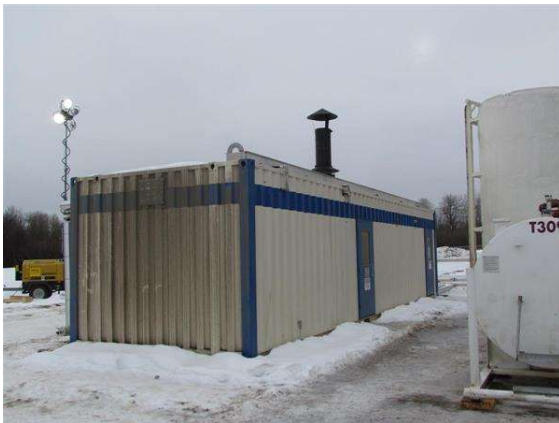
Figure: 1

The building houses the boiler, the blowdown vessel, the boiler feed water supply storage tank and the water treatment system.

Building is a sea can type with a checkered metal plate floor.

Building housing the boiler blowdown vessel

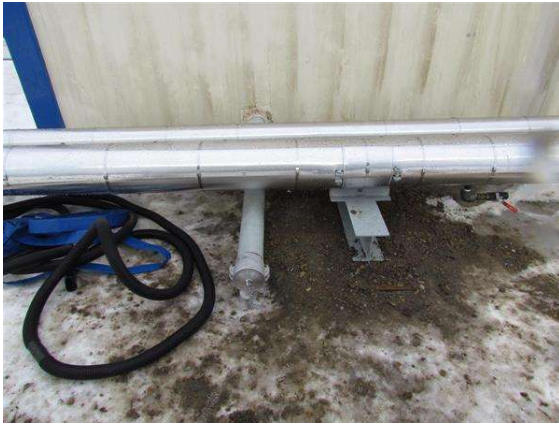
Figure: 2

The piping from blow down vessel comes to a truck out point.

Piping from blow down vessel comes to a truck out point

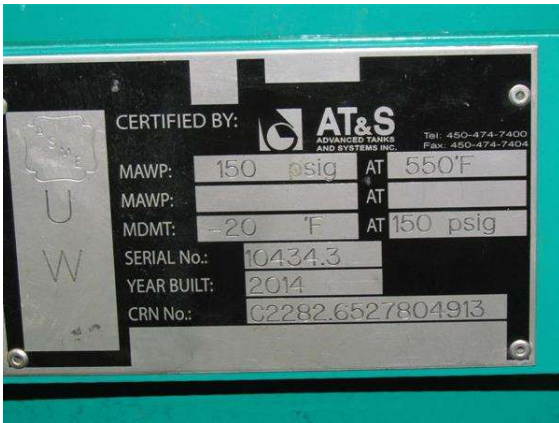
Figure: 3

Vessel nameplate

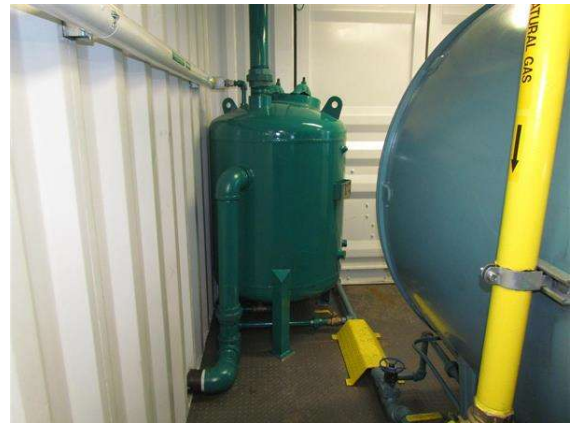
Figure: 4

The boiler blow down tank is not insulated.  
It has a coating which is green in color.  
The vessel is supported on 3 angle iron legs welded to the vessel and skid floor.  
Manway with internal manway door designed as per cyclic condition.  
The vessel is situated in a corner at the largest side of boiler inside the building.  
There is no level indication for the blow down vessel.

Vessel general view

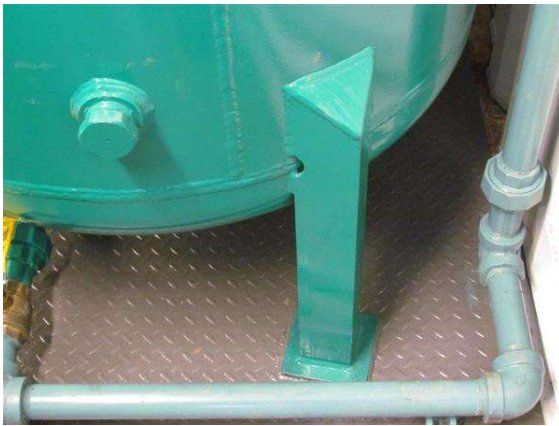
Figure: 5

Vessel supported on angle iron legs
