Client	Newalta Corporation	Inspection Date	Oct 20, 2016		
Prov. Reg. #	AB 0647152	Inspection Type	VE / VI / PSV		
Equipment Type	Scotch Marine Boiler	Location	Gold Creek Waste Management Facility		
Tag/Equip.	AS858009	LSD	AB 10-09-067-05W6		
Status	In Service	Downhole LSD			
Manufacturer	Cleaver Brooks	Area	Gold Creek		
Serial Number	T4853-1-1	Year Built	2014		
CRN #	U7388.21	Service	Steam		
Comp/Unit Id		Manway	Yes		
Nat.Board #	19013	Coating			
Interim Insp'n		Interim Type			
Next Thorough Insp	2018	Next Insp Type	VE / VI / PSV		
Length		Height			
Volume		Client Reference			
Owner	Newalta Corporation	RT		HT	NO
Foreman	Steve Wiseman	RAE Job No.	1435.008.010		
ABSA	Plant: H Vessel: F Process: T Special: Z	ASME	Sec.IV		
History Log	The boiler was initially inspected under RAE44213 (before it had an A-Number.) U1A - entered May 5, 2015 A0647152 (Scotch Marine Boiler) Inspection Plan - 00.144.389

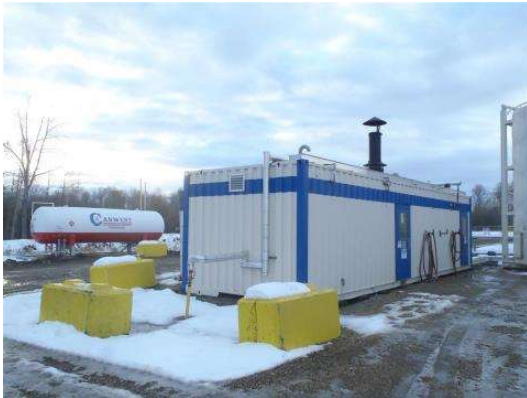
Figure: 2

The boiler is fully inside a building, and there is adequate room around the boiler to allow for inspection. There is adequate light around the boiler. There were no housekeeping issues around the boiler.

Building Overview

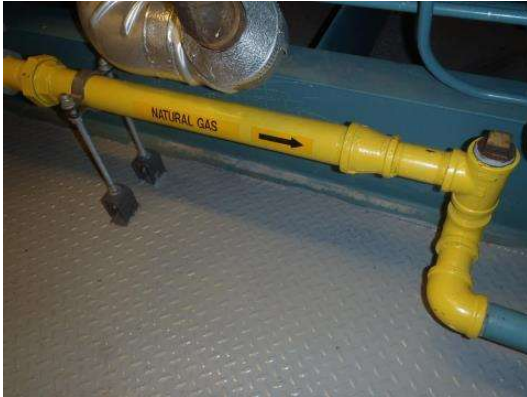
Figure: 3

The associated piping is well supported, and in generally good condition. The fuel gas piping is painted (color coded) yellow.

Fuel Gas Piping

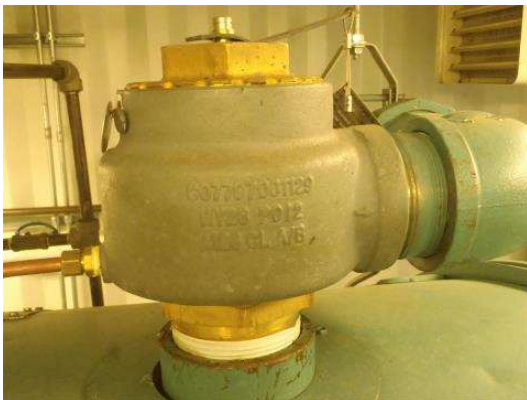
Figure: 4

The boiler has one PSV which relieves outside the building.
The PSV has a metal service tag correctly attached to the valve.
PSV has a correct nameplate with an ASME HV stamp.

PSV Overview

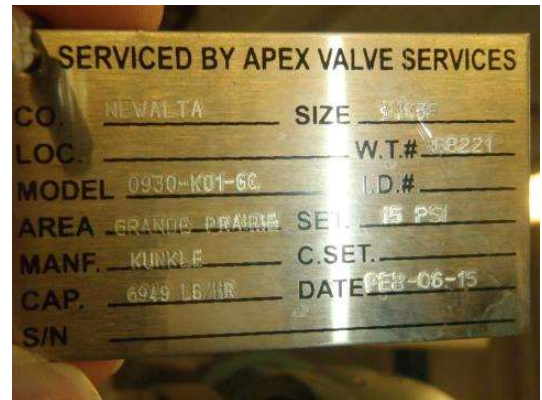
Figure: 5

PSV Service Tag

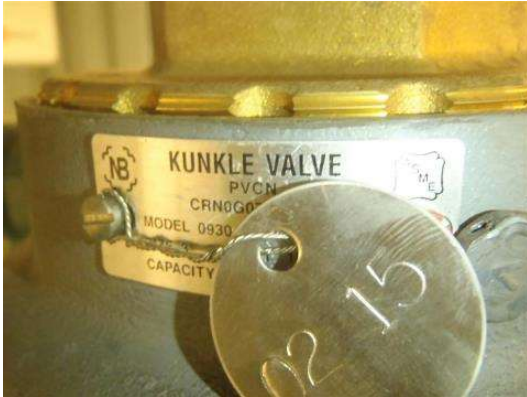
Figure: 6

PSV Nameplate

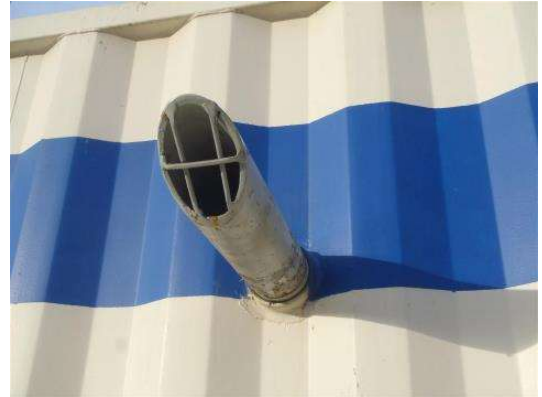
Figure: 7

PSV Relief

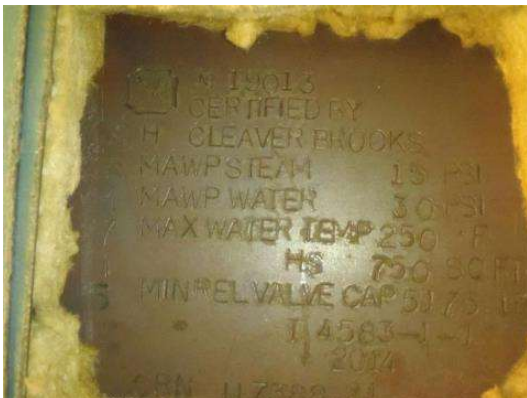
Figure: 8

The boiler was identified by the A number stamped on the nameplate. The boiler is on a skid frame supported by 2 saddles.

Boiler Nameplate

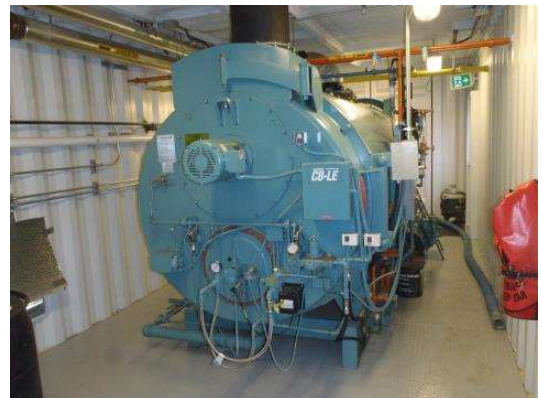
Figure: 9

The shell is insulated, cladded, and in generally good condition. The ends of the boiler are not insulated, as they are internally refractory lined.

The boiler appears to be in good external condition. The burner controls appeared to be in good condition. Boiler air intake is close to building air intake at the stack. The hand holds appear to be correctly installed.

Boiler Overview

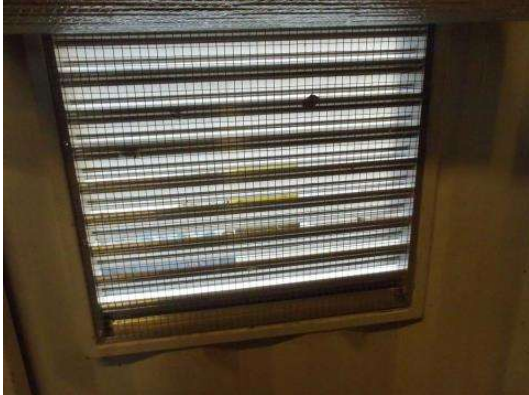
Figure: 10

Air Intake

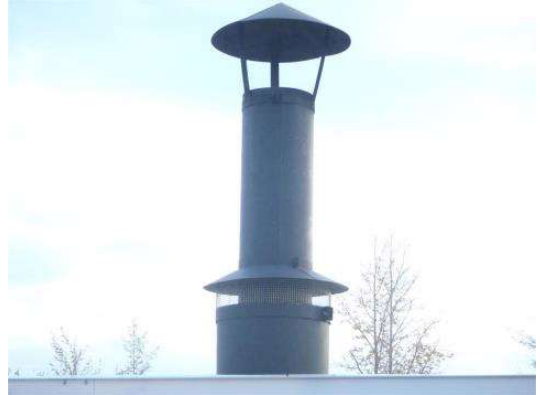
Figure: 11

Boiler Stack

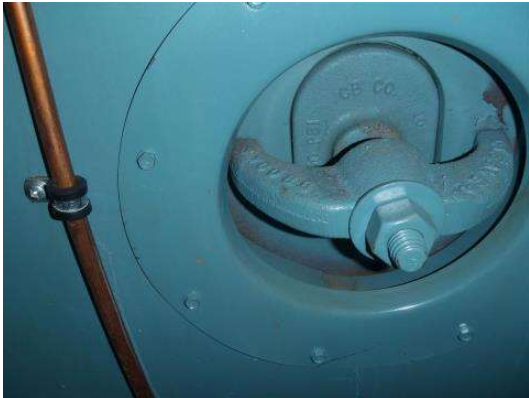
Figure: 12

Boiler Handholes

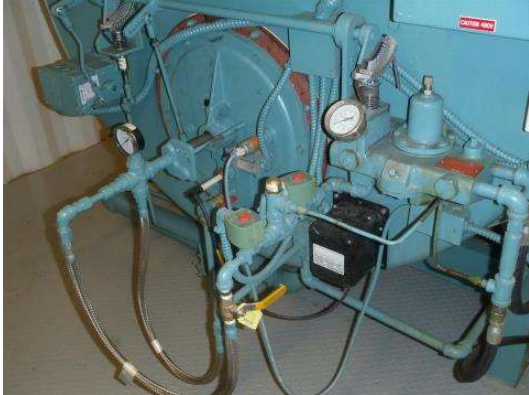
Figure: 17

A visual inspection from the return end revealed that the burner appeared to be in good condition. There was no significant corrosion or debris noted in the combustion barrel.

Burner Assembly

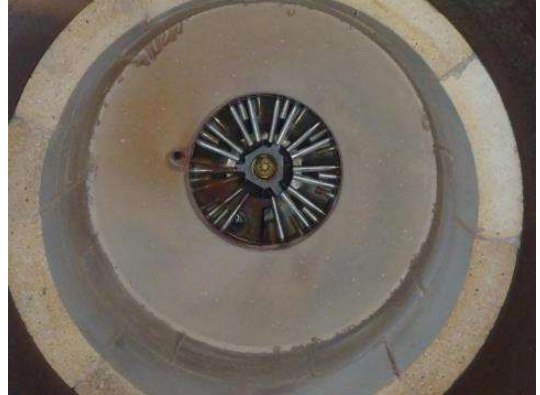
Figure: 18

Burner Close Up

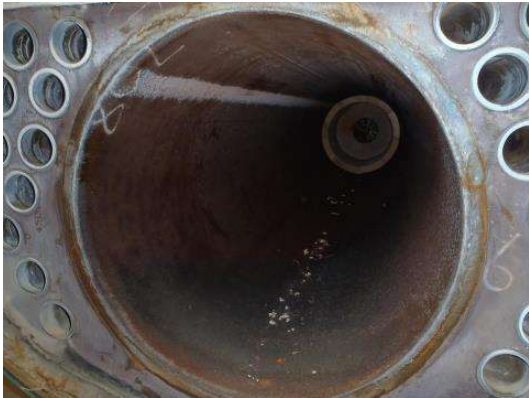
Figure: 19

Burner Barrel

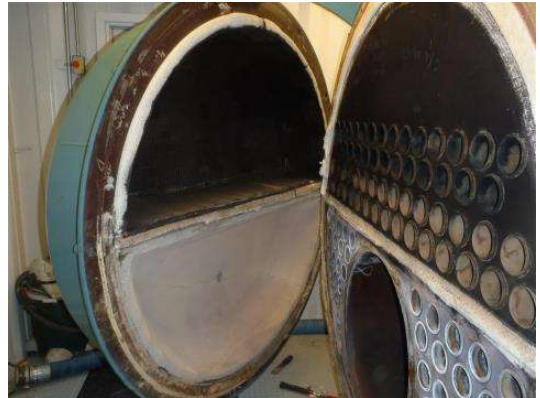
Figure: 20

The 2nd pass tube sheet and tubes were light color. The 3rd pass tube sheet and tubes were dark color. There was no sign of any significant corrosion on the tube sheet or tubes. There was no sign of any tube or tube end leaks.

All refractory around the burner, and on rear door was well adhered, and in good condition, with some hair line cracks. No refractory was missing or broken loose.

Rear Door / Tube Sheet
