Firetube Boiler Inspection Report

Insp Date: 17-Oct-2018	Client: Tervita	District:	LSD: 10-09-067-05 W6M
Facility: Gold Creek	Facility Type: TRD	Client Ref # 20057	IRM Ref #
Equipment #	Description: Steam Boiler	Type: Fire Tube	
Jur#: 647152	CRN U7388.21	MFR: Cleaverbrooks	Mfr S/N: T4583-1-1 Yr Blt: 2014
Capacity: 5175 #/hr	Code: Sect IV	Status: Operating	
MAWP: 103 kPa	MAWT: 121 C	Lowest Set PSV: 15 psi	Total PSV Capacity: 6949 #/hr

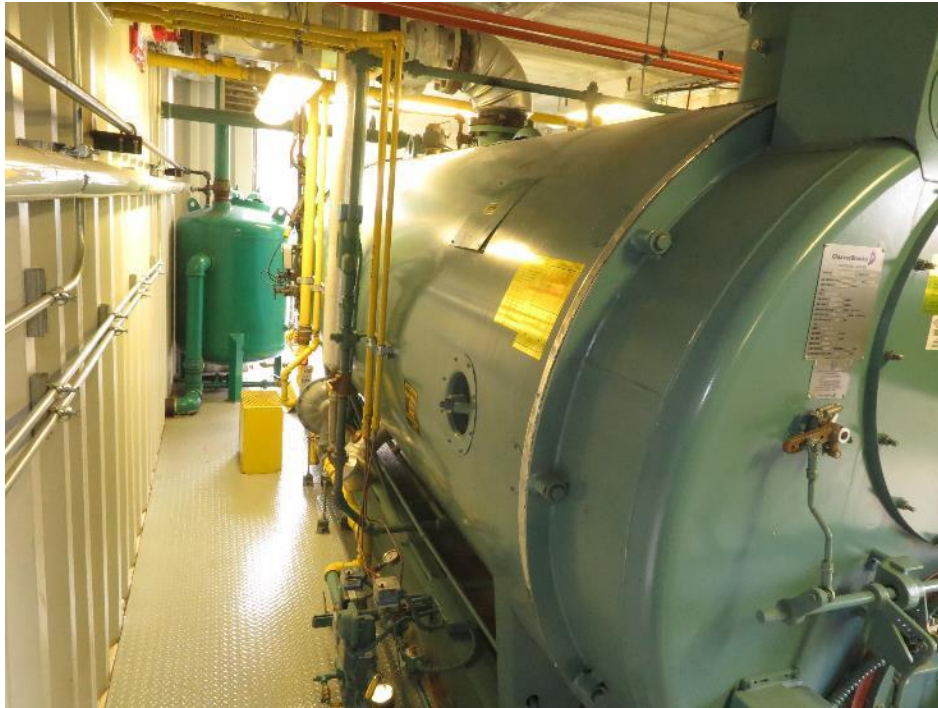
Base – is in good condition
 Cladding – is in good condition
 Stack – is in good condition
 Ground – present on building
 Attached Piping – properly made up and supported; no leaks or short bolts found; insulation and cladding on hot line in good condition

Cladding, base, and piping

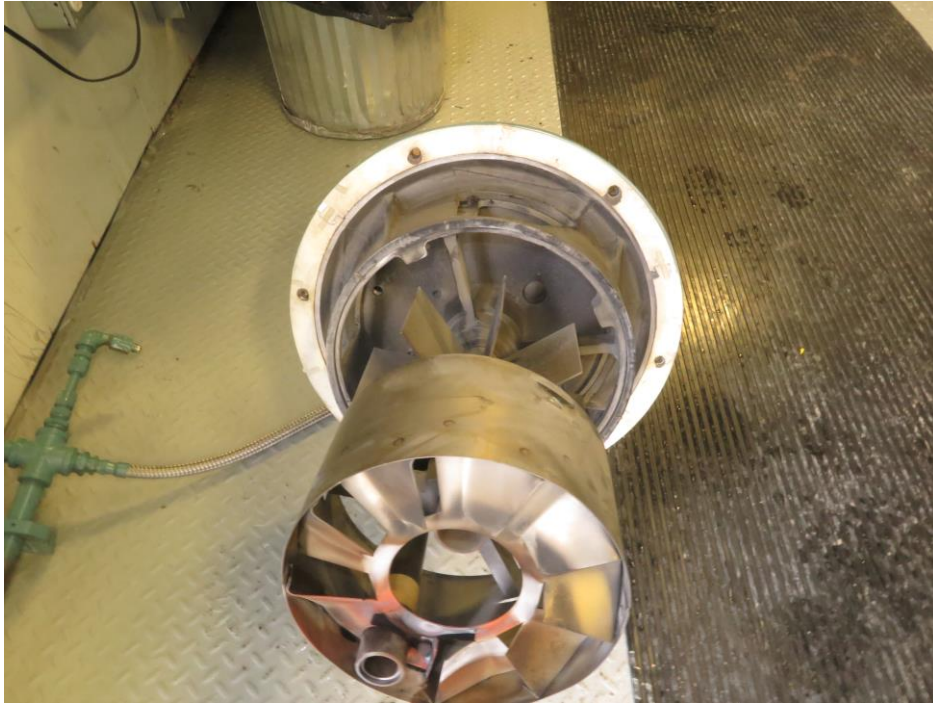
Burner System – all burner components are in good condition, fan and inlet grate is clean
 Gas Valves – gas valves bubble tested and was found to be gas tight
 Combustion was found to be surging – combustion was checked and adjusted to prevent vibration

Burner

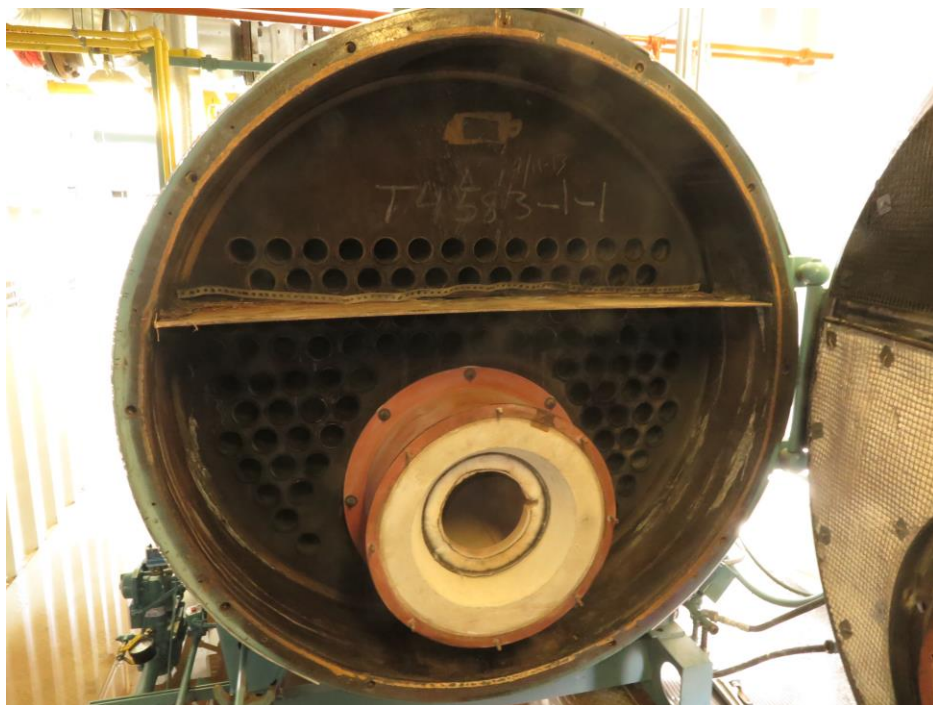
Front tube sheet baffle openings (corners and space where baffle meets the tubesheet) packed with castable refractory to reseal pass

Front tube sheet

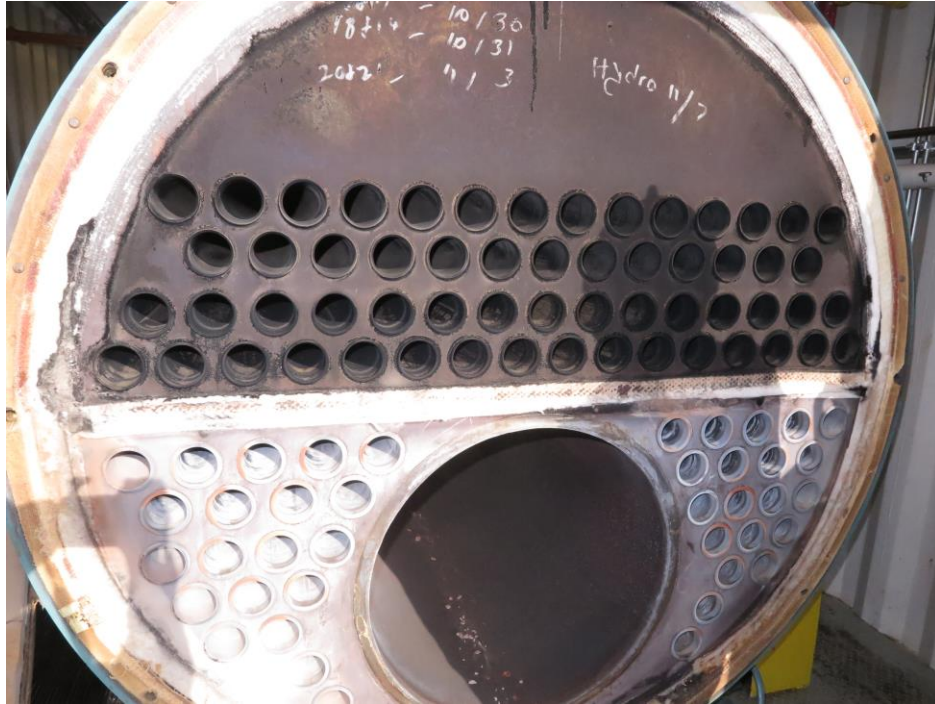
Rear tube sheet

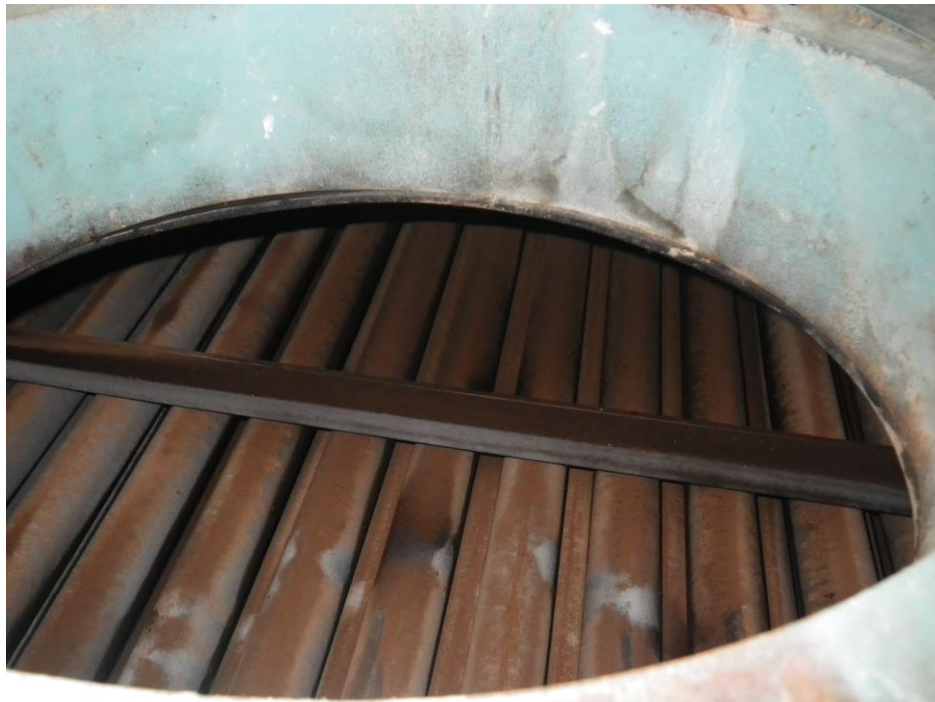
Tubes – light colored scale present on the tubes – about 1/16” typical with up to 1/8” on furnace tube on the bottom
 Drum – light colored scale is present on the drum that is thicker than on the tubes with loose scale/sludge in the front and back of the drum – tubes and shell pressure washed and all loose scale/sludge removed
 PLWFCO – bowl had moderate to high amount of sludge in bowl – cleaned; head is clean; steam and water connections are clean
 SLWFCO – probes gummed with sludge – cleaned, bowl had sludge that was cleaned

Top of tubes

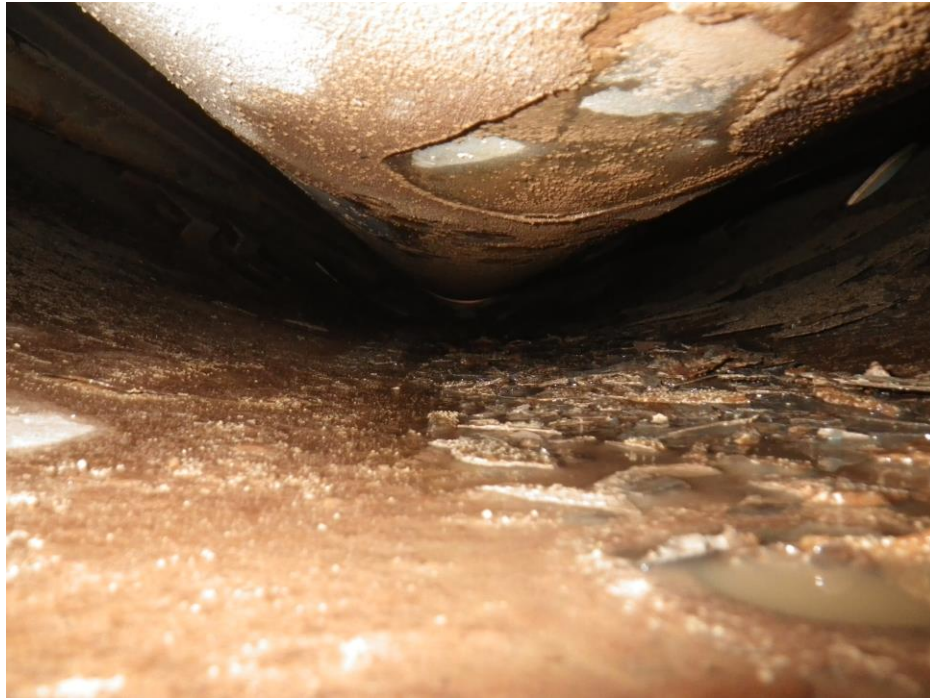
Bottom of furnace tube and shell (after cleaning)

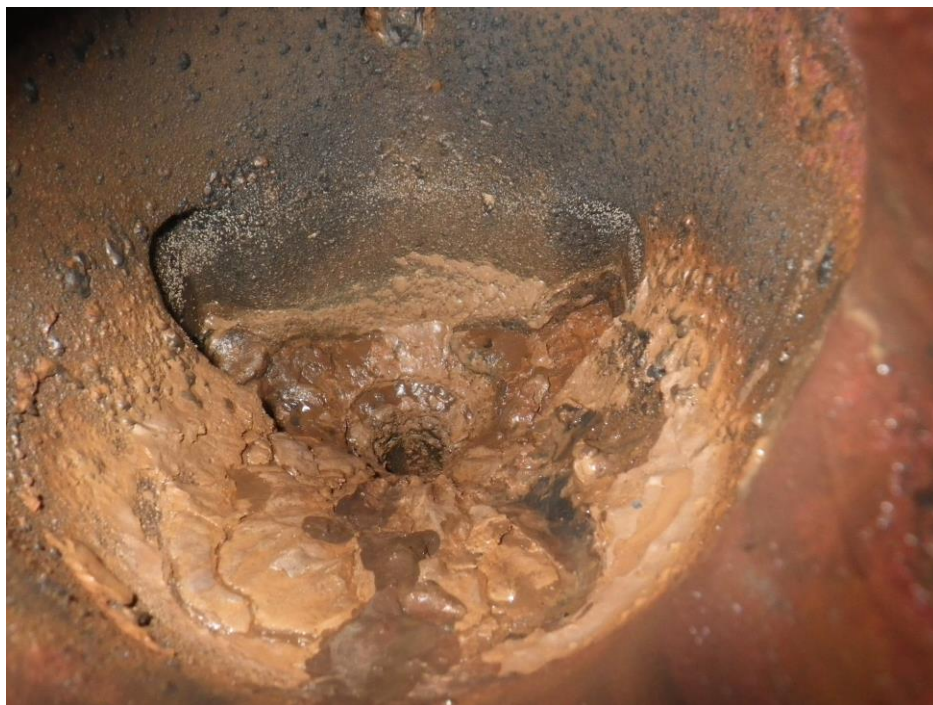
PLWFCO Bowl

ENSURE PROPER BLOWDOWN OF COLUMNS TO PREVENT SLUDGE BUILD UP
