Firetube Boiler Inspection Report

H-900

Date 18-Jun-2019

Insp Date: 18-Jun-2019	Client: Tervita	District:	LSD: 10-09-067-05 W6M
Facility: Gold Creek	Facility Type: TRD	Client Ref # 20057	IRM Ref #
Equipment # H-900	Description: Steam Boiler	Type: Fire Tube	
Jur#: 647152	CRN U7388.21	MFR: Cleaverbrooks	Mfr S/N: T4583-1-1 Yr Blt: 2014
Capacity: 5175 #/hr	Code: Sect IV	Status: Operating	
MAWP: 103 kPa	MAWT: 121 C	Lowest Set PSV: 15 psi	Total PSV Capacity: 6949 #/hr

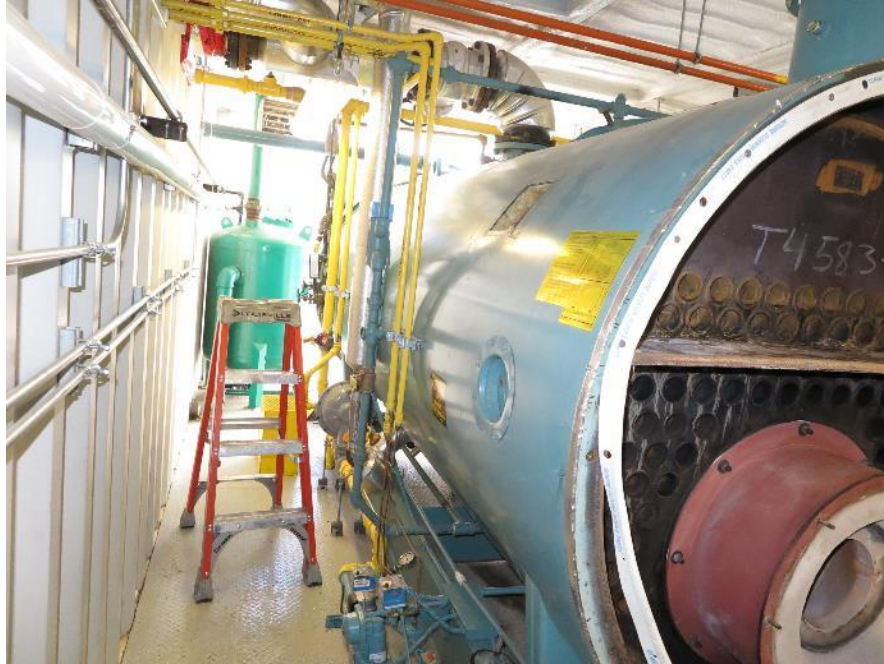
Base – is in good condition
 Cladding – is in good condition
 Stack – is in good condition
 Ground – present on building
 Attached Piping – properly made up and supported; no leaks or short bolts found; insulation and cladding on hot line in good condition

Cladding, base, and piping

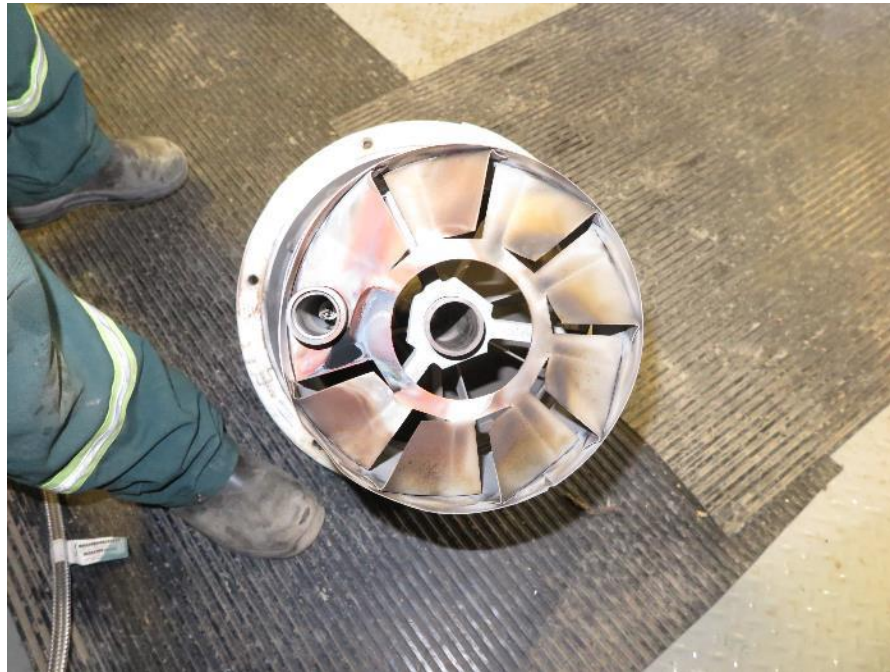
Burner System – all burner components are in good condition, fan and inlet grate is clean
 Gas Valves – gas valves bubble tested and was found to be gas tight

Burner

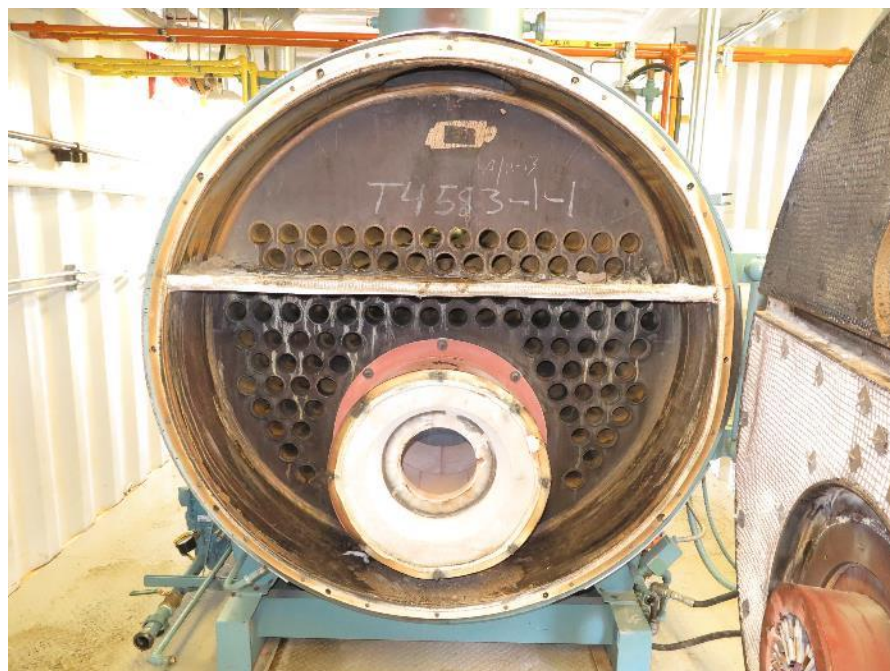
Tubes Sheets – circumferential weld and ligaments visually inspected with no issues noted, tube to tube sheet seals visually inspected with no issues noted
 Tubes – rolled and flared ends visually inspected with no issues noted; slight bow on tube static (top tube on open side of front door on third pass – will monitor for further movement next inspection) otherwise tubes are round and straight with no signs of overheating
 Furnace Tube – back tube sheet weld visually inspected with no issues noted, furnace tube long weld appears good, furnace tube clean with no issues
 Front door is in good condition
 Front tube sheet baffle openings (corners and space where baffle meets the tubesheet) packed with castable refractory to reseal pass
 Back door refractory cracks repaired – cracking from vibration from propane firing

Front tube sheet

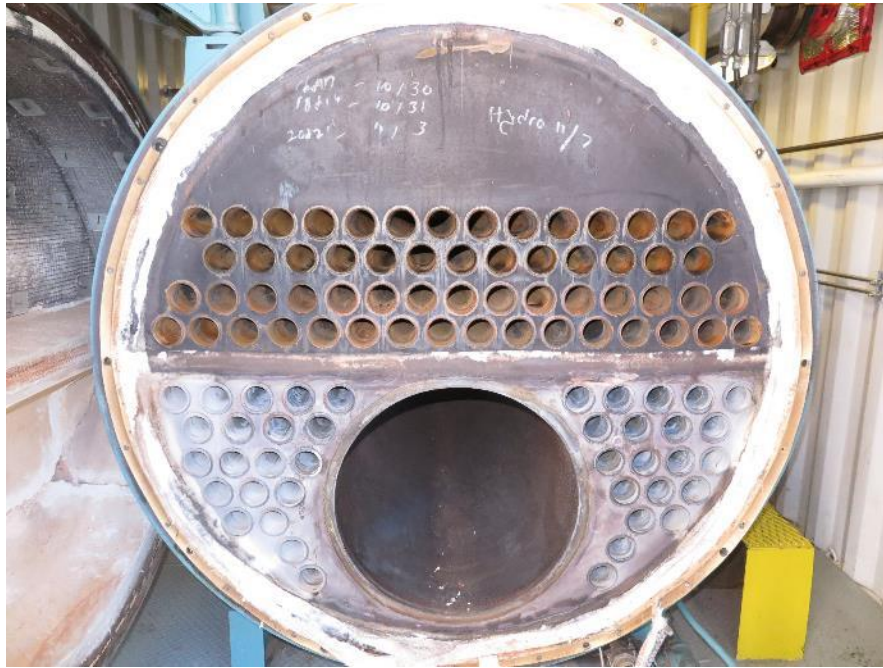
Rear tube sheet

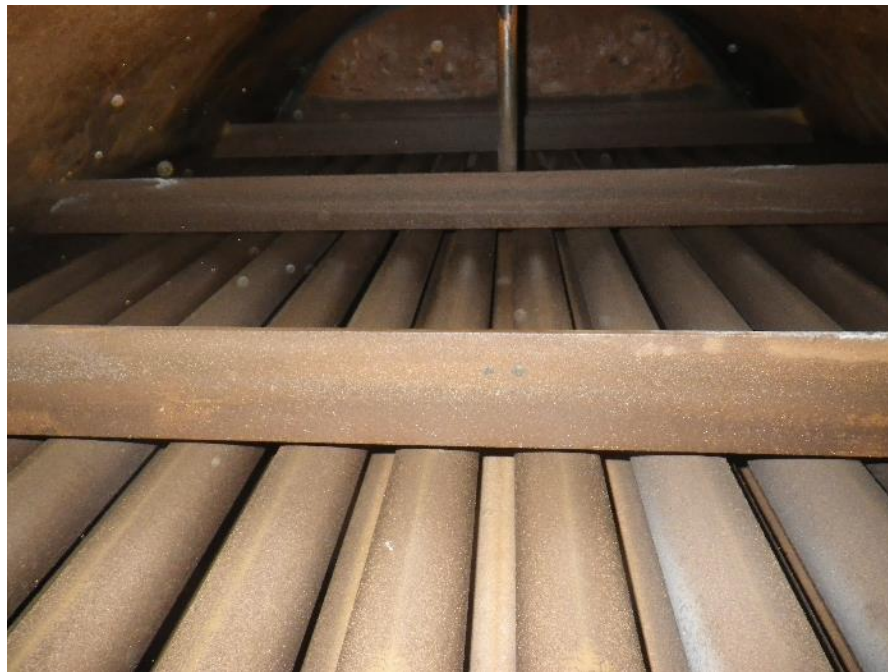
Tubes – bumpy light colored scale present on the tubes – about 1/16” typical with up to 1/8” on furnace tube on the bottom
 Drum – light colored scale is present on the drum that is thicker than on the tubes with loose scale/sludge in the front and back of the drum – tubes and shell pressure washed and all loose scale/sludge removed
 PLWFCO – bowl had small amount of sludge in bowl – cleaned; head is clean; steam and water connections are clean
 SLWFCO – hard sludge in the bottom – cleaned and rinsed out

Top of tubes

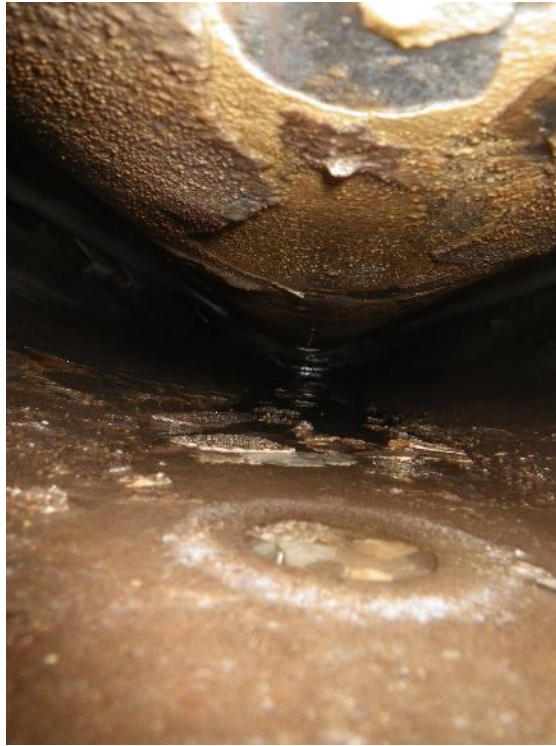
Bottom of furnace tube and shell (after cleaning)

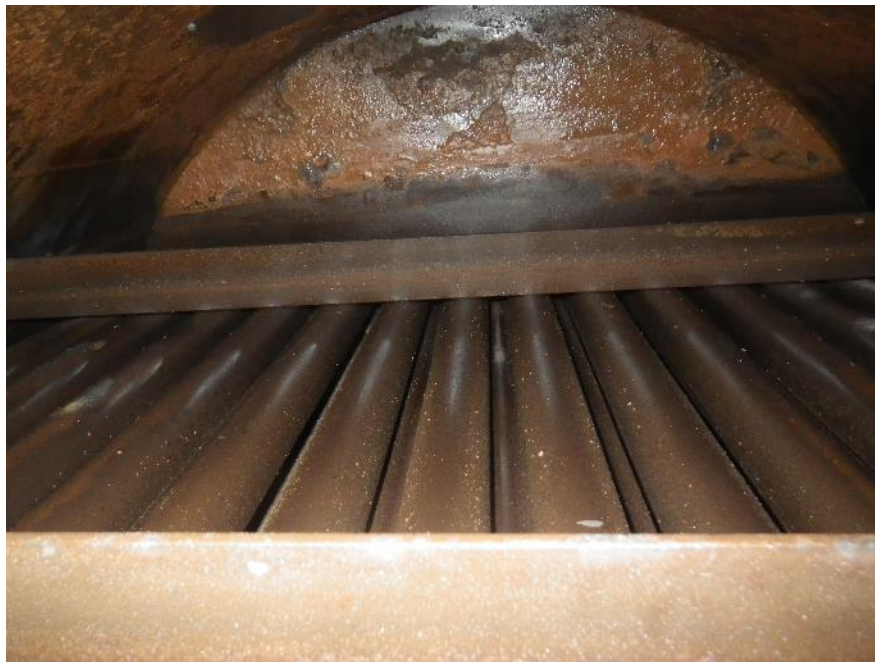
Top of tubes after cleaning

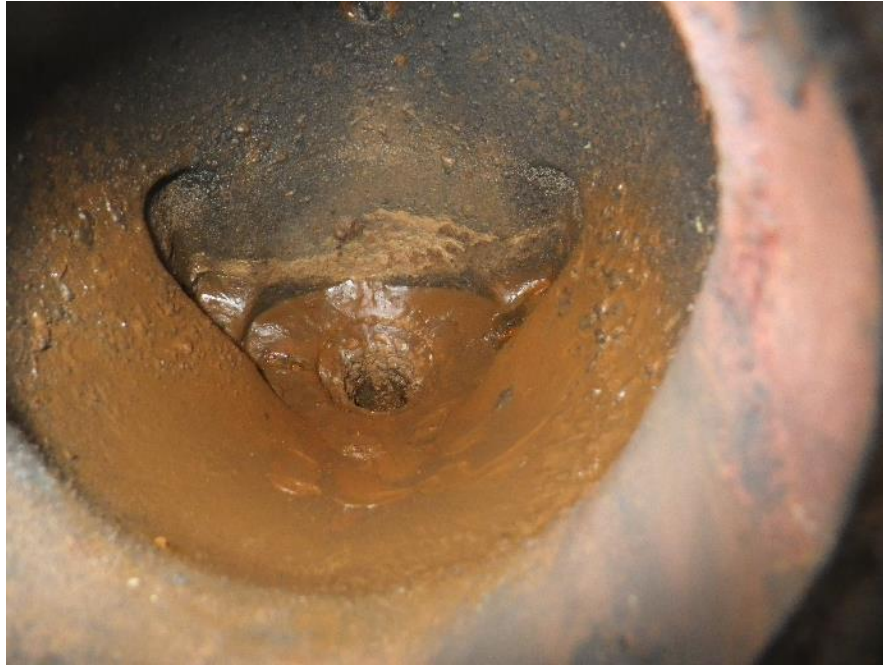
PLWFCO Bowl

ENSURE PROPER BLOWDOWN OF COLUMNS TO PREVENT SLUDGE BUILD UP

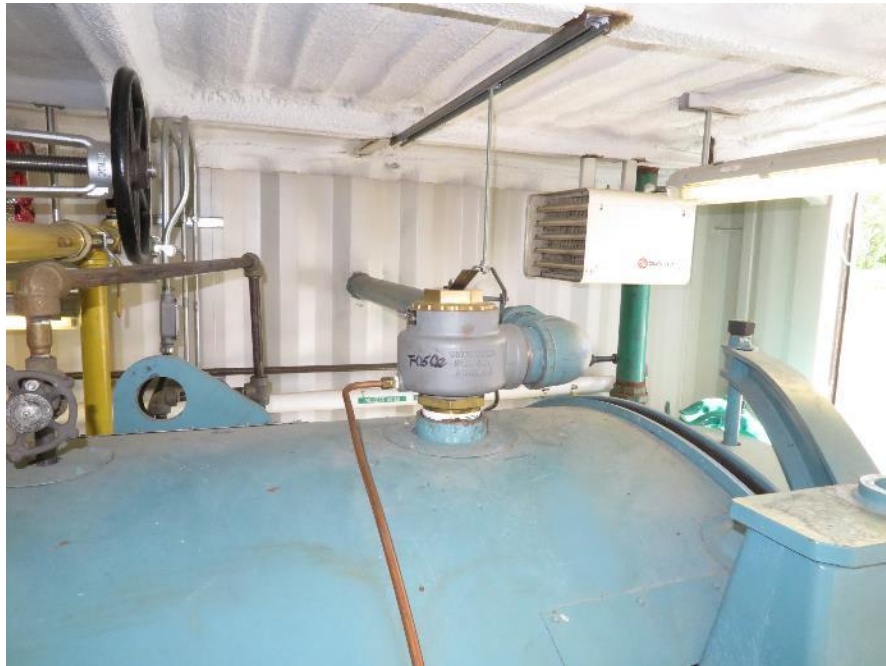
New PSV installed November 2018 – PSV will remain on a one-service interval to establish a service history.

PSV and piping
