# Tank Inspection Report

**400 bbl Produced Water Tank**

**COMPRESSOR**

**2016-12-21**

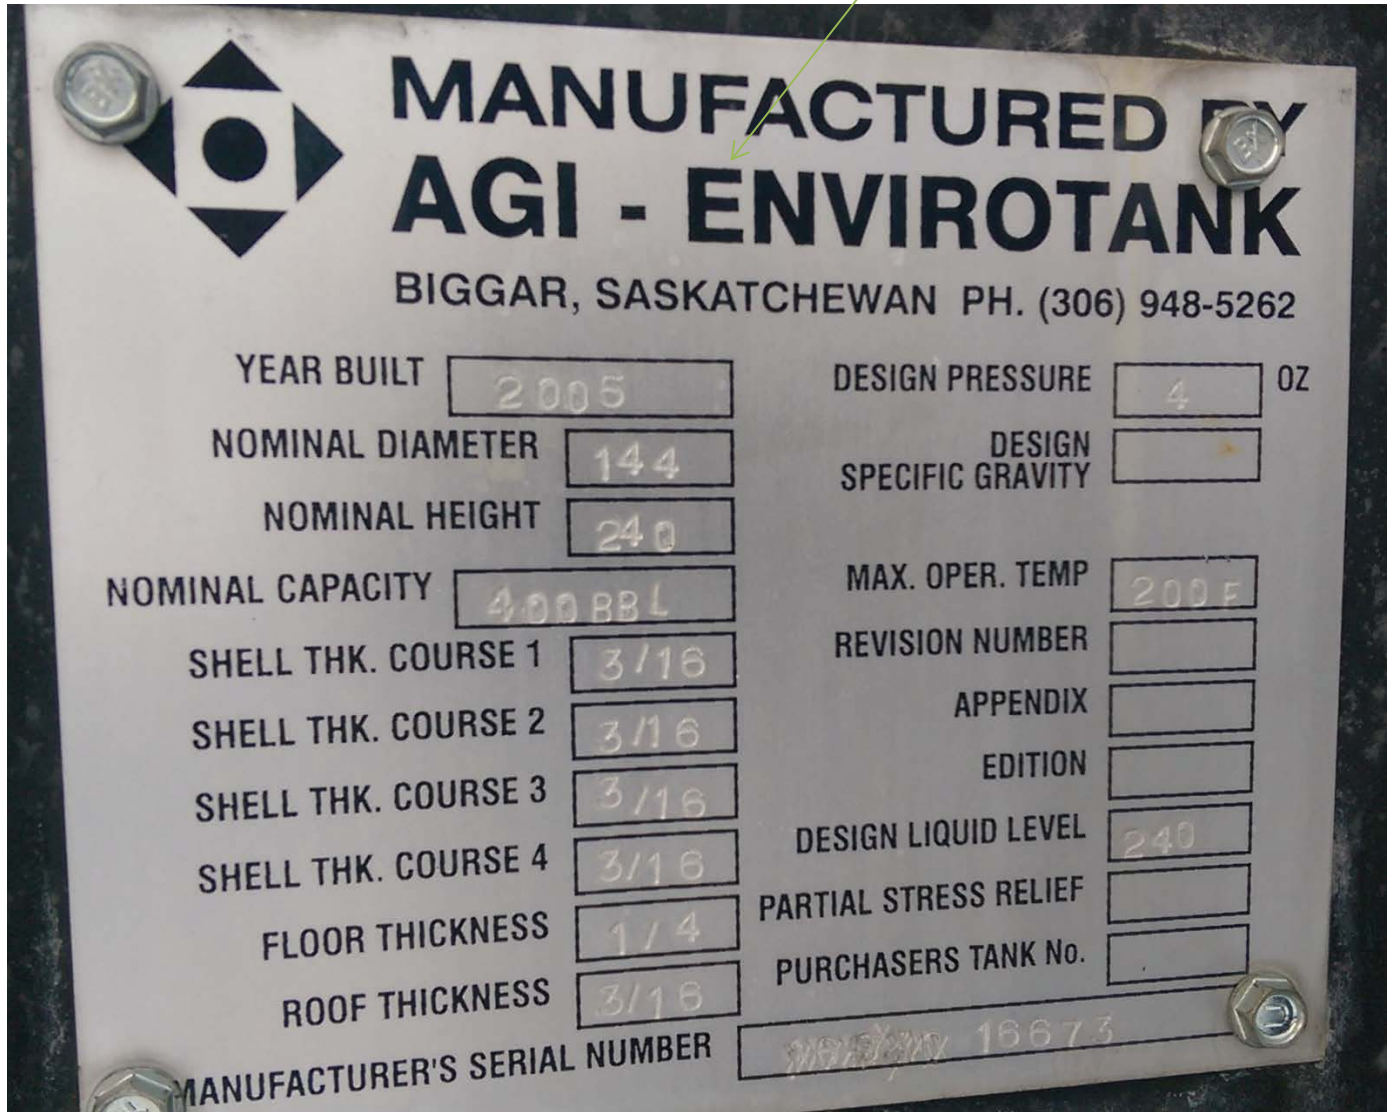
Inspection Photos	
Photo 1 – Depicts; Data Plate	Photo 2 – Depicts; External Overview

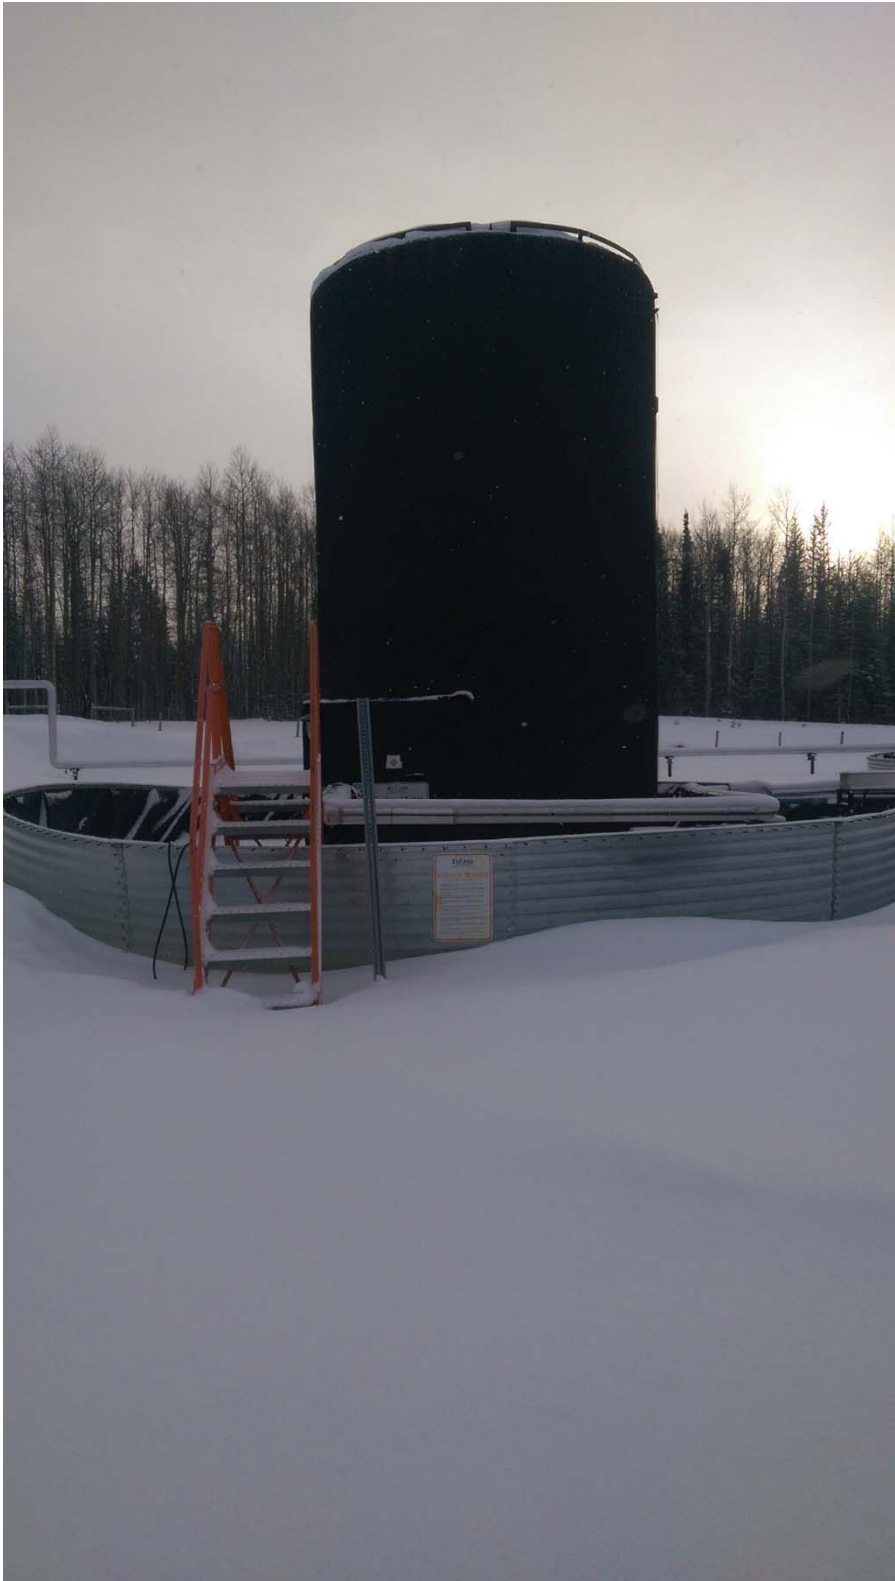
**Tank Summary:** PRODUCED WATER TANK IS IN OVERALL GOOD CONDITION
