Pressure Equipment Integrity Management System
Internal Inspection Form – Treaters / Heaters / Reboilers / FWKO

General Vessel Data					
Owner:	EOG Canada Oil and Gas			District/Area:	Northeast BC
Facility:	Maxhamish			Location (LSD) +:	D-36-I/94-O-14
A Number + :	SN-REB-01-0141-01-001-R			Serial Number +:	REB-01-0141-01-001-R
CRN ♦:				Vessel Type:	Reboiler
Description ♦:	Dehy #2 G	lycol Regenerat	or/Reboiler	Skid / Process:	Dehy Skid #2
Tag No:	6763, H-30	00		Status:	⊠ In Service □ Out of Service □ Other
Coating / Anode Data					
Internally Coated:		No Coverage:		Coating Type:	
Internal Anodes:	□Yes ⊠I	,		Anode Type:	
New Anodes Installed:	□Yes ⊠I	No Quantity:		Anode Type:	
Firetube / Tube Bundle					
	⊠Yes □I	No Quantity:	1	Serial Number(s):	1-14 1-1
Orientation:	Horizontal			Dimensions:	12" x 13'
Inspection					
External Nozzles (Viewe	ed from outs	<u>ide)</u>	N/A – not opened at time of ir	nspection	
Signs of internal corrosid	on?	□Yes □No _			
Flange faces deterioration	on?	□Yes □No			
Vessel Cleanliness					
Cleaning adequate?		□Yes ⊠No _	Not cleaned

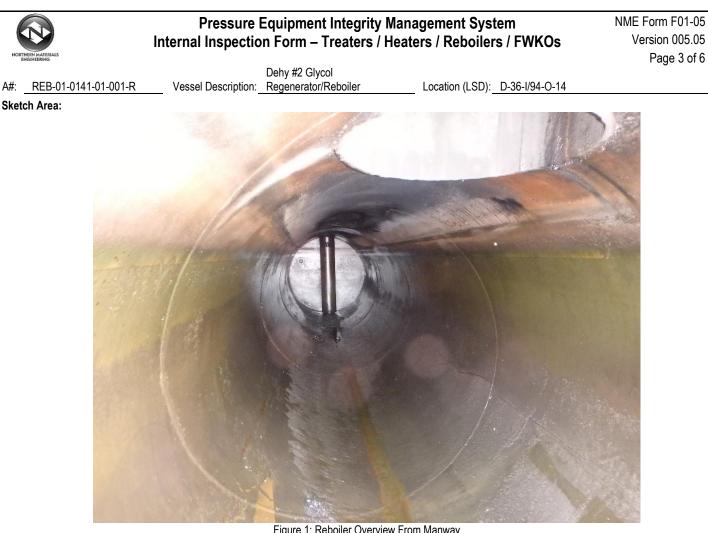
Figure 1: Reboiler Overview From Manway

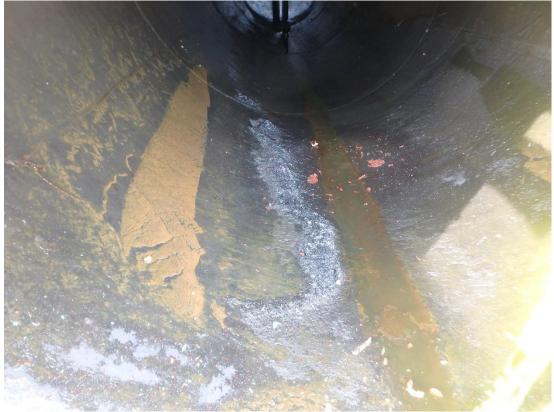
Figure 2: Reboiler Lower Shell Overview Form generated by EITigre, a product of Northern Materials Engineering Inc.

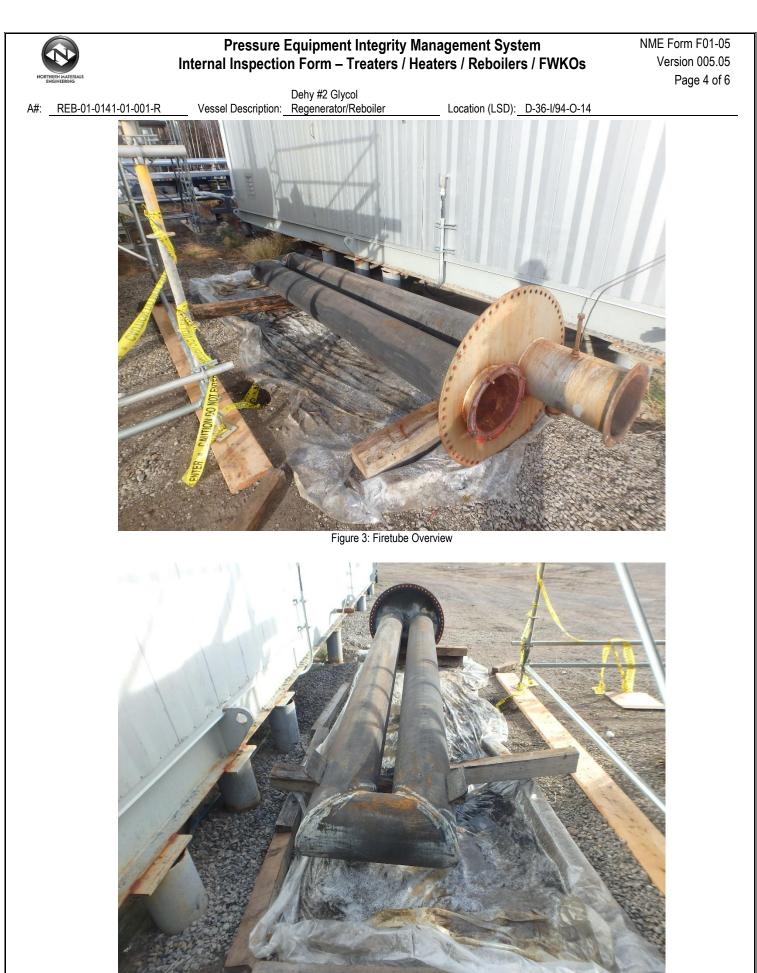
Figure 4: Firetube Overview

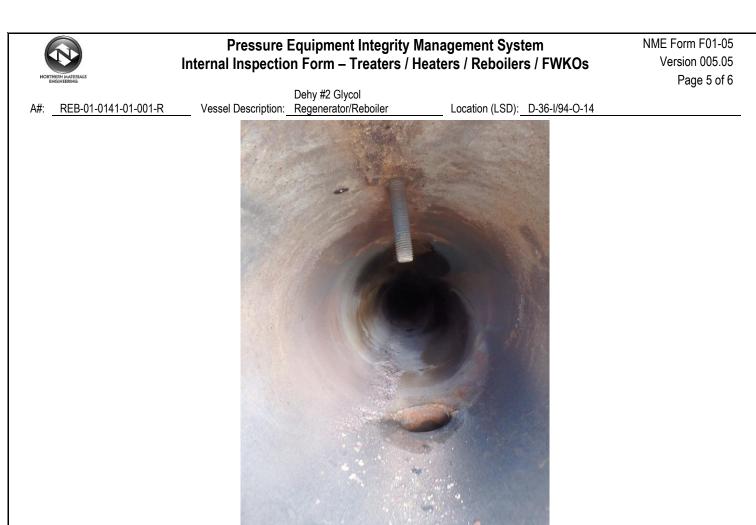
Figure 5: Firetube Internal Overview

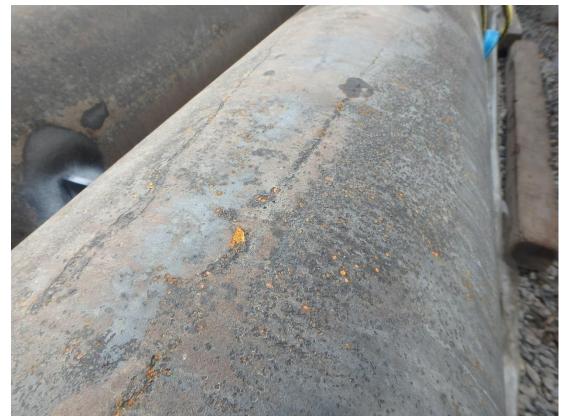
Scale/build-up remaining	g?	□Yes ⊠No _			
Internal Access					
Baffles/Weirs present?		□Yes ⊠No			
Other obstructions?		□Yes ⊠No _			
Firetube / Tube Bundle					
Indicate the degree of so	cale and sur	face deposits or	n the firetube / tube bundle: $ig \!$]Nil □Light □Moo	lerate 🗆 Heavy
Was the firetube sandbla	asted: 🗆 Ye	es □No □N//	A ⊠Not Required		
Surface Condition (pittin	a. aeneral c	orrosion): In	good overall condition. Some	pitting on tip of the fi	red side ~15 feet from the tubesheet. Deepest pit was

1.5mm deep.	0,0				·····
Distortion, warping, blist	ering, or oth	er deformation of	of the firetube / tube bundle?:	□Yes ⊠No If yes	, describe:
Were the welds inspecte	ed using MP	I? ⊠Yes □No	If yes, indicate results: M	PI performed by Pro	be Corrosion Services Ltd.
No relevant indications v	were noted o	during the exami	nation.		
Permanent Yoke Serial	Number:	PC-001		Procedure: P	C-MT1 Revision 1 - 2014
Wet Visible Magnetic Pa	articles:	Ardrox 8031		Visible Light: M	inimum 100fc (1000lux) @ surface of part
				Form g	enerated by EITigre, a product of Northern Materials Engineering Inc.

Figure 6: Pitting Present On Firetube
