## TANK INSPECTION REPORT

Field:	Drayton Valley	Inspection Date:	2017.03.07	Assigned Inspection Interval:	12 mths
Equip Desc:	Storage Tank	Mfr.:	GLM	Mfr. Date:	2001
Owner ID:	T-202	Mfr. S/N:	F-01-129-3	Construction Code	API 650 Modified
Location:	12-28-048-07W5	Tank Type	Cone, Bottom	Configuration	Vertical
Service		Length		Roof Girder System	No
UWI:		Diameter OD	4724.4 mm	Manway	Yes
Operating Status:	In-Service	Height	7315.2 mm	Elevated	
Suitable for continued service	Yes	Volume	625 bbl	Insulated	Yes
				Shell Material	A36 or equivalent
				Shell Nominal Thickness	0.25 – 0.1875
				Roof/Top/Left Material	
				Roof/Top/Left Thickness	
				Floor/Btm/Right Material	
				Floor/Btm/Right Thickness	0.25
				Internal Coated

Field: Drayton Valley	Inspector: Sam Han, P. Eng.
Equip Desc: Storage Tank	Credentials: API 653
Owner ID: T-202	Assessed By: Wade Stromquist
Location: 12-28-048-07W5	
UWI:	1 = As New      2 = Some Wear – Fit for Service      3 = Measurable Deterioration – Consider Repair      4 = Severe Deterioration – Repair Required      5 = Not fit for Service – Follow-up Required      6 = N/A

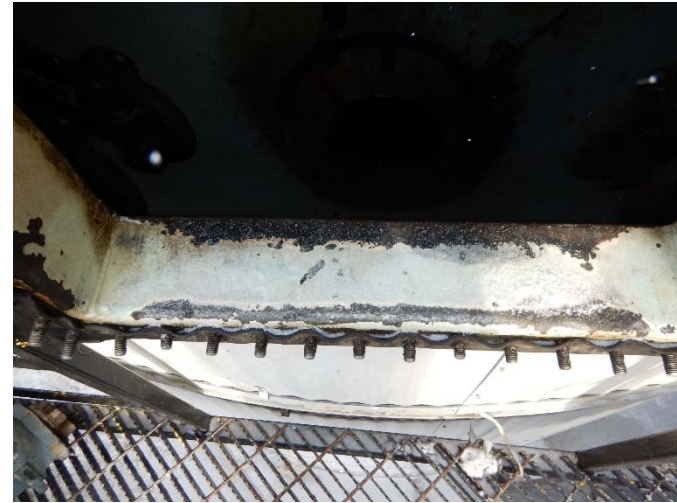
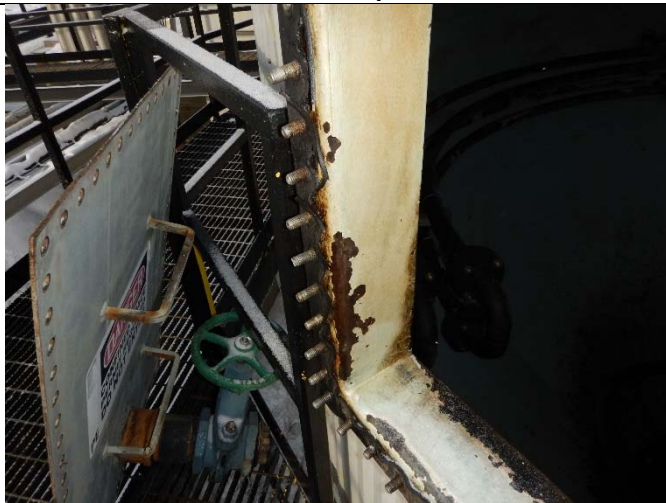
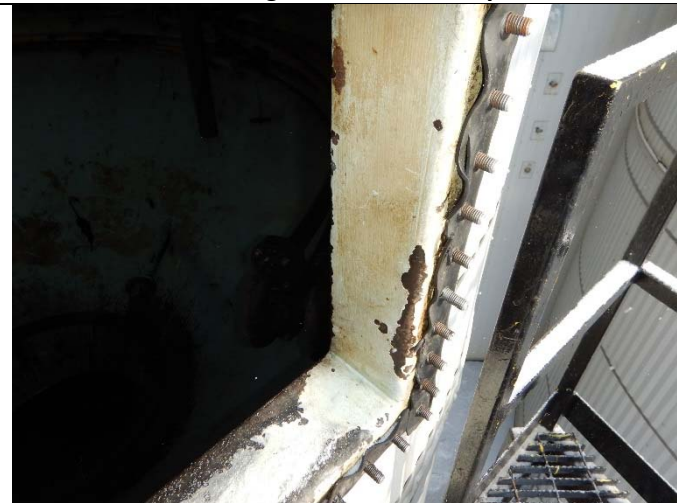
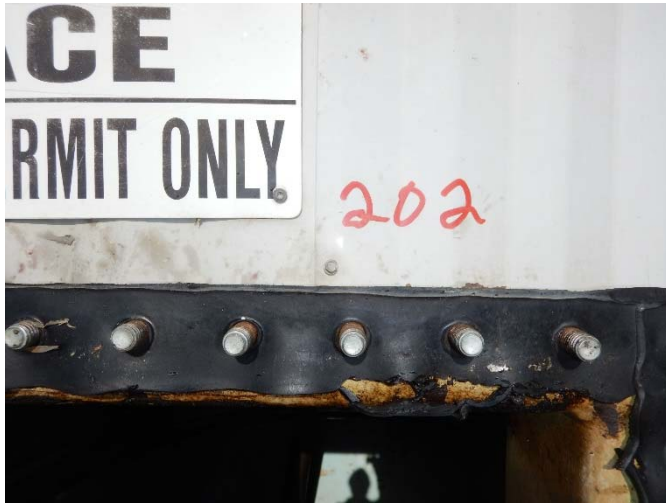
- Cladding seals at protrusion deteriorating
- Several coating holidays on cone bottom and roof. Coating holidays on shell difficult to identify. Significant coating loss at manway.
- Shell not adequately cleaned, preventing the use of UT crawler to measure shell thickness.
- Evidence of past leakage from cone bottom drain fittings.

Disposition		Comments	Disposition		Comments	
<b>Internal</b>						
Floor	2	Coating failure on ID of thief hatch and manway. Coating holidays on bottom and roof. General pitting found on ID of thief hatch.  Heat Coil appears to have some distortion.	Equipment	2	Coating failure on manway.	
Shell	2		Manways	2		
Roof	2		Ladders	6		
Roof Supports	6		Supports	2		
Coating	3		Other	6		
Piping	2		Interstitial Space	6		
Nozzles	2		<b>Fired Equipment</b>			
Flanges	2		Burner / Pilot Assemblies	6		
Level Controls	2		Flame Arrestor	6		
Gauge Cables	2		Tubes	6		
Cathodic Protection	6	<b>External Controls &amp; Safety Devices</b>				
Heat Coil	2	External Control Devices	6			
Sumps	2					
Drains	2					
Siphons	6

**Coating Failure on Manway**

Recommend coating repair prior to placing tank back into service.

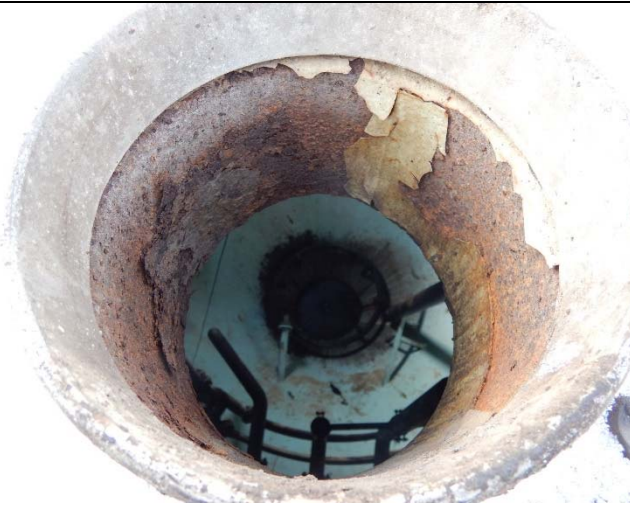
**Coating Failure on ID of Thief Hatch**

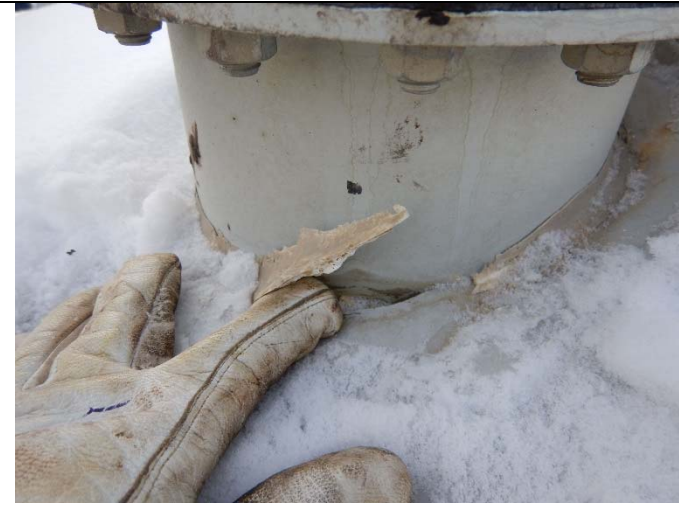
**Deteriorating Seals on Cladding**

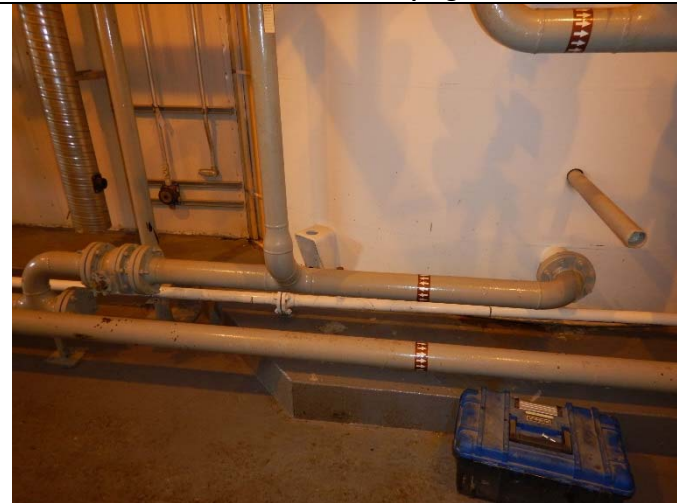
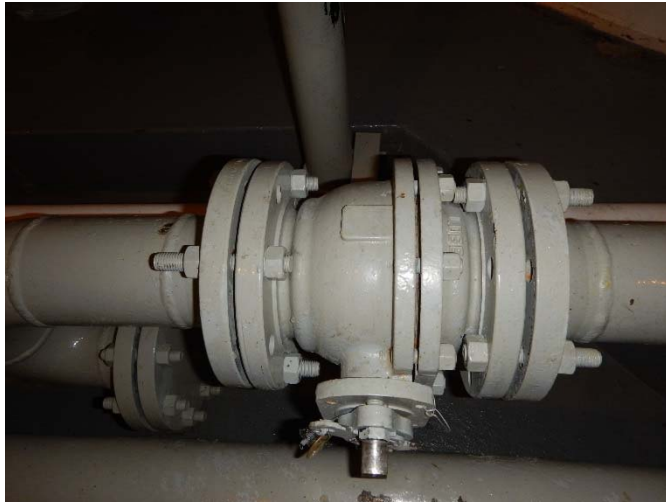
Disposition		Comments	Disposition		Comments
<b>Tank Exterior</b>					
Nameplate	2		Platforms	2	
Floor	2		Supports	2	
Shell	2		Manways	2	
Roof	2		PVRs	6	Removed for turnaround
Roof Supports	6		Cathodic Protection	6	
Paint	2		Anchor Bolts	6	
Insulation	2		Foundation	2	
Cladding	3		Grounding	6	Grounding cable not found.
Fireproofing	6		Firetubes	6	
Piping	2		Secondary Containment	2	
Bolting	3	Bolts missing on cone bottom drain valve.			
Ladders	2

**Missing Bolt on Flange**

Missing valve flange bolts on discharge line replaced prior to placing tank back into service.

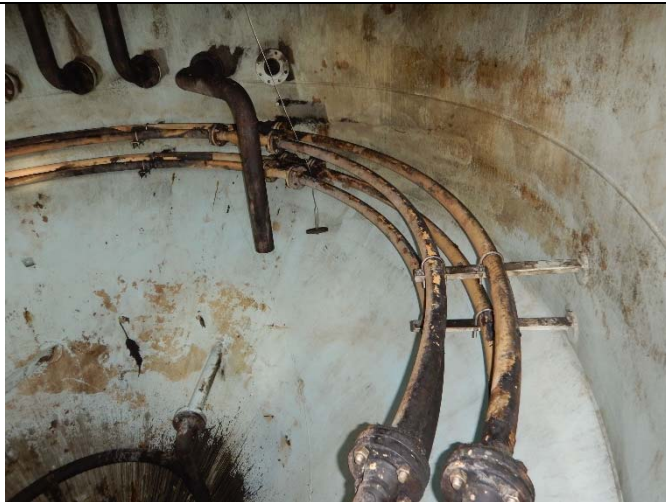
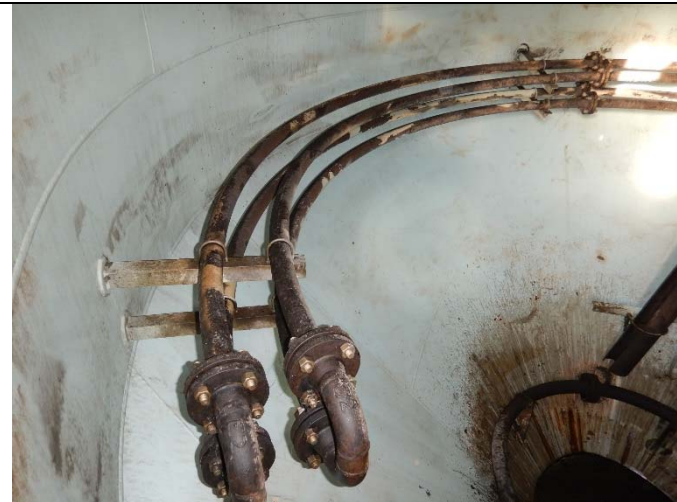
**Internal Heating Coils**

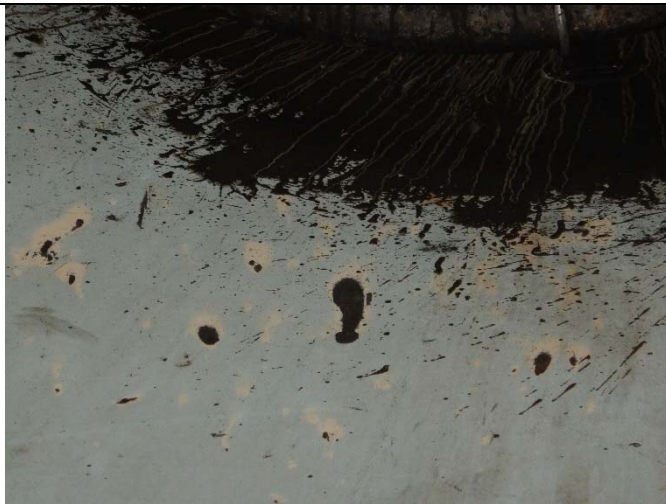
**Coating Holidays on Cone Bottom**

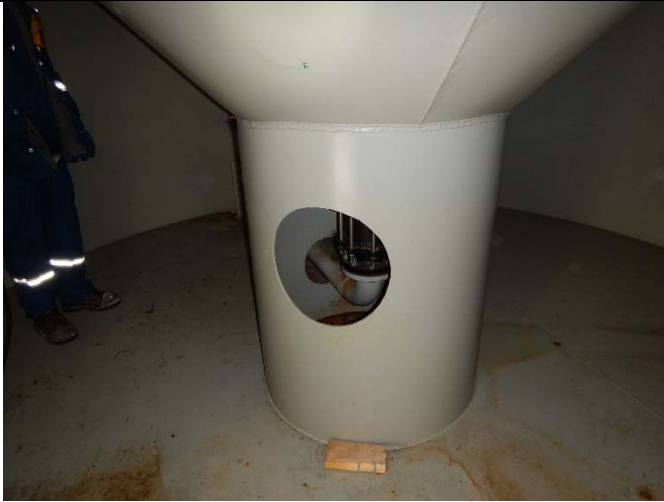
**External Cone Bottom – Some Evidence of Prior Leaking**
