## TANK INSPECTION REPORT

Field:	Drayton Valley	Inspection Date:	2017.03.07	yyyy.mm.dd	Assigned Inspection Interval:	12	mths
Equip Desc:	Storage Tank	Mfr.:	GLM	Mfr. Date:	2001	Shell Material	A36 or equivalent
Owner ID:	T-204	Mfr. S/N:	F-01-129-5	Construction Code	API 650 Modified	Shell Nominal Thickness	0.25 – 0.1875
Location:	12-28-048-07W5	Tank Type	Cone, Bottom	Configuration	Vertical	Roof/Top/Left Material	
Service		Length		Roof Girder System	No	Roof/Top/Left Thickness	0.25
UWI:		Diameter OD	4724.4 mm	Manway	Yes	Floor/Btm/Right Material	
Operating Status:	In-Service	Height	7315.2 mm	Elevated		Floor/Btm/Right Thickness	0.25
Suitable for continued service	Yes	Volume	625 bbl	Insulated	Yes	Internal Coated

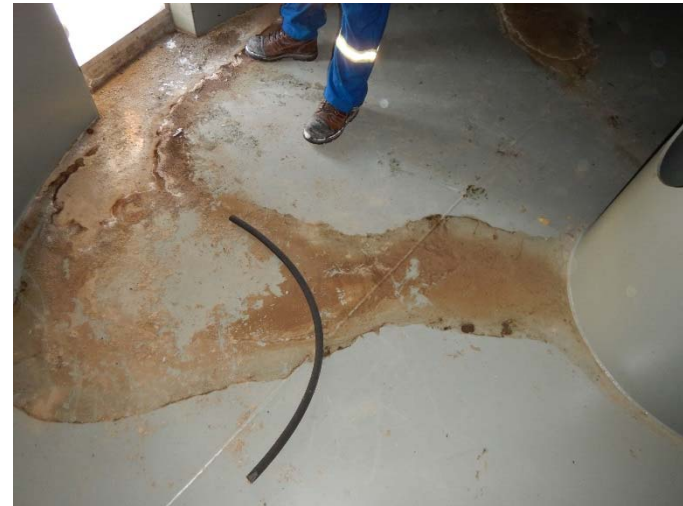
**Evidence of Past Leakage**

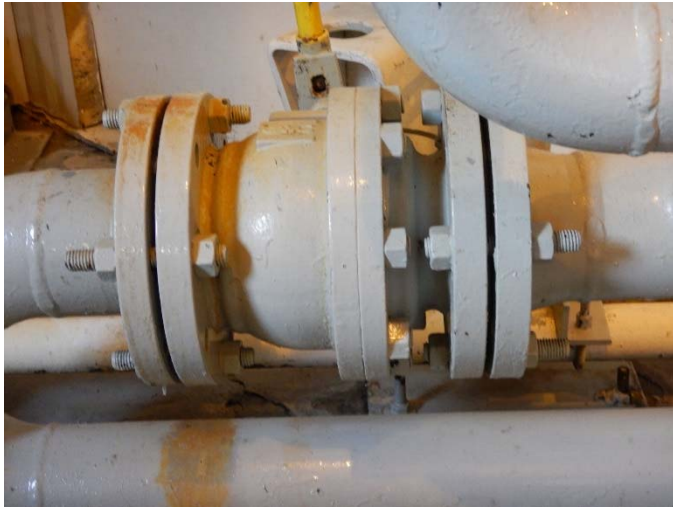
Disposition		Comments	Disposition		Comments
<b>Tank Exterior</b>					
Nameplate	2		Platforms	2	
Floor	2		Supports	2	
Shell	2		Manways	2	
Roof	2		PVRs	2	
Roof Supports	6		Cathodic Protection	6	
Paint	2		Anchor Bolts	6	
Insulation	2		Foundation	2	
Cladding	3	Seals at protrusions are deteriorating	Grounding	6	Grounding cable not found
Fireproofing	6		Firetubes	6	
Piping	3	Evidence of past leakage from cone bottom drain fittings	Secondary Containment	2	
Bolting	3	Cone bottom drain valve flange missing bolts.			
Ladders	2

**Cone Bottom Drain Valve Flange Missing Bolts**

Missing valve flange bolts on discharge line replaced prior to placing tank back into service.

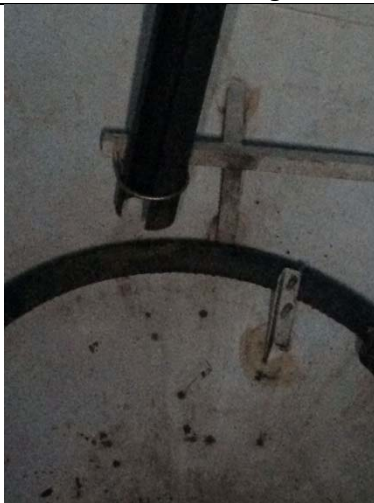
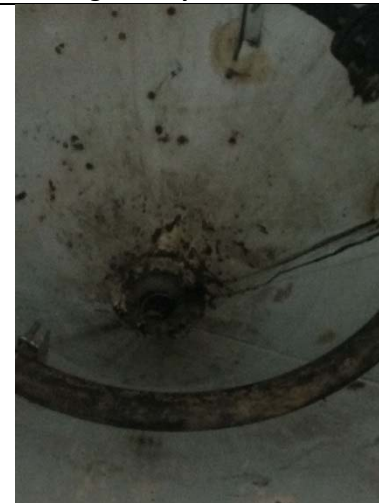
Disposition		Comments	Disposition		Comments
<b>Internal</b>					
Floor	3	Coating repairs required	Equipment	3	
Shell	2	Looks good	Manways	3	
Roof	2	Looks good	Ladders	6	
Roof Supports	6		Supports	2	
Coating	3	Repairs required floor	Other	6	
Piping	3		Interstitial Space	6	
Nozzles	2		<b>Fired Equipment</b>		
Flanges	2		Burner / Pilot Assembles	6	
Level Controls	2		Flame Arrestor	6	
Gauge Cables	2	Working	Tubes	6	
Cathodic Protection	6		<b>External Controls &amp; Safety Devices</b>		
Heat Coil	3	Baked on material should be removed	External Control Devices	6	
Sumps	2				
Drains	2				
Siphons	6

**Comments and Recommendations:**  
 Internal - looks good, coating repairs on floor.

**Coating Holidays on Cone Bottom**

Recommend coating repair prior to placing tank back into service.

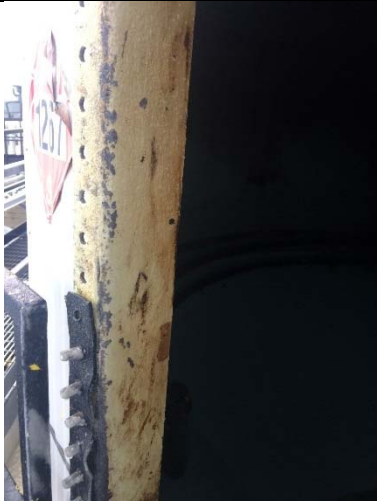
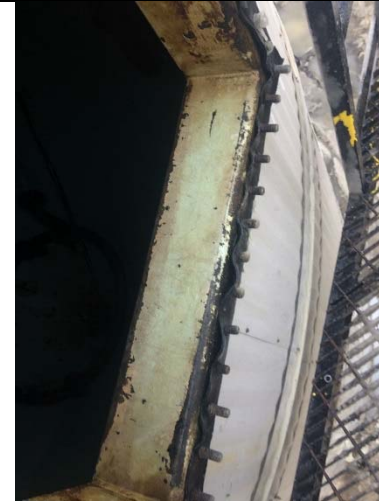
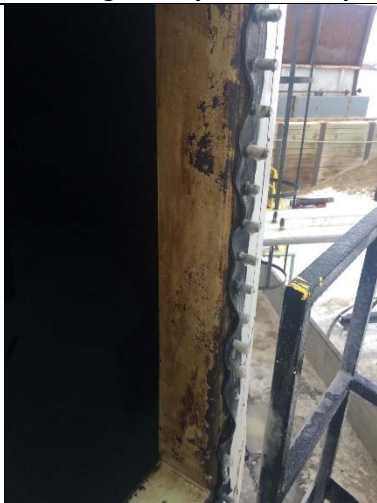
**Coating Holidays on Manway**

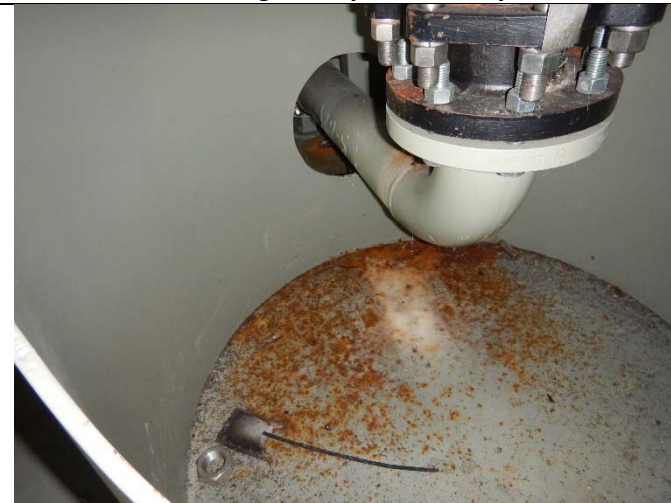
**Evidence of Past Leakage of Bottom Cone**

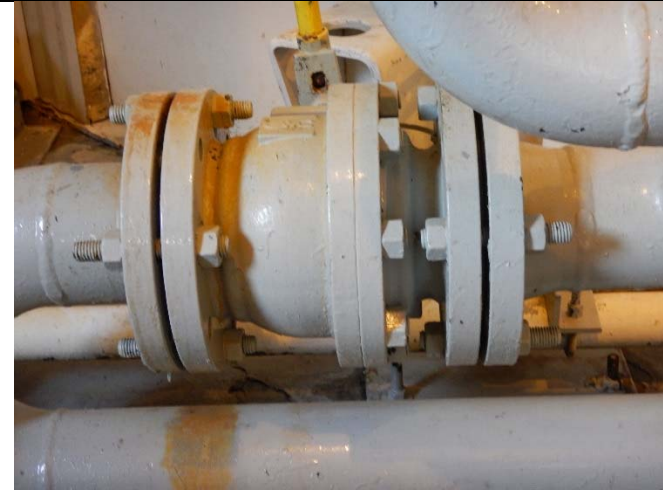
**Missing Bolts on Drain Valve Flange**
