# Pressure Vessel Inspection Report - EXTERNAL

PIM Sales Order #:	115- 02	Date:	May 19 ,2022
PIM Work Order #:	IS- 01	Sales # Desc.

Client: Fuelled Inc c/o Imperial						
Facility: La Corey Yard	Vessel Name: Inlet Separator					
Location (LSD): La Corey, AB	Equipment Number: V-5800					
Status: Operating In-Service Inspected <input type="checkbox"/> Yes <input checked="" type="checkbox"/> No	Tag #: Orientation: Horizontal					
Not Operating In-Service Inspected <input checked="" type="checkbox"/> Yes <input type="checkbox"/> No	Remains In-Service: <input type="checkbox"/> Yes <input checked="" type="checkbox"/> No					
Type of Inspection: <input checked="" type="checkbox"/> Baseline <input type="checkbox"/> Interval <input type="checkbox"/> Repair/Alteration						
<b>1.0 NAMEPLATE DATA</b>						
Jurisdictional Registration Number: A587074	CRN: U7552.2					
Manufacturer: Pyramid Process Fabricators	Year Built: 2008					
Vessel Serial Number: 08-3180-0000	Size (diameter x length-estimate): 78" x 20'					
Shell Thickness: 0.750 "	Shell material: SA-516-70N

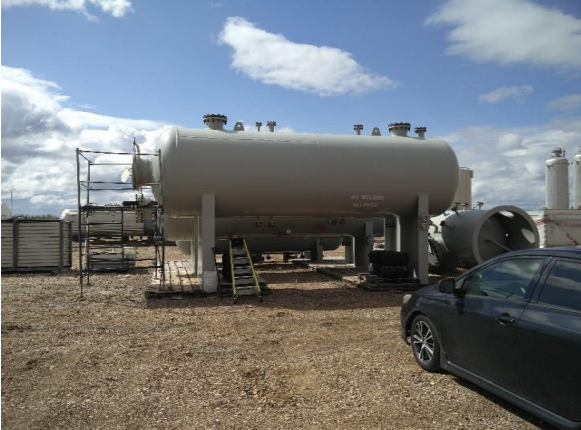
Photo 1 Description: Overall

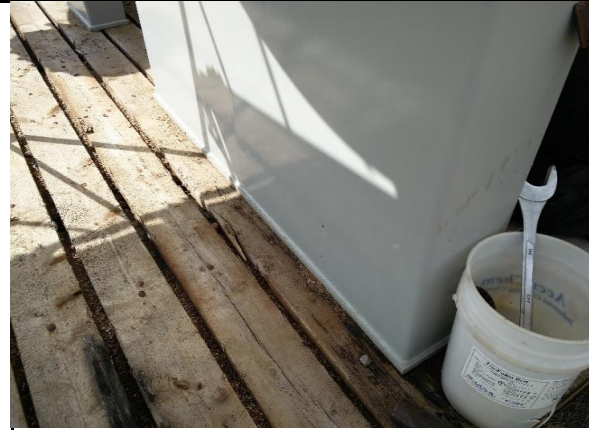
Photo 2 Description: Saddle

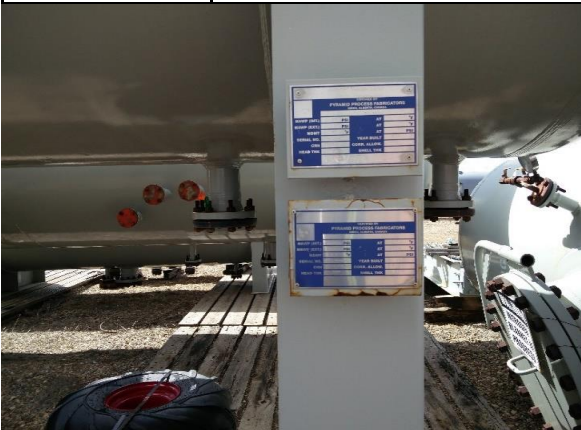
Photo 3 Description: 2 nameplates, 1 metric and 1 SAE

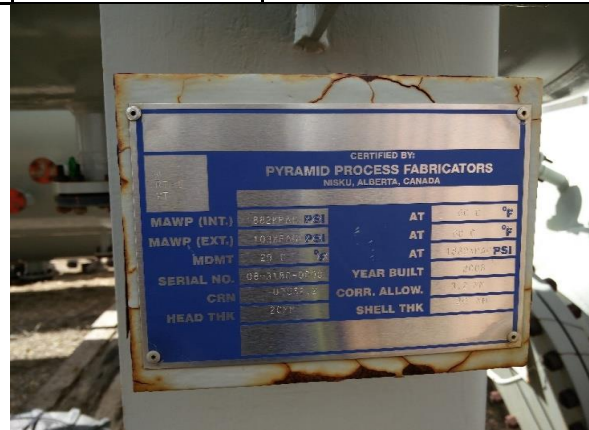
Photo 4 Description: Nameplate

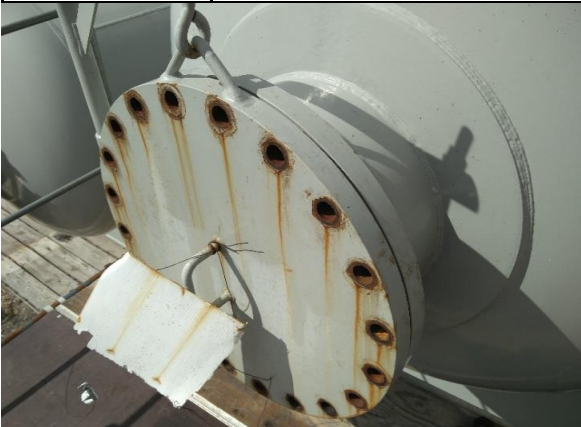
Photo 5 Description: Manway cover

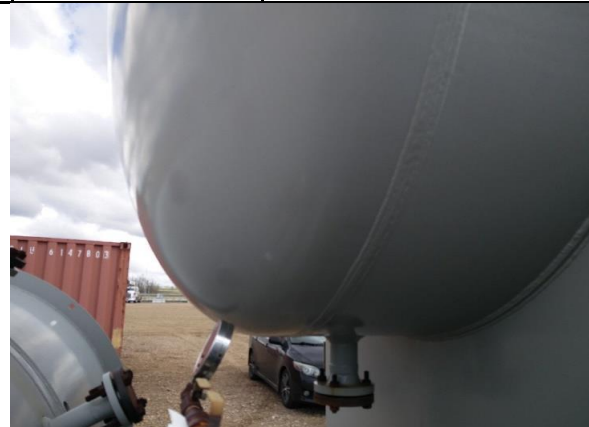
Photo 6 Description: Overall

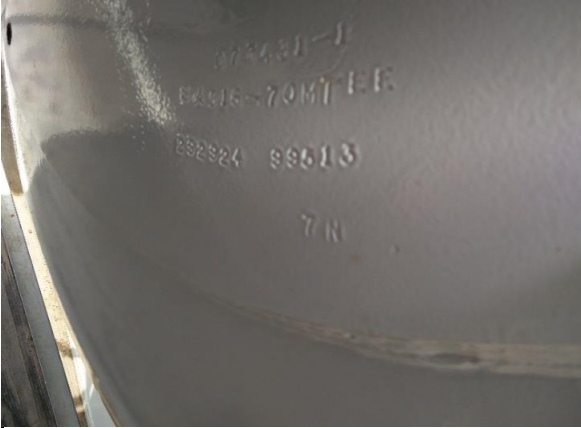
Photo 7 Description: Manway split repad stamping

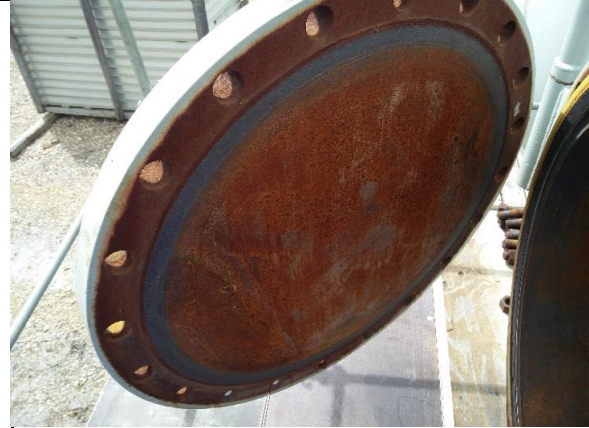
Photo 8 Description: Manway blind slight surface rust

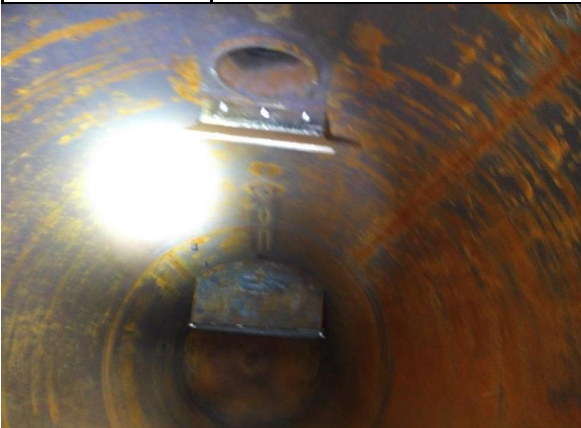
Photo 9 Description: Internal inspection, slight surface rust

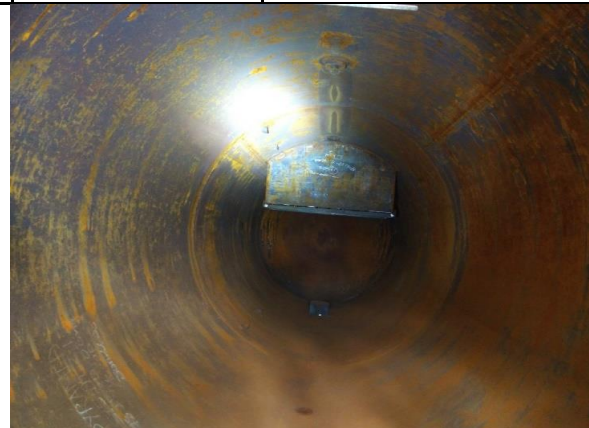
Photo 10 Description: Internal inspection, slight surface rust

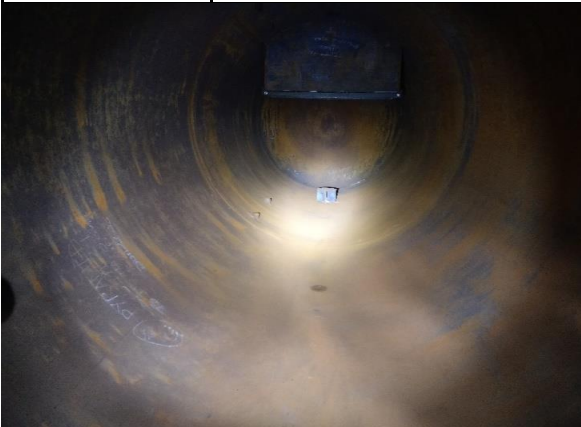
Photo 11 Description: Internal inspection, slight surface rust

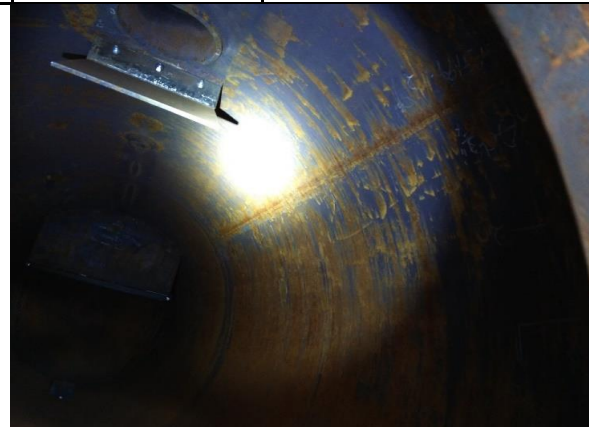
Photo 12 Description: Internal inspection, slight surface rust

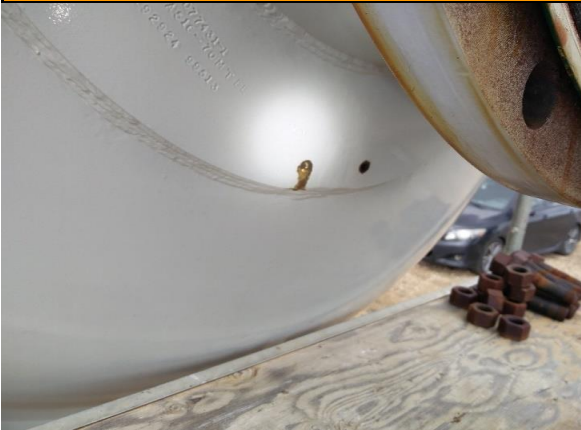
Photo 13 Description: Split repad on manway weep hole still grease

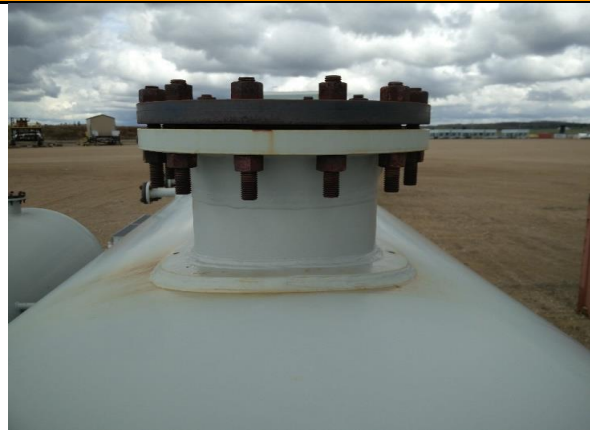
Photo 14 Description: Split repad on nozzle weep hole still grease

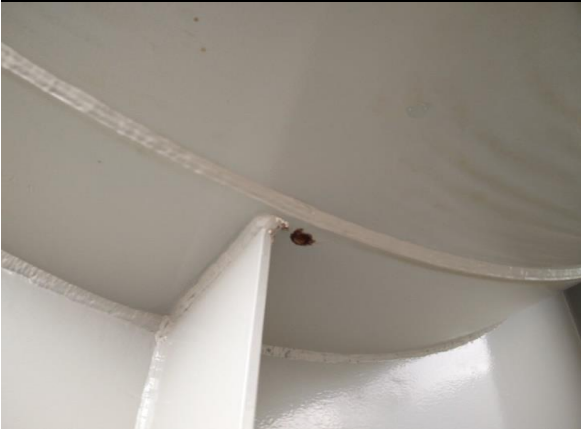
Photo 15 Description: Saddle weep hole still with grease

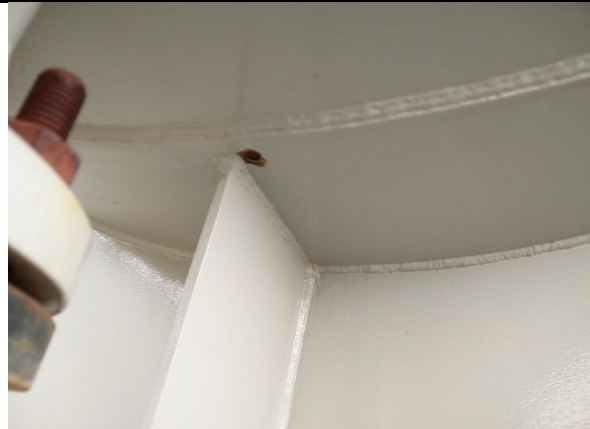
Photo 16 Description: Saddle weep hole still with grease

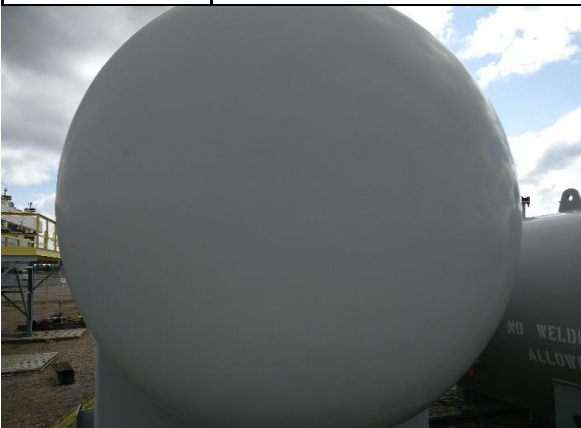
Photo 17 Description: Overall Rust free

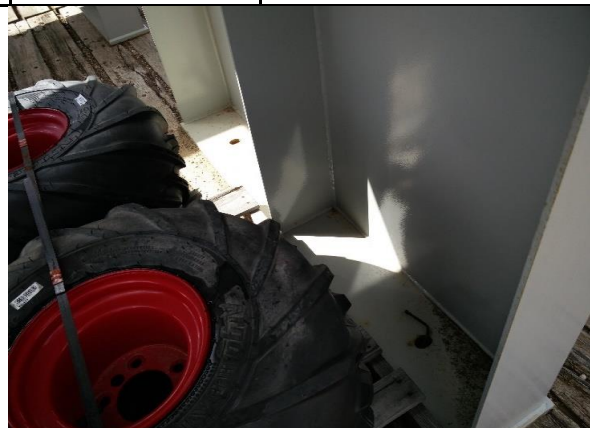
Photo 18 Description: Anchor bolt holes
