Pressure Vessel Inspection Report - EXTERNAL

PIM Sales Order #:	115- 03	Date:	March 01 ,2023
PIM Work Order #:	IS- 01	Sales # Desc.	LPG Storage Bullet

Client:	Fuelled Inc.		
Facility:	Industrial Park, Drayton Valley	Vessel Name:	LPG Storage Bullet
Location (LSD):	Drayton Valley, AB	Equipment Number:	V-820
Status:	In-Service Inspection on Operating Equipment <input type="checkbox"/> Yes <input checked="" type="checkbox"/> No	Tag Number:	n/a
	In-Service Inspection on Non-Operating Equipment <input checked="" type="checkbox"/> Yes <input type="checkbox"/> No	Orientation:	Horizontal
Type of Inspection:	<input checked="" type="checkbox"/> Baseline <input type="checkbox"/> Interval <input type="checkbox"/> Repair/Alteration	Remains In-Service:	<input type="checkbox"/> Yes <input checked="" type="checkbox"/> No

Ultrasonic Thickness External Report

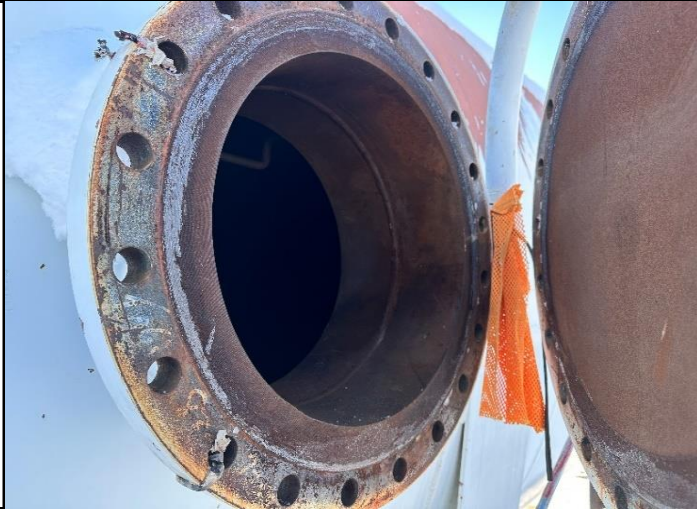
Photo 2: Manway gasket face

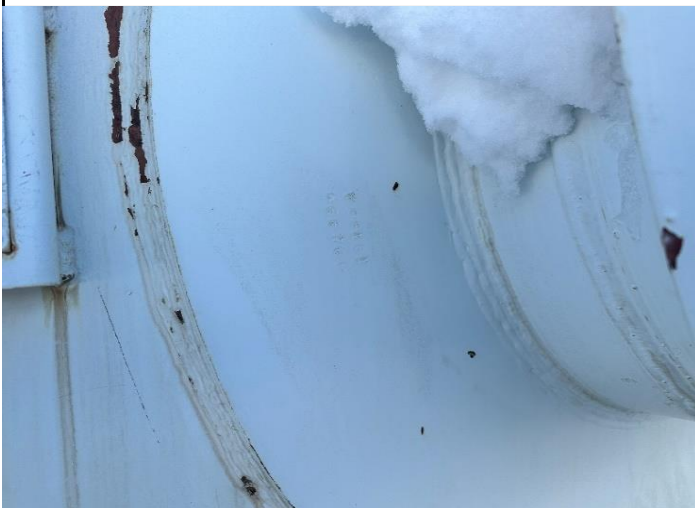
Photo 3: Repad traceability stamping

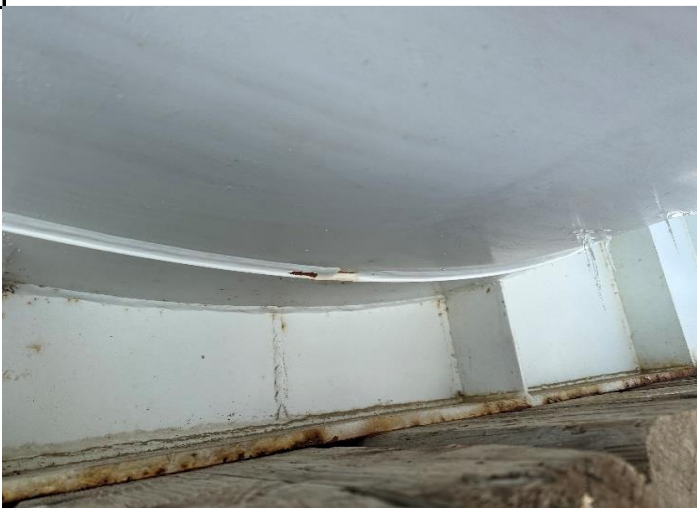
Photo 4: Saddles with vent in welding

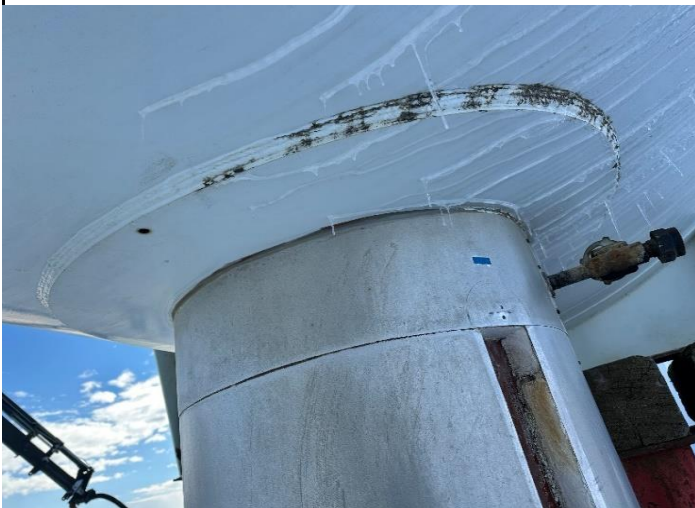
Photo 5: Insulated sump, repad

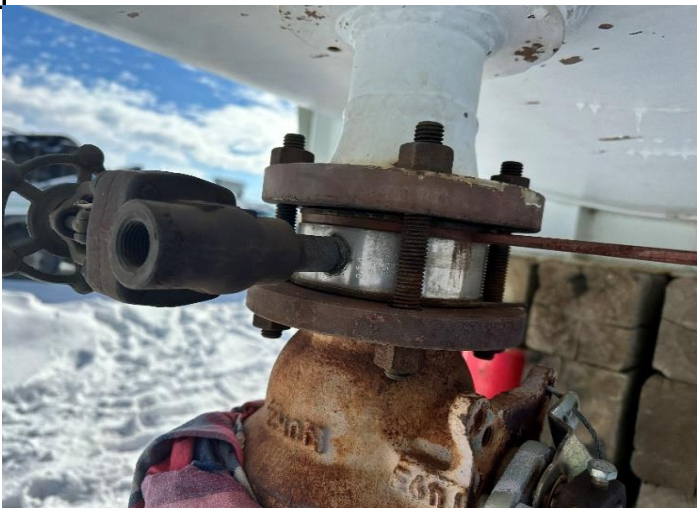
External Inspection Items	G	F	P	N/A	COMMENTS
Valving Verify/record visible leaks properly supported and CSO/CSC.	<input type="checkbox"/>	<input type="checkbox"/>	<input type="checkbox"/>	<input checked="" type="checkbox"/>	Bleed ring and valve installed, no information on these
PSV Verify set is at or below vessel MAWP. Discharge piping is greater to or equal to valve outlet and is properly supported / routed. Verify PSV seals/ tags. Status of block valves, check car seal log.	<input type="checkbox"/>	<input type="checkbox"/>	<input type="checkbox"/>	<input checked="" type="checkbox"/>	
PSV Verify properly installed and is supported adequately for the discharge loads.	<input type="checkbox"/>	<input type="checkbox"/>	<input type="checkbox"/>	<input checked="" type="checkbox"/>	
Insulation/Cladding Verify condition around appurtenances no damage present, and there is no ingress of moisture.	<input type="checkbox"/>	<input type="checkbox"/>	<input checked="" type="checkbox"/>	<input type="checkbox"/>	Only the communicating chamber is insulated, no moisture within insulation noted.

Photo 6: Bled ring and valve installed

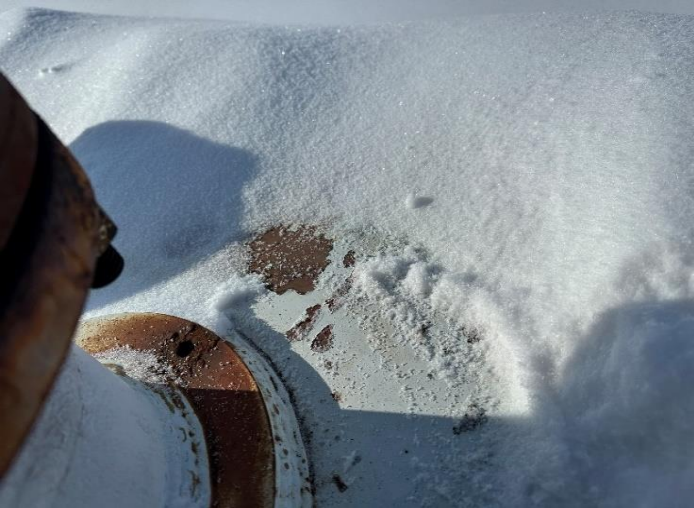
Leakage Record Report leakage at flanges, threaded joints, weep holes on repads, etc.	<input checked="" type="checkbox"/>	<input type="checkbox"/>	<input type="checkbox"/>	<input type="checkbox"/>	Slight corrosion in weepholes and on flange surfaces of both PSV nozzles on top of vessel
Saddle Record corrosion, buckling, dents, etc. Look at vessel surface area near supports and attachment welds. Verify no signs of leakage at attachment to vessel and ground wire attached.	<input checked="" type="checkbox"/>	<input type="checkbox"/>	<input type="checkbox"/>	<input type="checkbox"/>	Fixed and sliding saddles
Anchor Bolts Hammer tap to ensure secure. Record corrosion, cracking in threads or signs of deformation.	<input type="checkbox"/>	<input type="checkbox"/>	<input type="checkbox"/>	<input checked="" type="checkbox"/>	
Concrete Foundation Record cracks, spalling, etc.	<input type="checkbox"/>	<input type="checkbox"/>	<input type="checkbox"/>	<input checked="" type="checkbox"/>

Photo 7: Corrosion around weepholes

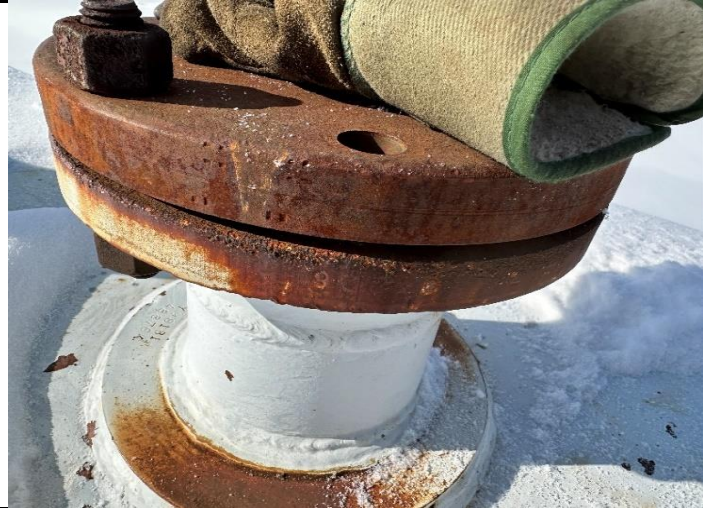
External Inspection Items	G	F	P	N/A	COMMENTS
NDE methods UT/MPI report done on vessel Chief Inspection to review methods	<input checked="" type="checkbox"/>	<input type="checkbox"/>	<input type="checkbox"/>	<input type="checkbox"/>	See UT Report Attached
External Condition Assess paint, record location, size and depth of corrosion or damage.	<input checked="" type="checkbox"/>	<input type="checkbox"/>	<input type="checkbox"/>	<input type="checkbox"/>	<input type="checkbox"/> Tell Tale Drilled <input checked="" type="checkbox"/> Not Tell Tale Drilled Slight paint erosion all along top of vessel
Nozzle Assess and record paint look for leakage, and stud engagement and corrosion, verify / inspect gussets. Record any damage, deflection, etc.	<input checked="" type="checkbox"/>	<input type="checkbox"/>	<input type="checkbox"/>	<input type="checkbox"/>	Blind flange lost traceability on 6" nozzle because of corrosion, to be replaced or removed, one nozzle blind flange installed upside down

Photo 8: Untraceable blind flange to be removed/replaced

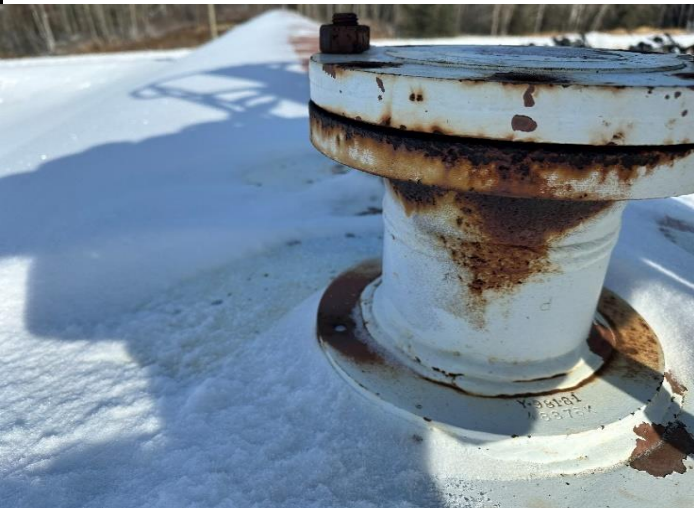
Photo 9: Flange surface corroded

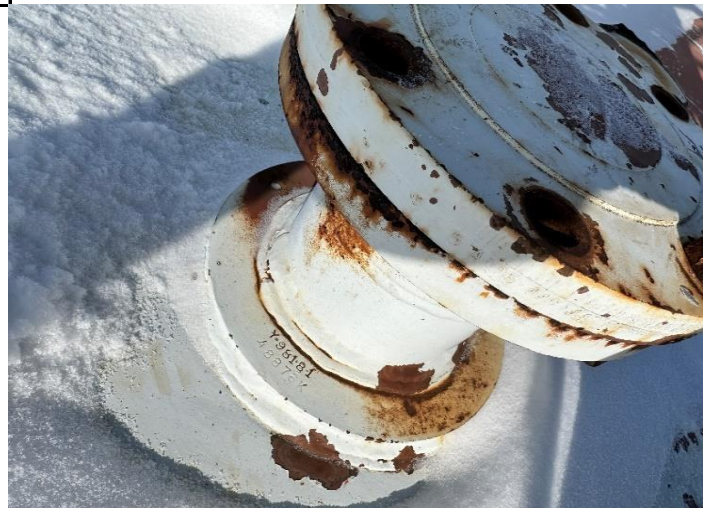
Photo 10: Blind flange installed upside down

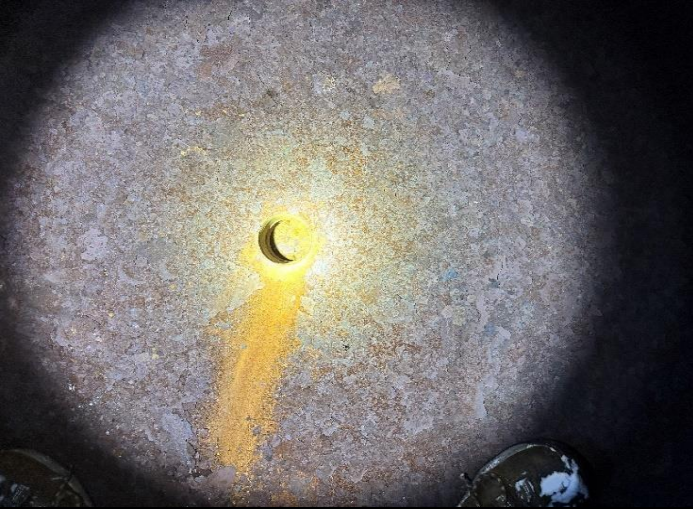
Photo 1: Surface debris in vessel welding good condition

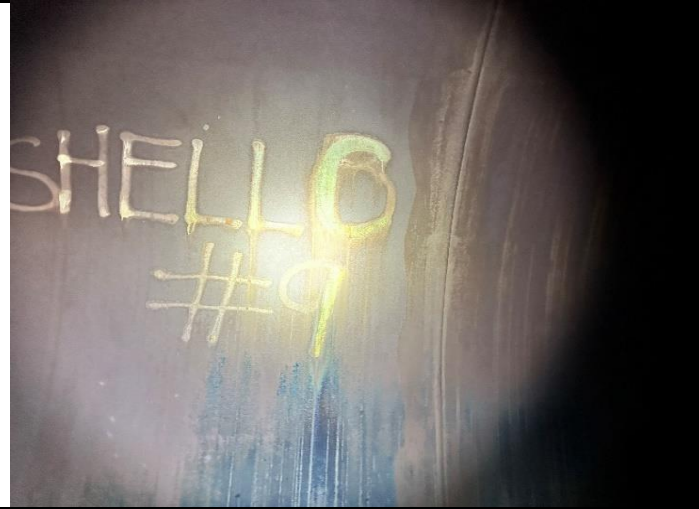
Photo 2: Shell longseam and circseam welding in good condition

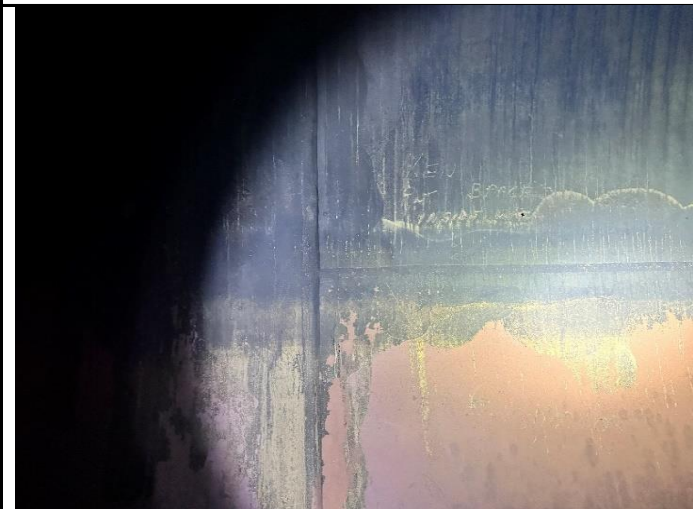
Photo 3: Shell longseam and circseam welding in good condition

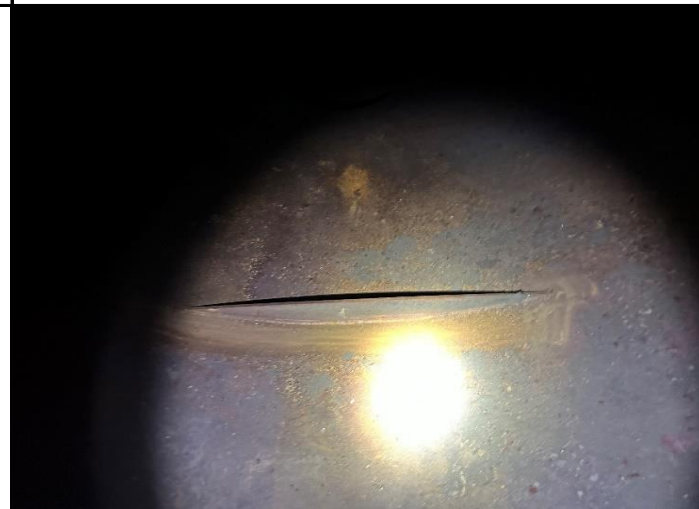
Photo 4: Weir Plate in good condition

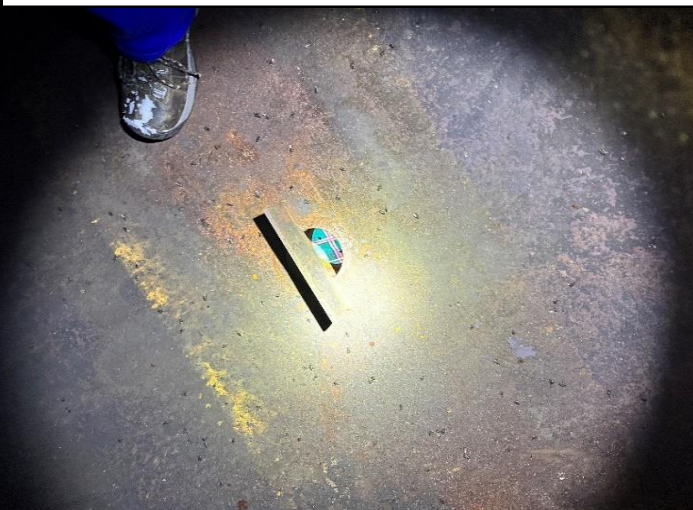
Photo 5: Vortex Breaker in good condition

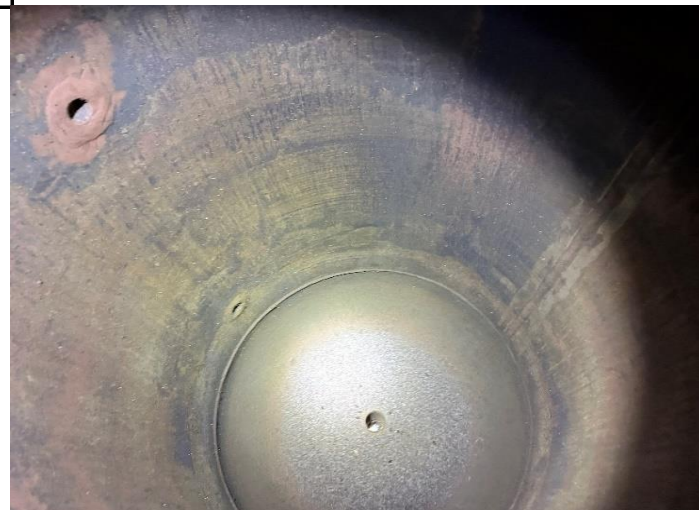
Photo 6: Sump in good condition, to be cleaned of debris

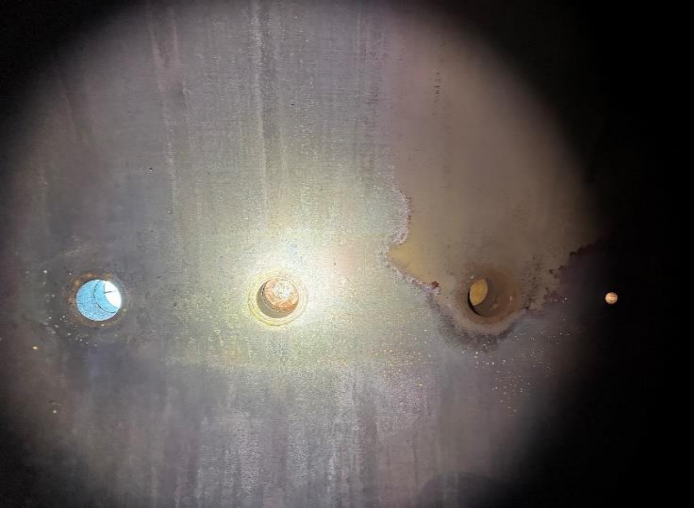
Photo 7: PSV nozzles on top of vessel in good condition

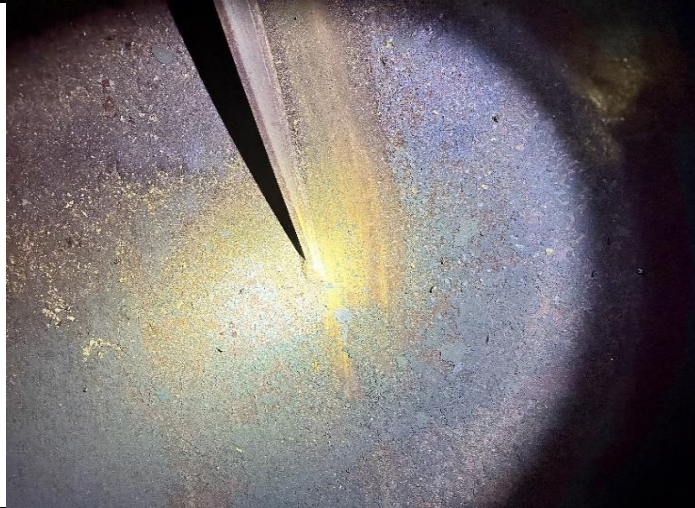
Photo 8: Debris in vessel

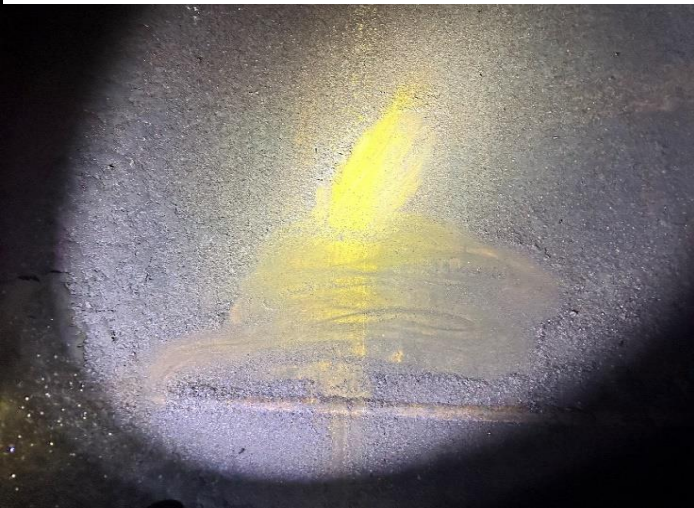
Photo 9: Debris in vessel

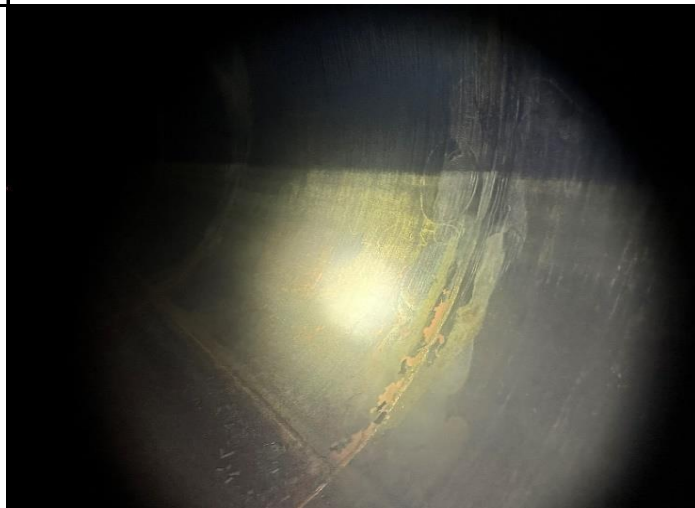
Photo 10: Debris in vessel

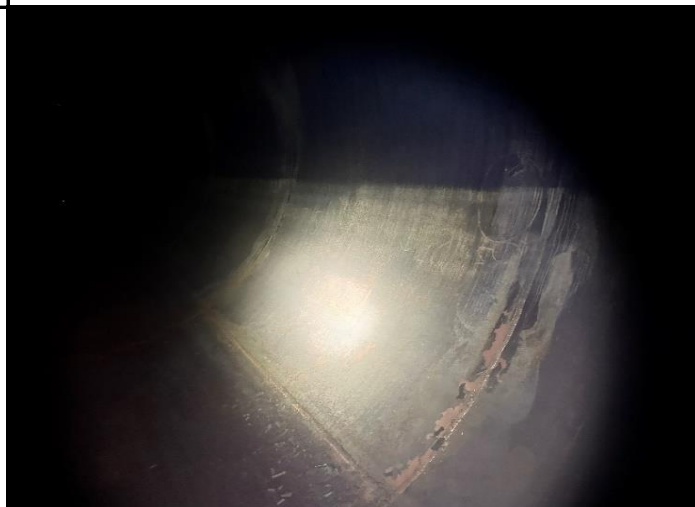
Photo 12: Debris in vessel

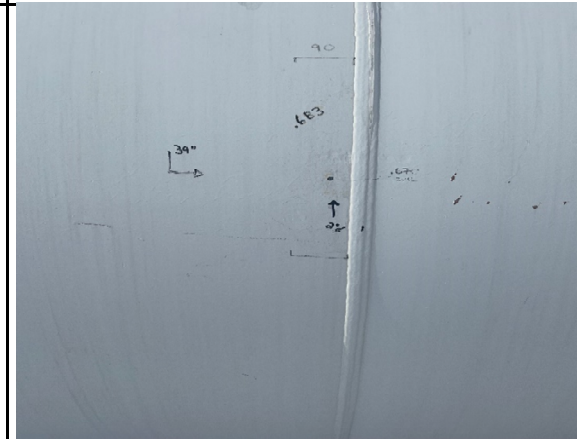
Comments:
1) TML 60 Location previously marked as a Low Spot. After internal inspection and external inspection it was determined to be grinding during original fabrication.
2) Each area was scanned and the low average and high WT's were recorded.
3) Each course was examined on both sides and on the bottom to provide the results above.
4) The shell readings were taken closer to the bottom.

Photo 12: Ring 3 - Low Point
