DIAMONDBACK
INTEGRITY

UT Survey Information

Equipment Description: Global Flow Metering Skid

UT Survey Report	
	Date:	May 9th, 2024
Report #		DBI45-01
Static Data		
Owner:	IPC Canada	
Facility/Area:	Dollard Sask	
LSD:	N/A	
A No.:	-	
Serial No.:	-	
CRN:	-	
Description:	Global Flow Metering Skid

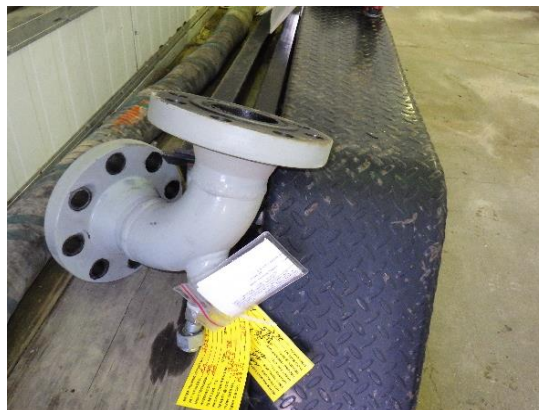
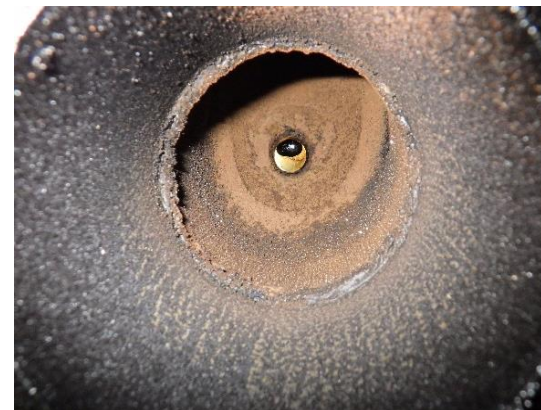
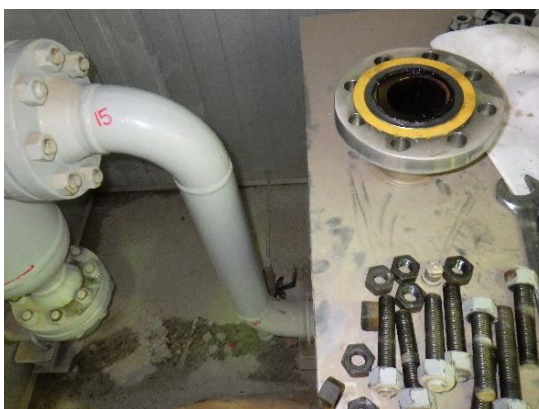
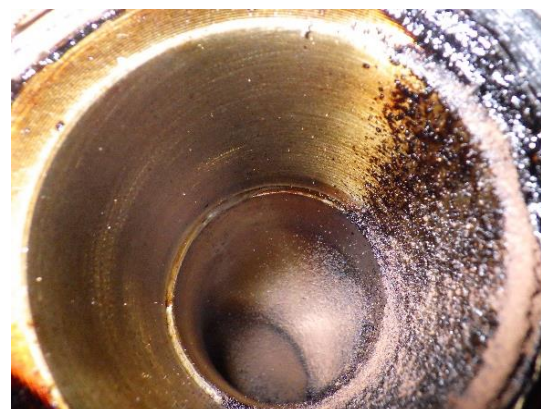
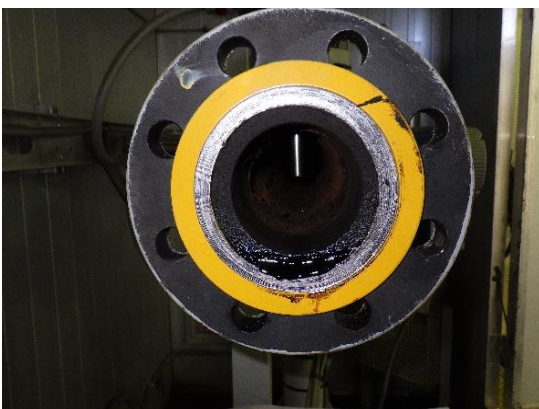
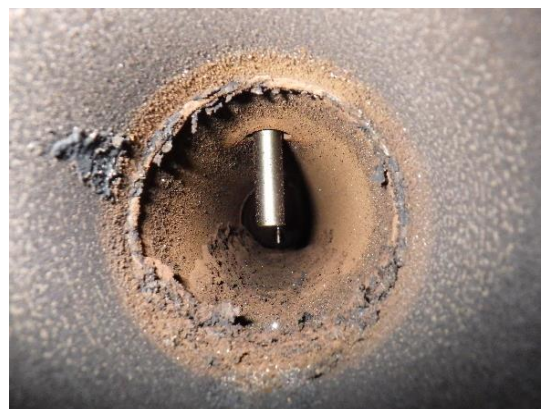
Internal Inspection Photos

Internal Inspection Summary - An elbow was removed to allow for visual inspection. Minor deposits were visible throughout. No areas of corrosion or mechanical damage was identified throughout the inspection. Good overall condition.
