Report #: 155741-MD-06
Inspect Date: 07/07/2012
Page: 1 of 11
nsp. Co. Job #: 155741

Insp. Co. Job #: Yellow **Criticality Designation:** Insp. Comp: Matrix Inspection District: Grande Prairie - North Field: South Hamburg Location: 12-29-096-11W6 Unit / Skid #: Glycol Reboiler LSD: 12-29-096-11W6 Jurisdiction #: A3092314 Equip Tag #: V-2402 Serial #: 1844 N/A Year Built: 1995 CRN #: M5097.2 Nat'l Bd #: Equipment Description: Other: Glycol Charcoal Filter Manufacturer: Moss Fab. Ltd. Service: Sweet Status: In Service -Equip. Type: Vessel: MAWP Shell: 100 200 °F Volume: Code Stamp:

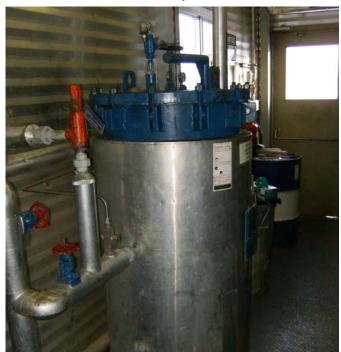
02 overview with PSV

Leaks		No		ed at time of inspection				<u>_</u>	
	Piping from Vessel		Accept		upporting on associated piping	~	Ш	Ш		
	Previous UT Survey		No	No history or	•	UT Coi	mnanı	ι: NI/Λ		
	T Tevious OT Guivey		110	140 History of	markings	01 00	прап	y. 14/74		
Е	external Visual Observations	6								
	The protrusion cladding ca	ulkin	g seals are c	leteriorated, a	llowing for moisture ingress ar	nd CUI.				
	The shell and bottom head	are	insulated; the	erefore, an ass	sessment of shell conditions of	ould not be	e mad	le at the time	of inspection.	
	There is oil staining noted condition.	on th	e top flanged	d head. The da	avit arm and hardware as well	as the flar	nged f	ilter head is in	good	
	The PSV is due for service	7								
	A UT corrosion survey was	s perf	ormed with r	no significant v	vall losses recorded at the tim	e of insped	ction.			
R	Recommendations:									
	Service the PSV									
	Recaulk the seals to preve	ent mo	oisture ingre	SS

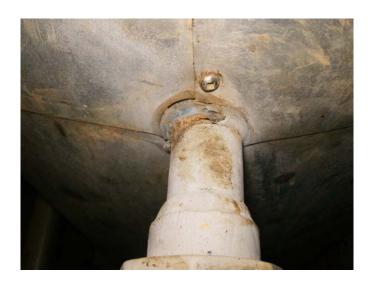
03 deteriorated caulking seal

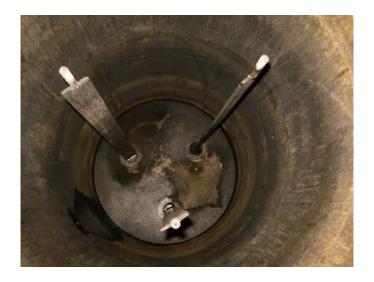
g				
The overall condition is good, with no recordable mechanical damage or service related damage on the welds, shells and bottom head								
The top head is a flanged head that has minor flash corrosion from oxidation after washing								
The top head ring gasket is in good condition with no evidence of mechanical damage or impingement areas								
At the time of inspection	n the filte	er was remo	ved					
Recommendations:								
Maintain regulatory ins	pections	to ensure th	ne safe operatir	ng conditions of the filter				
1

04 internal overview
