Crescent Point visual inspection report – pressure vessel

☐ Installation			
Date:	February 7, 2018	Description:	☑ Vessel ☐ Exchanger ☐ Furnace	Boiler
Inspector:	Ryan Hogg	Unit #:	Equip #:	848874
Agent Co:	101292687 Saskatchewan Ltd	Equip. Name:	Filter	
		Jurisdiction	CRN #:	T4805.4
Province:	Manitoba	Manufacturer:	ESS Corp	
Area:	Run 009 – Ingoldsby/Pierson	Year Built:	2014 S/N :	4550 B
Subarea:	Battery 09-32-001-28W1	Location/LSD	BAT/09-32-001-28W1

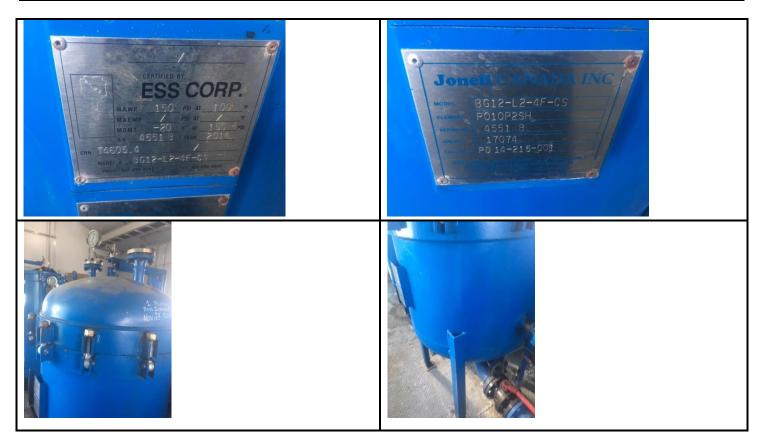
Filter is showing internal pitting and corrosion at the time of inspection. Bottom head was UT'd readings throughout were:																		
	spection	i iitei is t	SHOWING	, iiiteii	ιαι ριιιι	ig and coi	103101	rat the time	ן פווו וט	pection.	Donc	iii iicau	was OT u	readings	s ti ii Ou	grioui	ı were	·-		
Summary		Head nominal 0.500" with areas in the radius area down to 0.405" in pitts, the center between the nozzles in the bottom head was an 8" circular area with readings from 0.350" to 0.295" remaining – design is the same as 4551 - A was open at the time of inspection and																		
								the filter cart			15 1116	Same a	5 433 I - A	was ope	zii at ti	ie uiii	ie oi ii	ispeci	lion and	
		Filters are at end of life prepare for future replacement.																		
		Recommended Actions:									NCR/IDR									
V	sually inspe	ot once opened.																		
VESSEL STATUS Integrity Status Suitable for Continued Service Vess No. Future Pennire Pequired

Internally inspect at next filter change – internal corrosion is expected to be similar to 4550-A.

UT after 6 month of service due to corrosion issues in the adjacent filters.

Filters should be cleaned out on a regular basis when switching to opposite bank of filters.

Filter is at end of life – prepare for future replacement.
