Crescent Point

VISUAL INSPECTION REPORT-PRESSURE VESSEL

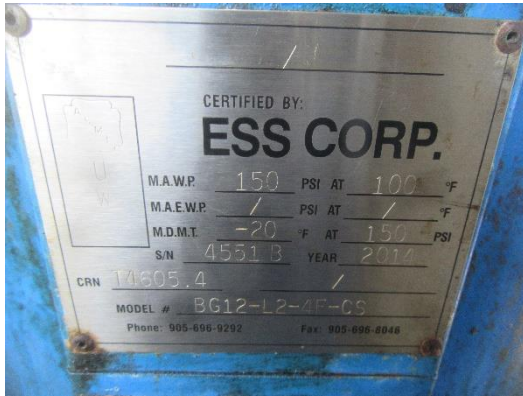
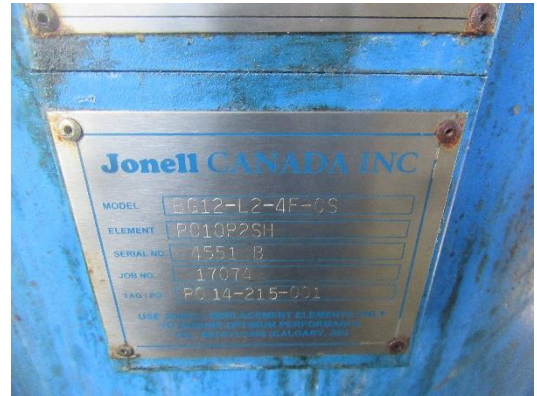
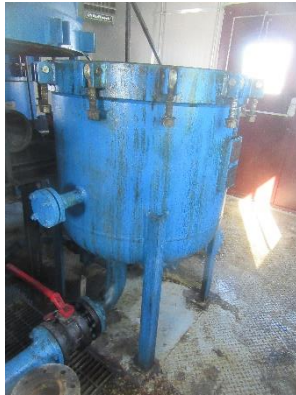
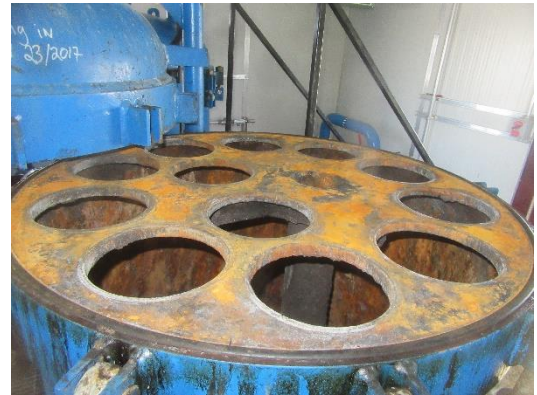
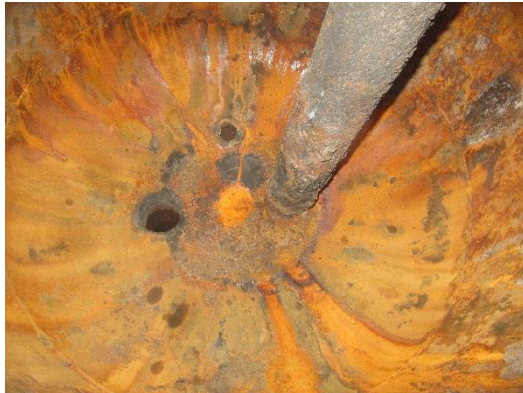
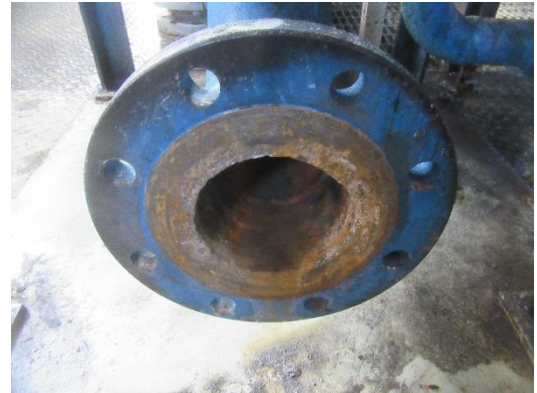
Welds	Uniform Corrosion:	<input checked="" type="checkbox"/> Insignificant amount	Comment	
	Pitting Corrosion:	<input type="checkbox"/> None noted	Comment Pitting and minor corrosion throughout filter plate	
	Welding Defects:	<input checked="" type="checkbox"/> None noted	Comment	
NDE	<input checked="" type="checkbox"/> NDT was performed by: Ryan Hogg		Extent: Bottom head externally	
	NDE Type: UT	NDE Type:		
	Results: UT on bottom head showed pitting corrosion internally – nominal 0.500" pitting to 0.295" in center of head 4" area between the nozzles.			
Nozzles	Obstructions:	<input checked="" type="checkbox"/> None noted	Comment

Recommended Actions	<p>Due to the design of the filters the bottom head is pitting throughout, there is no access for repairing. The filter is at the end of life – prepare for a future replacement - vessel could be pulled – nozzle replaced and internals blasted and coated.</p>		
Integrity Status	Suitable for Continued Service <input checked="" type="checkbox"/> Yes <input type="checkbox"/> No <input checked="" type="checkbox"/> Future Repairs Required		
Inventory Status	<input checked="" type="checkbox"/> Active <input type="checkbox"/> Out of Service <input type="checkbox"/> Surplus <input type="checkbox"/> Rental <input type="checkbox"/> Scrap

Internally inspect at next filter change.

UT after 6 month of service due to corrosion issues in the adjacent filters.

Filters should be cleaned out on a regular basis when switching to opposite bank of filters.

Filter is at end of life – prepare for future replacement – or removal and repair.
