Pressure Vessel Inspection Report - EXTERNAL

PIM Sales Order #:	133- 03	Date:	June 06 ,2024
PIM Work Order #:	IS- 01	Equipment #:	Suction Scrubber A193905

EXTERNAL - Suction Scrubber
A193905

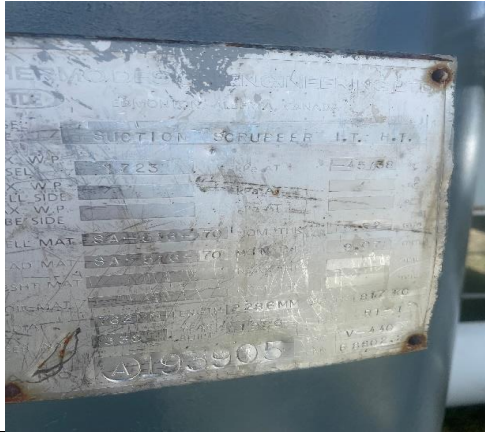
Photo 1: Nameplate

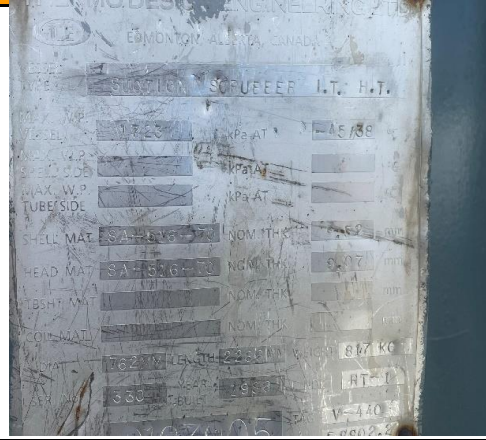
Photo 2: Nameplate

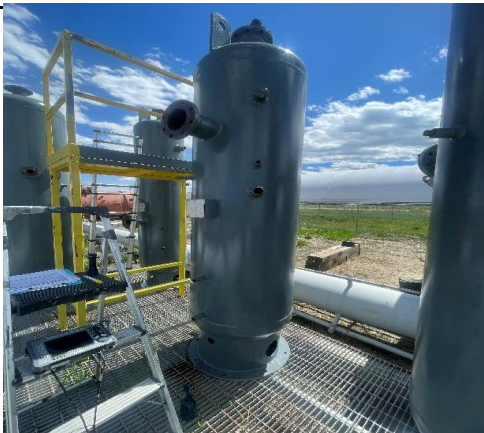
Photo 3: Vessel Overview

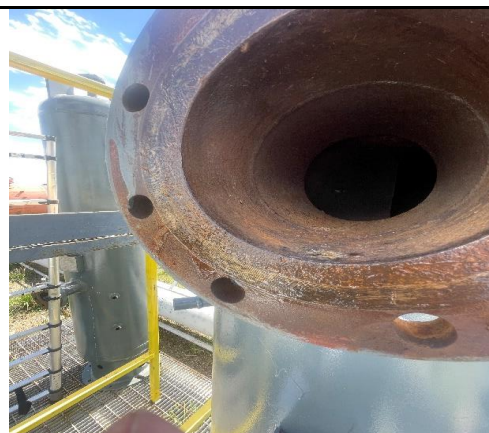
Photo 4: Surface Corrosion on Flange Face

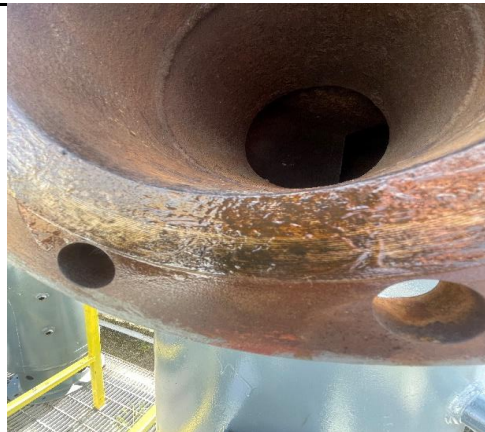
Photo 5: Surface Corrosion on Flange Face

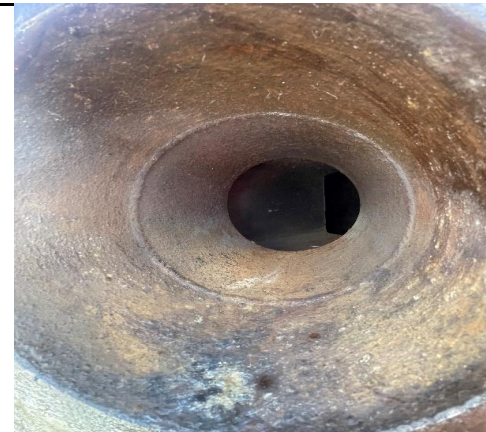
Photo 6: Internal Rust

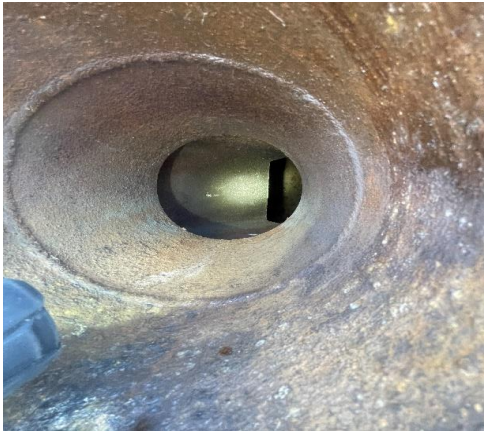
Photo 7: Internal Rust

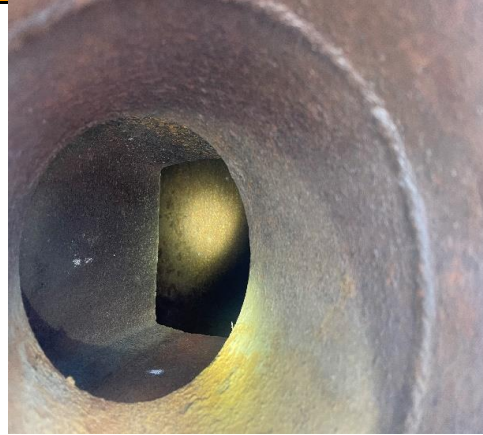
Photo 8: Internal Rust

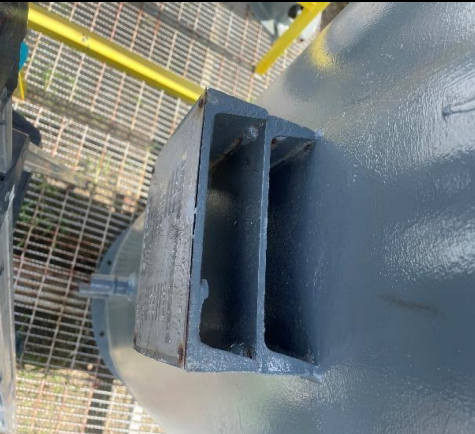
Photo 9: Nameplate has 2 mounts

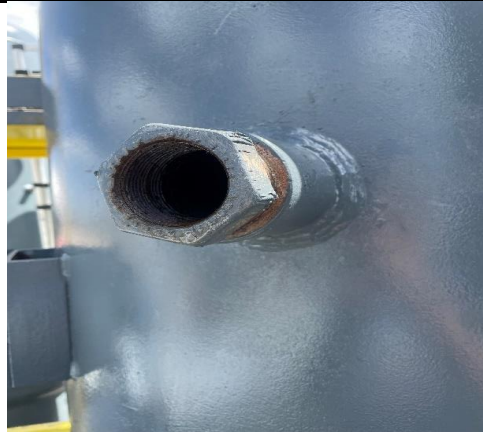
External Piping Verify pipe is supported. (Clamps, supports, shoes, etc. in place). Record any structural overload, deflection, verify paint condition, external corrosion, studs and nuts, etc.	<input type="checkbox"/>	<input checked="" type="checkbox"/>	<input type="checkbox"/>	<input type="checkbox"/>	2 bolted flanges and 8 threaded connections. Threads appear good.

Photo 10: Threaded connection

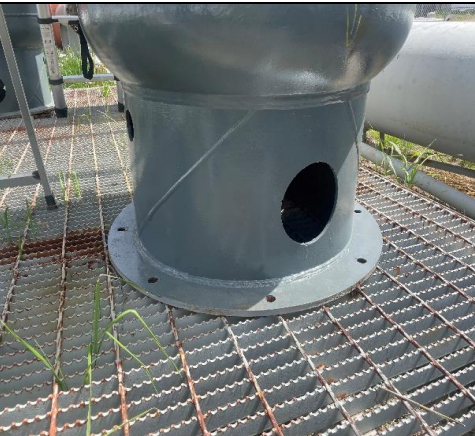
Saddle Record corrosion, buckling, dents, etc. Look at vessel surface area near supports and attachment welds. Verify no signs of leakage at attachment to vessel and ground wire attached.	<input checked="" type="checkbox"/>	<input type="checkbox"/>	<input type="checkbox"/>	<input type="checkbox"/>	No cracks. Skirt.
Anchor Bolts Hammer tap to ensure secure. Record corrosion, cracking in threads or signs of deformation.	<input type="checkbox"/>	<input checked="" type="checkbox"/>	<input type="checkbox"/>	<input type="checkbox"/>	Anchor holes look acceptable.
Concrete Foundation Record cracks, spalling, etc.	<input type="checkbox"/>	<input type="checkbox"/>	<input type="checkbox"/>	<input checked="" type="checkbox"/>	
Gauges Verify gauges are visible, working, no leakage, and suitable for range of MAWP/ Temp.	<input type="checkbox"/>	<input type="checkbox"/>	<input type="checkbox"/>	<input checked="" type="checkbox"/>

Photo 11: Skirt

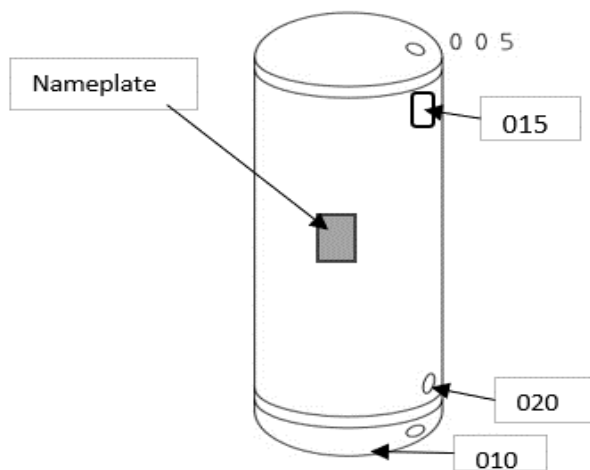
CONDITION MONITORING LOCATIONS (TML's)

1) TML Number	005	010	015	020	025	030	035
TML Description	Top Head	Bottom Head	Top Shell	Bottom Shell			
Direction:							
Flange Rating:							
Pipe Schedule:							
Nominal Thickness:	0.357 "	0.357 "	0.375 "	0.375 "			
Mill Tolerance:	0.000 "	0.000 "	0.010 "	0.010 "			
Corr. Allowance:	0.0326 "	0.0326 "	0.0326 "	0.0326 "			
Minimum Thickness:	0.324 "	0.324 "	0.332 "	0.332 "			
Readings							
Jun 06, 2024	1)	0.360 "	0.385 "	0.366 "	0.360 "		
Jun 06, 2024	2)	0.366 "	0.391 "	0.364 "	0.366 "		
	3)						
	5)						
	6)						
	7)						
	8)						
	9)						
	10)						
	11)						
	12)						
	13)						
	14)						
	15)						
	16)
