ULTRASONIC REPORT

CUSTOMER / CLIENT:	RARE OILFIELD SERVICES	CLIENT JOB NO.:		REPORT NO. :	231214-UDT-1
CONTRACTOR:		CLIENT CODING:		PAGE:	1 OF 3
PROJECT:	UT ON SEPERATOR A0438682			DATE:	14-Dec-23
LOCATION / LSD:	TWIST OILFIELD MANUFACTURING, STETTLER, AB			TECHNICIAN:	DUSTIN TUCKER
CODE / CLIENT SPEC:	ASME VIII Div. 1 / ASME V Art. 5 (2021)	APPROVER:	TYLER HEBBLETHWAITE	ASSISTANT:

Vessel External Inspection Report

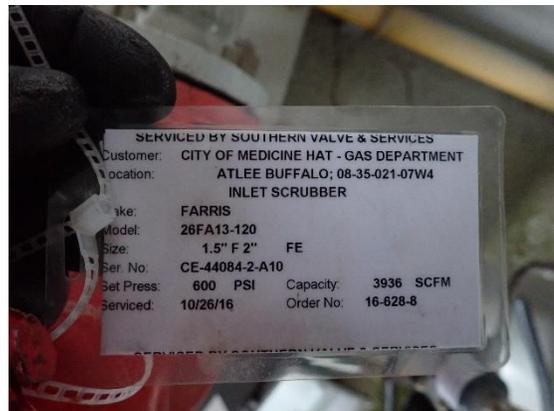
PSV Service Tag

Fit for Service:						
YES						
PSV Details						
PSV#:		Make/Model:	26FA13-120	CRN:	0G2369.2	
MFR:	Farris	MFR S/N:	CE-44084-2-A10	MFR Date:	N/A	
Service Co.:	Southern Valve	Service Tag #:	16-628-8	Last Service:	26-Oct-16	
Set:	600 psi	Cap:	3936 scfm	PSV Side:	Shell	
Code:	NB / UV	Location:	Outlet piping	Vented to:	N/A	
Cap Seal:	Intact	Nameplate:	Secure, Legible	Drainage:	Good, no concerns	
Properly Supported:	Yes	External Body Condition:	Good, no concerns			
	Size:	Type:	Block Valve:	Locked / Carsealed:		
Inlet:	1.50 in	Flanged	No	N/A		
Outlet:	2.00 in	Flanged	No	N/A		
PSV Comments:	PSV set at / below MAWP, cap seal wire intact, properly installed in the vertical position. PSV is overdue for service. Service required before vessel is put back into service.					
Inspector:	Name: Dustin Tucker		Signature:
