## FIELD REPORT

| <b>Name:</b> Cardinal Energy Ltd | <b>Site:</b> Mitsue | <b>Contact Name:</b> Scott L. |

| <b>Model:</b> Centaur 4702S | <b>Customer ID:</b> Turbine P980 | <b>S/N:</b> OHE09-C1259 |

### Detailed Borescope Report

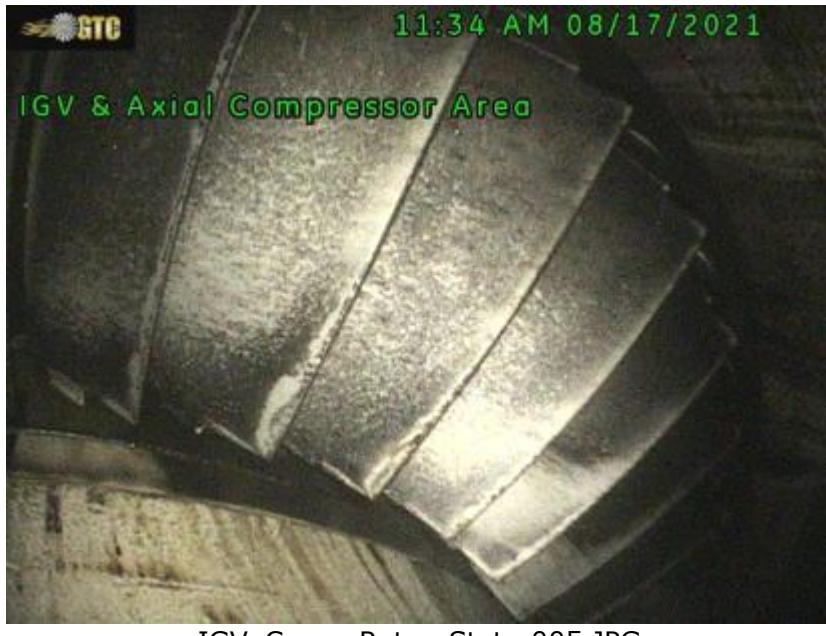
IGV\_Comp\_Rotor\_Stator005.JPG

| Inspect for Damage Mesh, Foreign Object Damage (FOD), Cracks, Nicks and Dents, Excessive Fouling, Pitting Corrosion, Tip Rub. | No Visible Signs of Damage.<br><br>Significant contamination.<br><br>Some Flaking Paint Chips from the Air Inlet Duct stopped by the Intake Mesh Screen. |

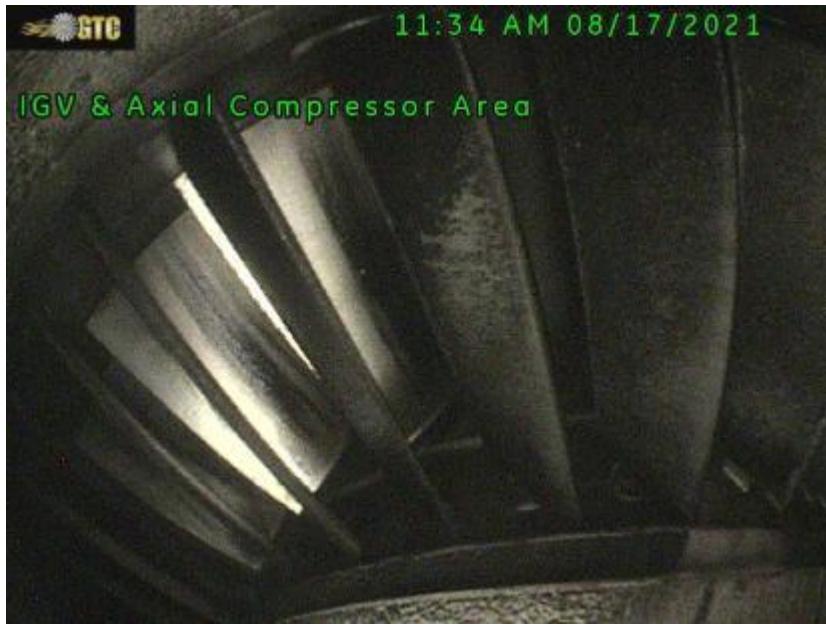
IGV\_Comp\_Rotor\_Stator006.JPG

The borescope inspection revealed no visible damage, no noticeable cracks, or signs of abnormal operation of hot section components. The air inlet had significant contamination traces, possibly from the turbine oil tank vent or surrounding equipment exhaust, similar to the previous year. A corrective action to identify the contamination source is crucial to prevent reoccurrence (*Please refer to inspection pictures section 4 – Detailed Borescope Report*).

| Inspect for Damage Mesh, Foreign Object Damage (FOD), Cracks, Nicks and Dents, Excessive Fouling, Pitting Corrosion, Tip Rub. | No Visible Signs of Damage.<br><br>Significant contamination.<br><br>Most likely Turbine Oil Tank Vent or close by equipment Oil Mist Contamination Traces. |

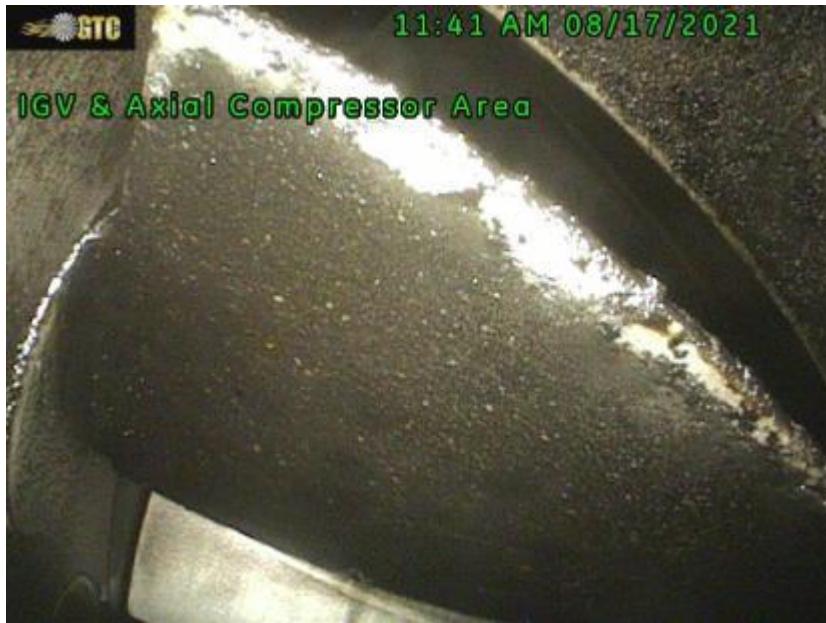
IGV\_Comp\_Rotor\_Stator010.JPG

| Inspect for Damage Mesh, Foreign Object Damage (FOD), Cracks, Nicks and Dents, Excessive Fouling, Pitting Corrosion, Tip Rub. | No Visible Signs of Damage.<br>Significant contamination. |
| | Most likely Turbine Oil Tank Vent or close by equipment Oil Mist Contamination Traces. |

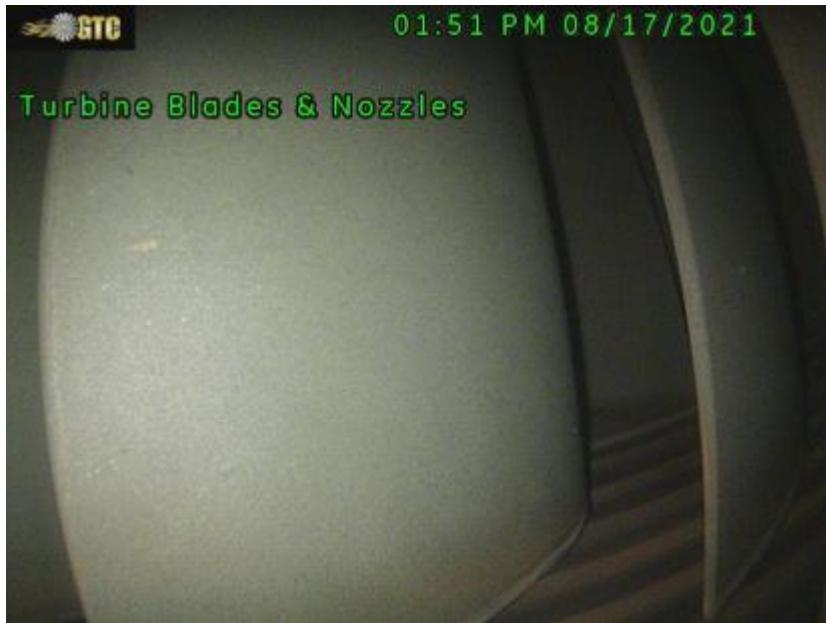
Blades\_Nozzles\_Tip-Shoes002.JPG

| Inspect for Cracks (Trailing Edge, Leading Edge & Vane Profile), Thermal Erosion, FOD, Excessive Tip Rub, Severe Dents & Corrosion. | No Visible Signs of Damage on Second Stage Turbine Blades (FWD view) and Tip Shoe. |

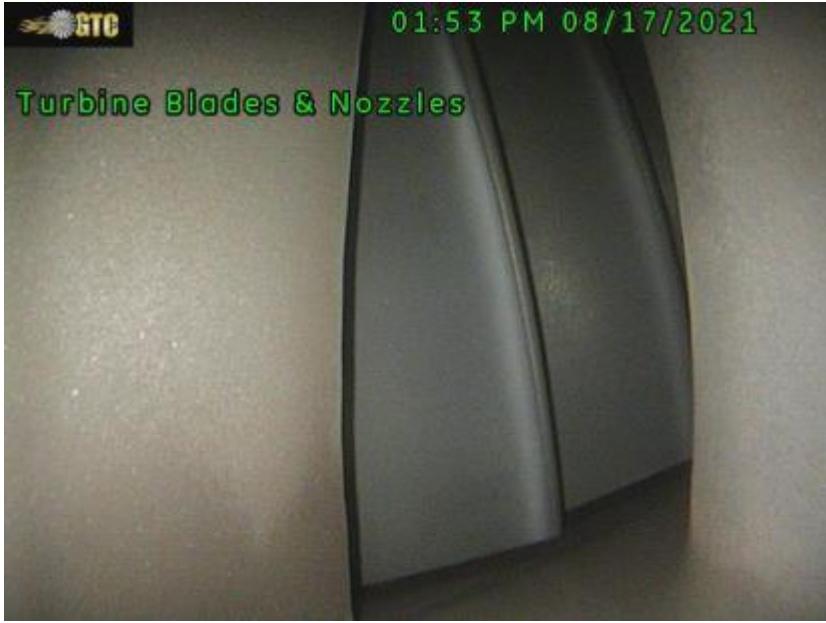
Blades\_Nozzles\_Tip-Shoes005.JPG

| Inspect for Cracks (Trailing Edge, Leading Edge & Vane Profile), Thermal Erosion, FOD, Excessive Tip Rub, Severe Dents & Corrosion. | No Visible Signs of Damage on Third Stage Turbine Blades (AFT view). |

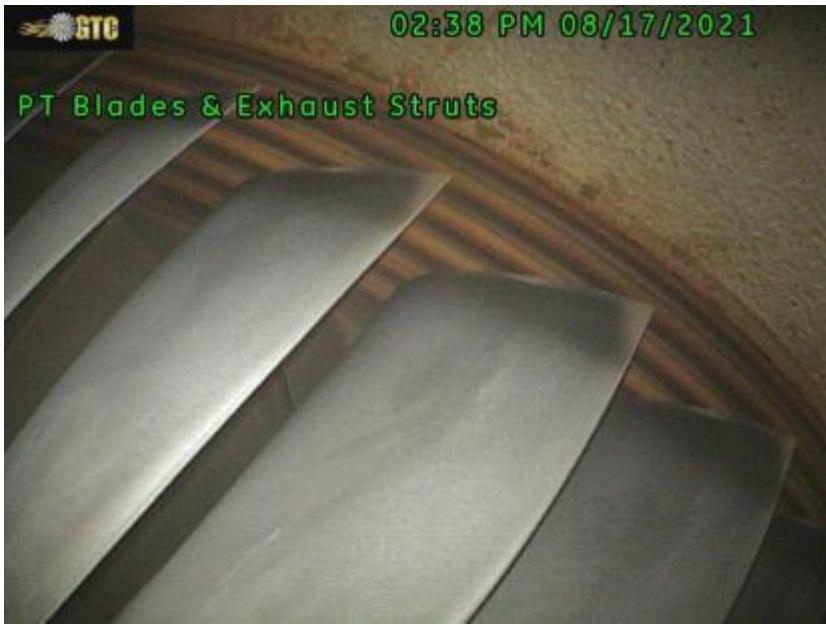
PT-Blades\_Exhaust-Diffuser007.JPG

| Inspect for Cracks (Trailing Edge, Leading Edge & Exhaust Struts), Thermal Erosion, FOD, Excessive Tip Rub, Severe Dents & Corrosion. | No Visible Signs of Damage on Third Stage Nozzle and Power Turbine Blades (FWD view) and Tip Shoe. |

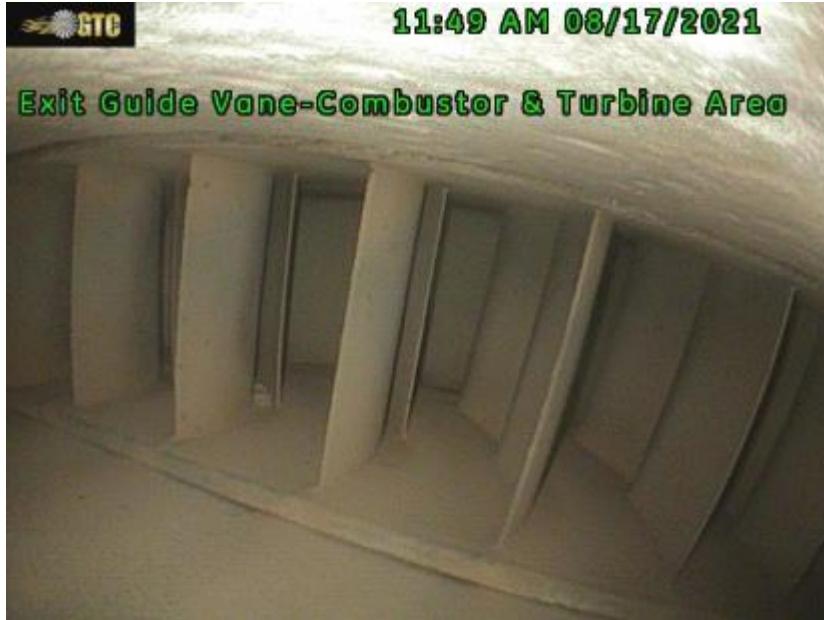
Injectors\_Comp\_Exit\_Comb\_Turb\_1st\_Stg002.JPG

| Inspect for Foreign Object Damage (FOD), Cracks, Nicks and Dents, Excessive Fouling, Pitting Corrosion, Tip Rub. | No Visible Signs of Tip Rub on Blade Tip or Damage on the Exit Guide Vane. |

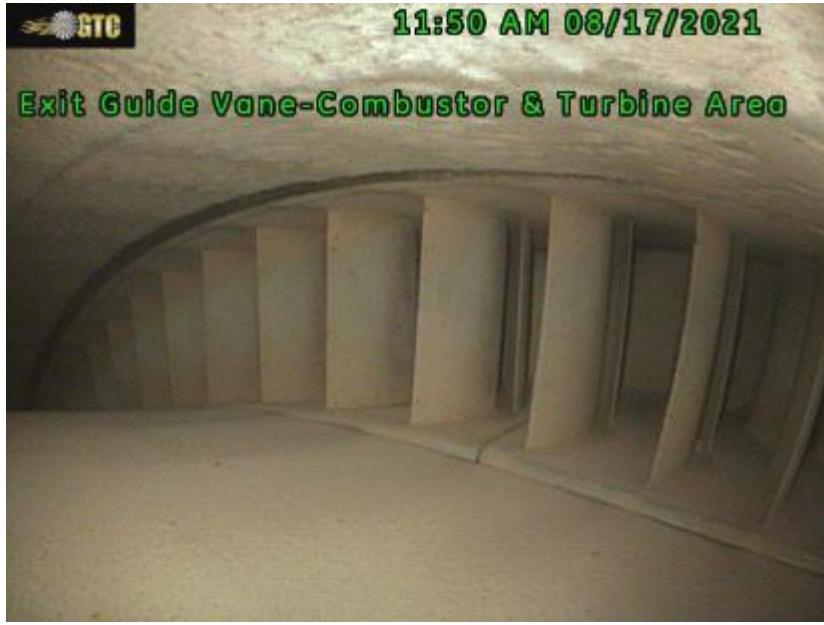
Injectors\_Comp\_Exit\_Comb\_Turb\_1st\_Stg003.JPG

| Inspect for Foreign Object Damage (FOD), Cracks, Nicks and Dents, Excessive Fouling, Pitting Corrosion, Tip Rub. | No Visible Signs of Damage on Exit Guide Vane. |

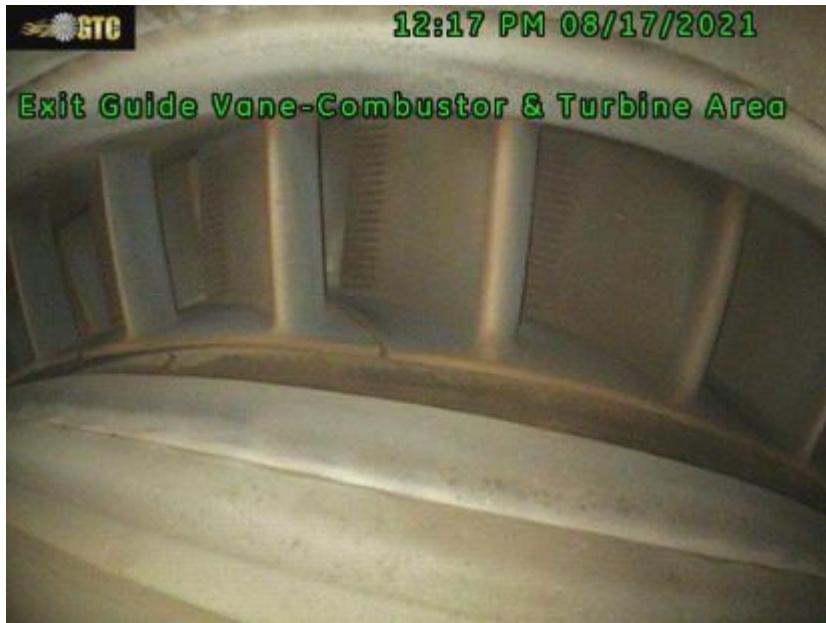
Injectors\_Comp\_Exit\_Comb\_Turb\_1st\_Stg018.JPG

| Inspect for Cracks (Trailing Edge, Leading Edge, Airfoil Surface & Vane Profile), Thermal Erosion, FOD, Excessive Tip Rub, Severe Dents & Corrosion. | No Visible Signs of Damage on First Stage Turbine Nozzle Assembly and Combustion Chamber Area. |

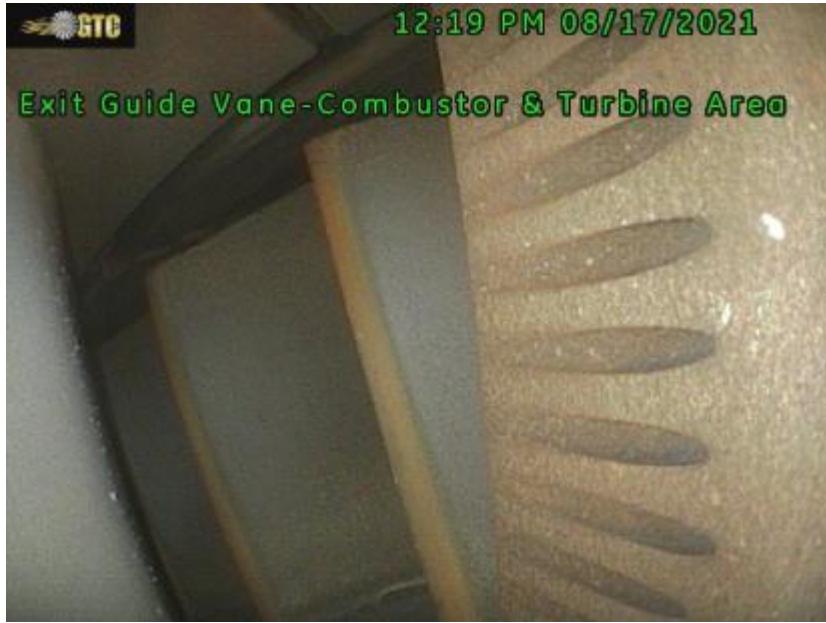
Injectors\_Comp\_Exit\_Comb\_Turb\_1st\_Stg019.JPG

| Inspect for Cracks (Trailing Edge, Leading Edge, Airfoil Surface & Vane Profile), Thermal Erosion, FOD, Excessive Tip Rub, Severe Dents & Corrosion. | No Visible Signs of Damage on First Stage Turbine Nozzle Assembly. |

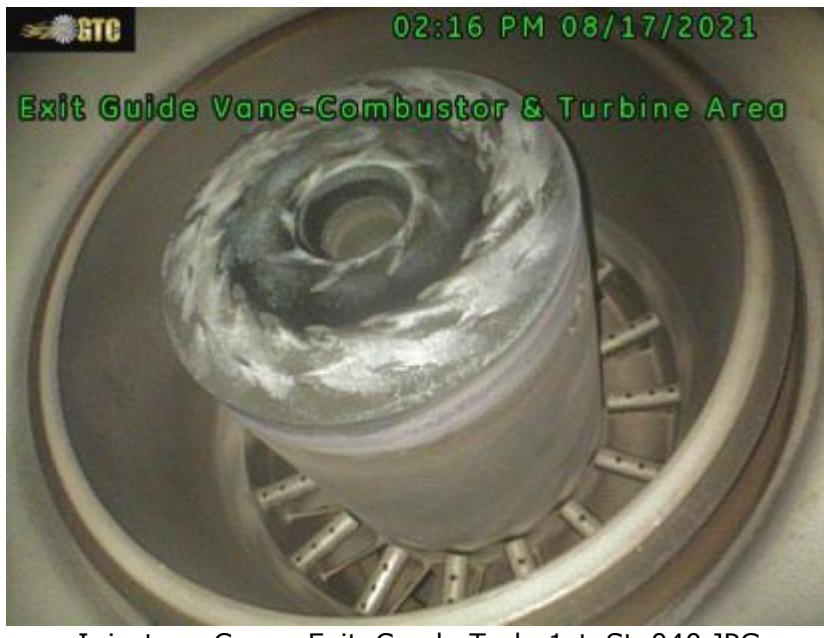
Injectors\_Comp\_Exit\_Comb\_Turb\_1st\_Stg040.JPG

| Inspect for Liners<br>Cracks, Thermal<br>Erosion, Hot Spots, Fuel<br>Main & Pilot Holes<br>Contamination or<br>Blockage & Swirlers<br>blockage or Cracks on<br>Fuel Injectors. | No Visible Signs of<br>Blockages.<br><br>Removed Injectors<br>#4, #8 & #11 to<br>access the<br>Combustion<br>Chamber Area<br>during Borescope<br>Inspection. |

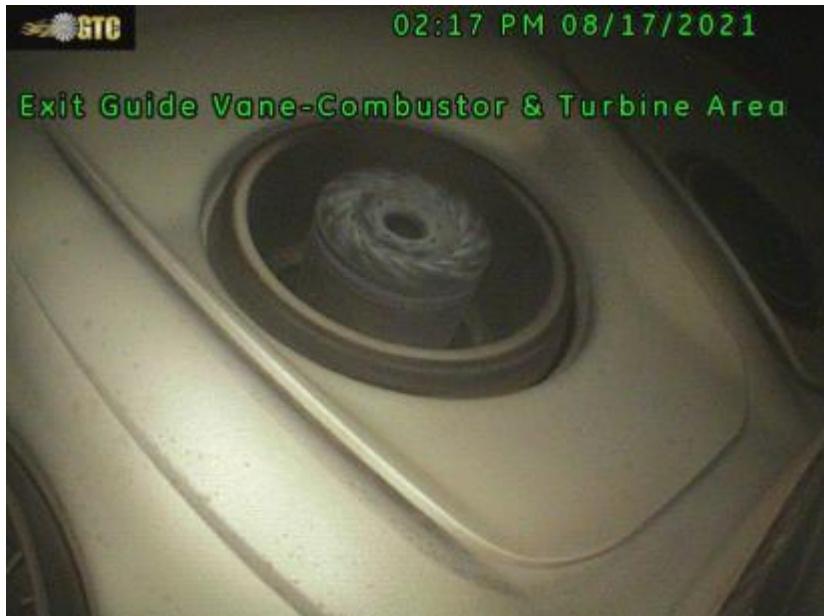
Injectors\_Comp\_Exit\_Comb\_Turb\_1st\_Stg041.JPG

| Inspect for Liners<br>Cracks, Thermal<br>Erosion, Hot Spots, Fuel<br>Main & Pilot Holes<br>Contamination or<br>Blockage & Swirlers<br>blockage or Cracks on<br>Fuel Injectors. | No Visible Signs of<br>Blockages.<br><br>Removed Injectors<br>#4, #8 & #11 to<br>access the<br>Combustion<br>Chamber Area<br>during Borescope<br>Inspection. |

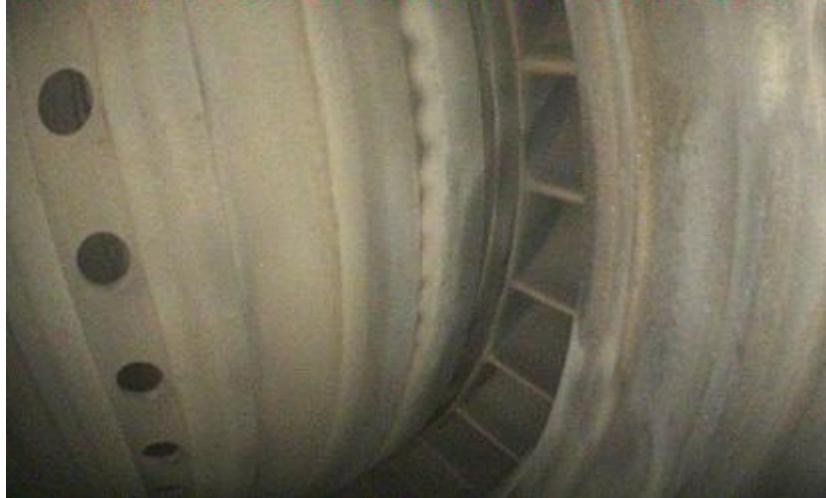
Injectors\_Comp\_Exit\_Comb\_Turb\_1st\_Stg062.JPG

| Inspect for Cracks (Trailing Edge, Leading Edge, Airfoil Surface & Vane Profile), Thermal Erosion, FOD, Excessive Tip Rub, Severe Dents & Corrosion. | No Visible Signs of Damage on First Stage Turbine Nozzle Assembly and Combustion Chamber Area. |

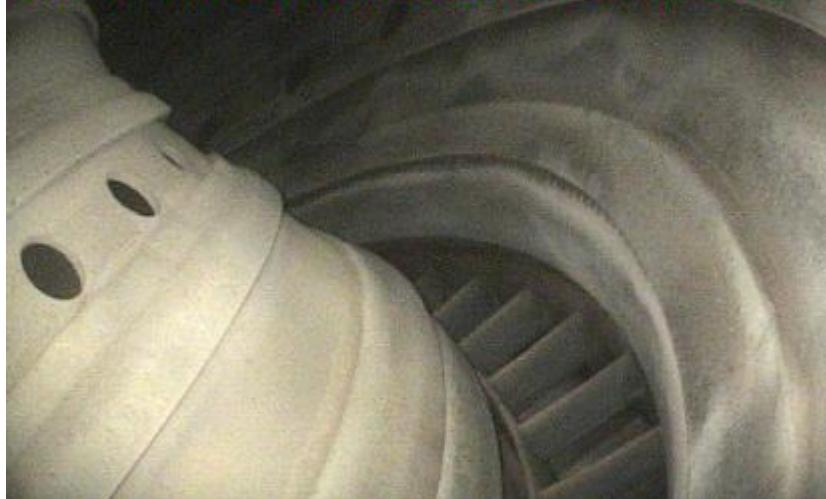
Injectors\_Comp\_Exit\_Comb\_Turb\_1st\_Stg063.JPG

| Inspect for Cracks (Trailing Edge, Leading Edge, Airfoil Surface & Vane Profile), Thermal Erosion, FOD, Excessive Tip Rub, Severe Dents & Corrosion. | No Visible Signs of Damage on First Stage Turbine Nozzle Assembly and Combustion Chamber Area. |

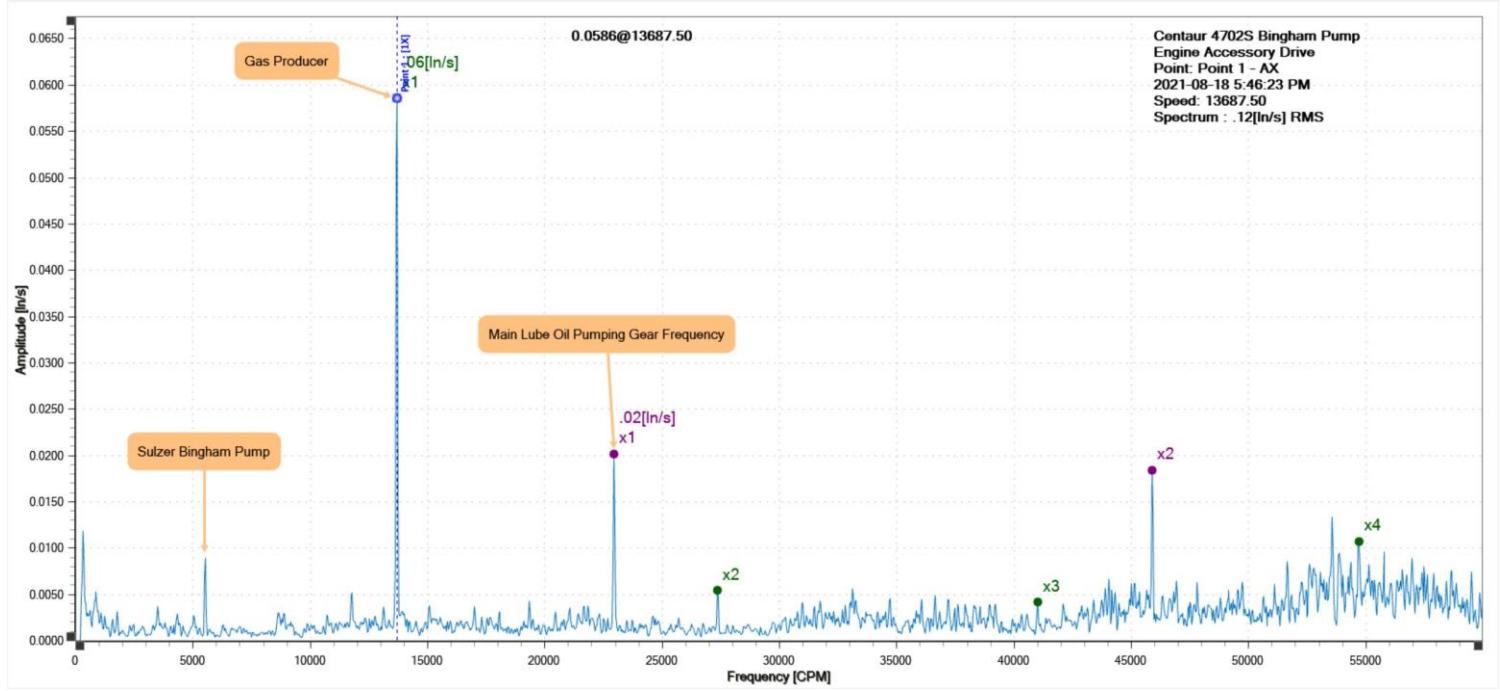
## 1 - ACCESSORY DRIVE, AD

| TURBINE P980 - Ngp = 91.15% & Npt = 90.90% | | | | |
|---|---|---|---|---|
| 1 - Accessory Drive, AD | 0.16 IPS | 0.6 IPS | 0.7 IPS | SLIGHTLY ROUGH |

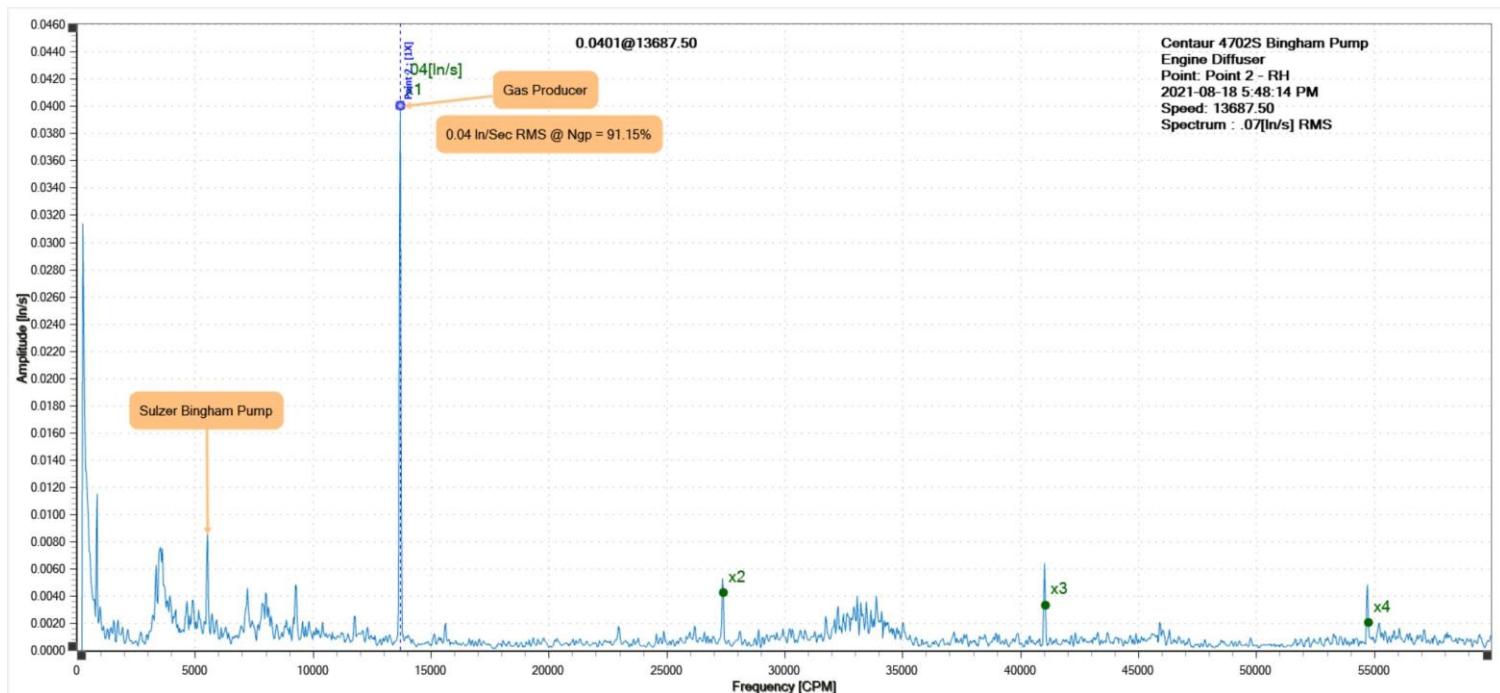
## 2 - ENGINE DIFFUSER, GP

| TURBINE P980 - Ngp = 91.15% & Npt = 90.90% | | | | |
|---|---|---|---|---|
| 2 - Engine Diffuser, GP | 0.09 IPS | 0.6 IPS | 0.7 IPS | FAIR |

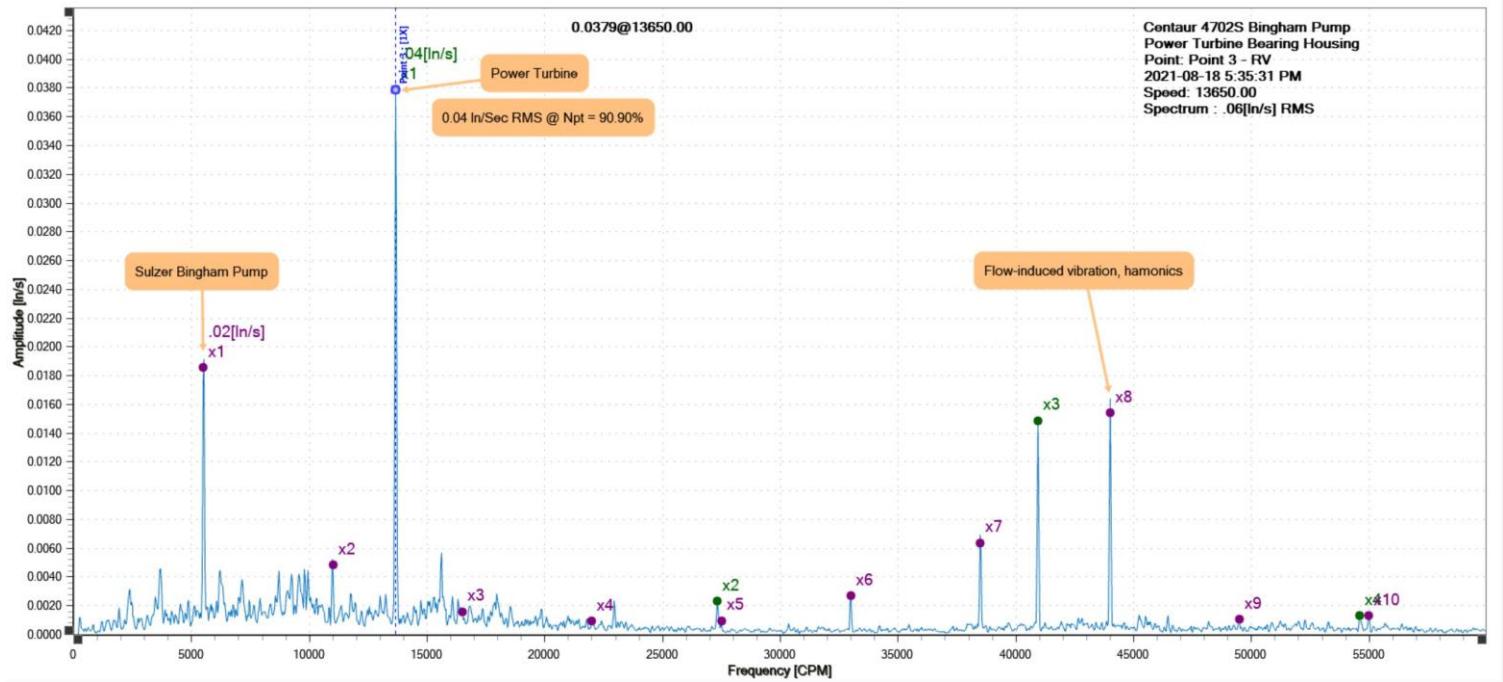
### 3 - POWER TURBINE BEARING HOUSING

| TURBINE P980 - Ngp = 91.15% & Npt = 90.90% | | | | |
|---|---|---|---|---|
| 3 - Power Turbine Brg Hsg | 0.08 IPS | 0.6 IPS | 0.7 IPS | FAIR |

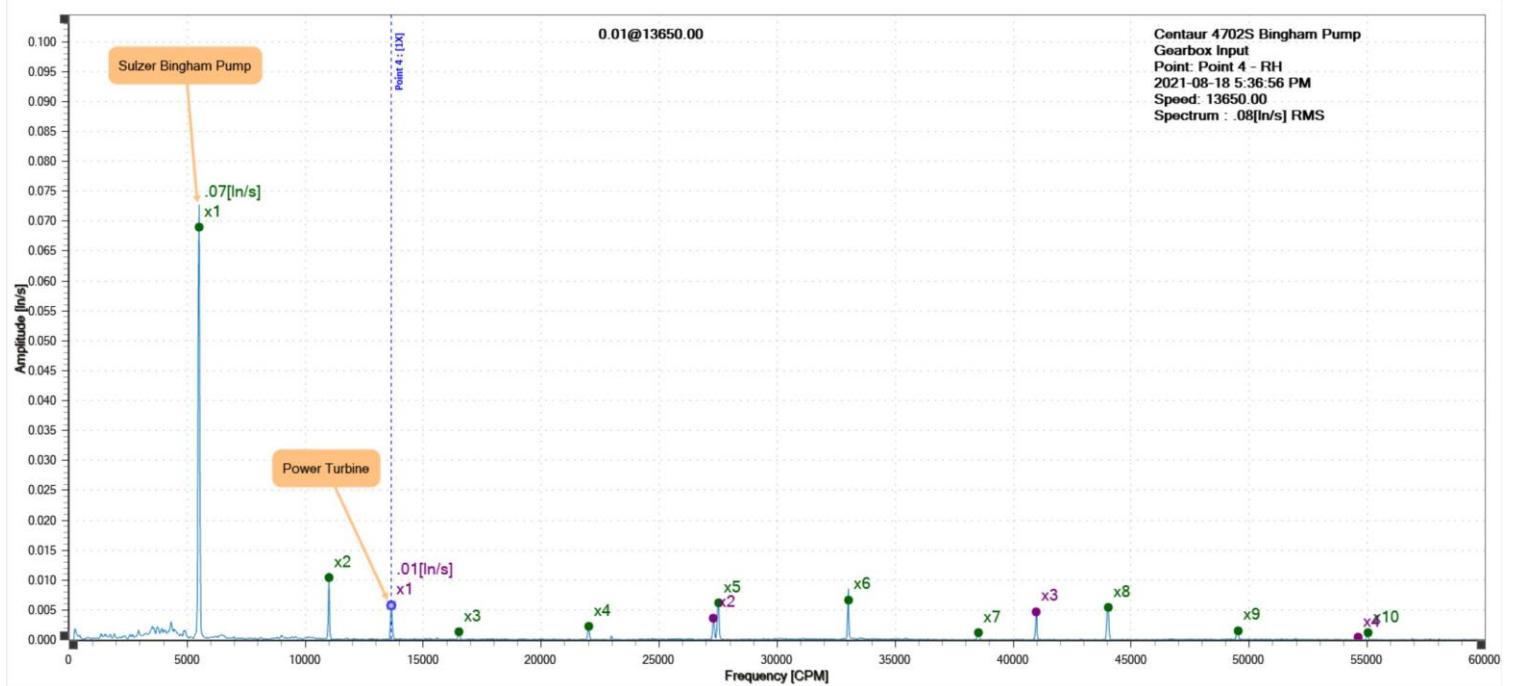
### 4 - GEARBOX INPUT

| TURBINE P980 - Ngp = 91.15% & Npt = 90.90% | | | | |
|---|---|---|---|---|
| 4 - Gearbox Input | 0.11 IPS | 0.6 IPS | 0.7 IPS | FAIR |

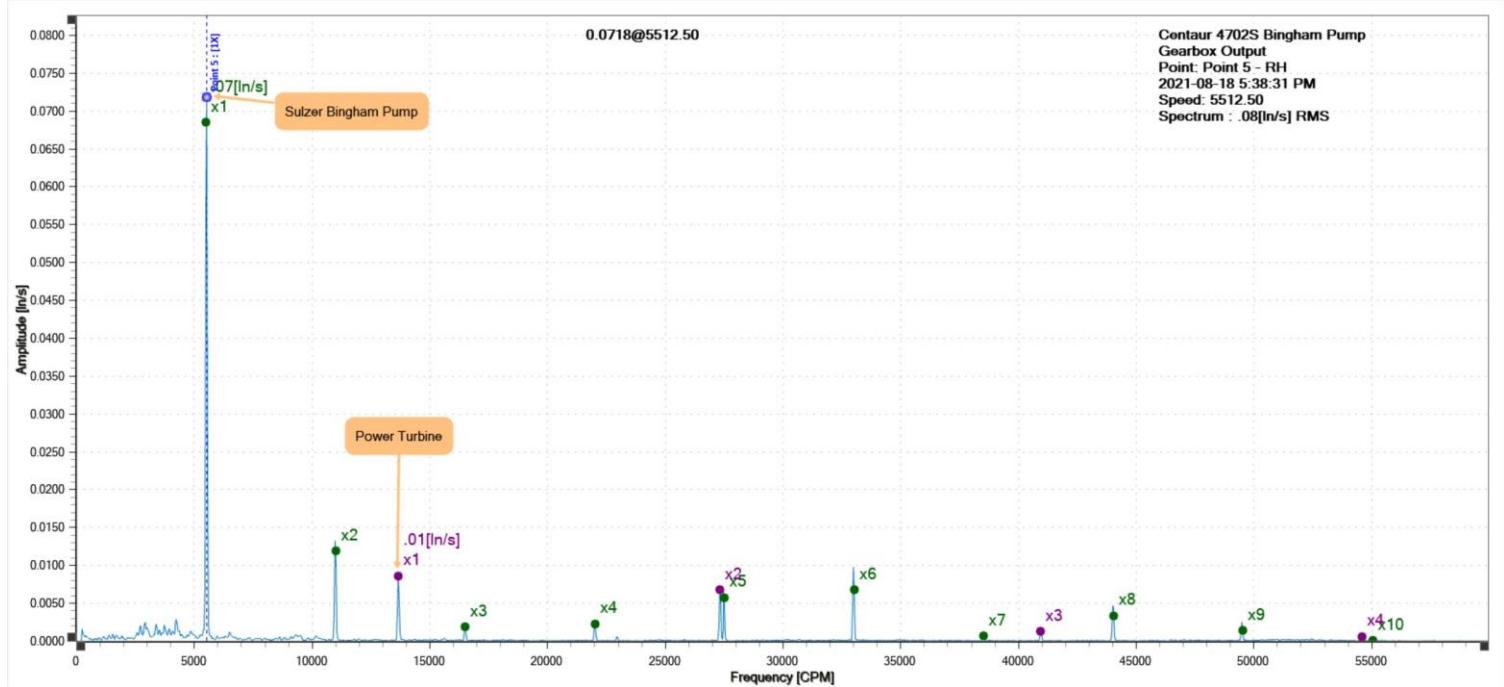
## 5 - GEARBOX OUTPUT

| TURBINE P980 - Ngp = 91.15% & Npt = 90.90% | | | | |
|---|---|---|---|---|
| 5 - Gearbox Output | 0.11 IPS | 0.6 IPS | 0.7 IPS | FAIR |

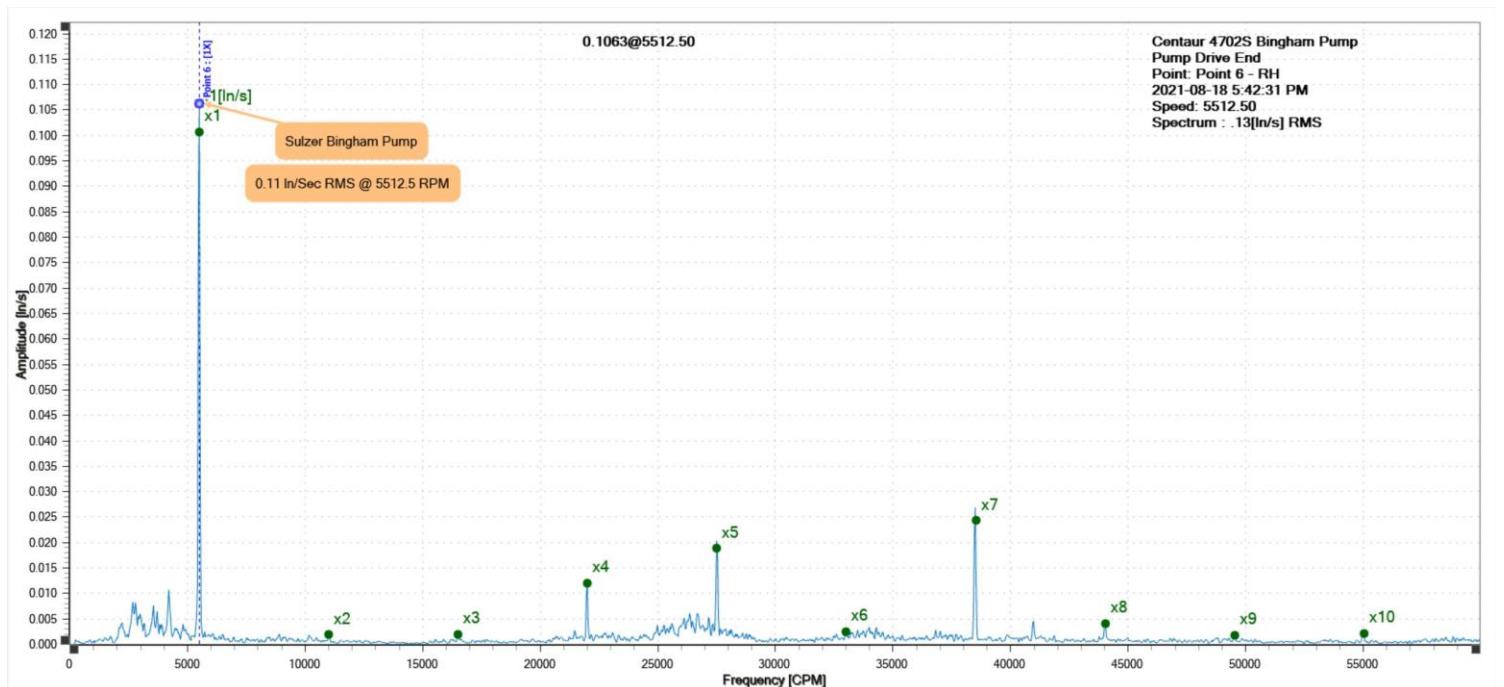
## 6 - PUMP DRIVE END

| TURBINE P980 - Ngp = 91.15% & Npt = 90.90% | | | | |
|---|---|---|---|---|
| 6 - Pump Drive End | 0.18 IPS | 0.6 IPS | 0.7 IPS | SLIGHTLY ROUGH |

Overall's vibration data are all within the OEM specifications. The high vibration malfunction occurring on the reduction gearbox output was superficial and addressed after resolving the engine's overall poor performance issue. The slight change on the pump drive end readings could result from the visible inboard pump seal damage and, as a result, leaking water on the entire skid.

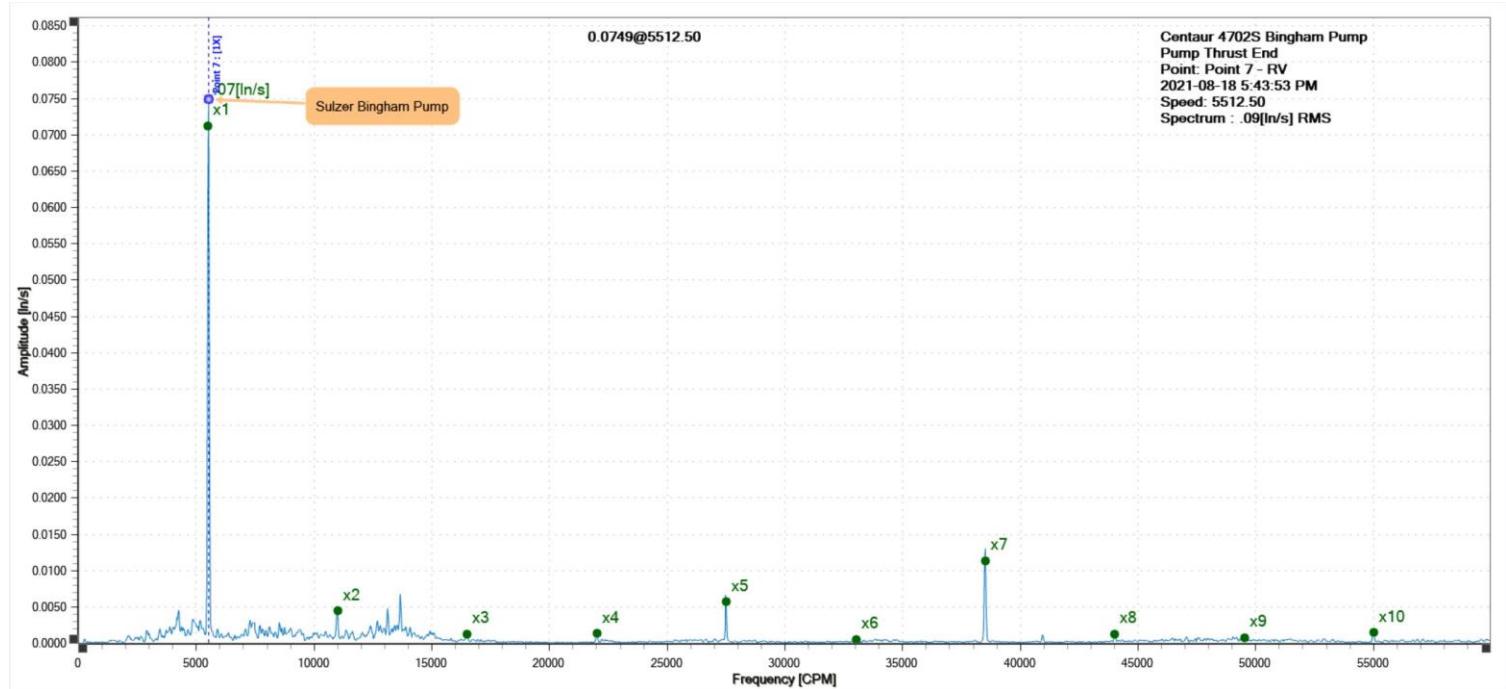
## 7 - PUMP THRUST END

| TURBINE P980 - Ngp = 91.15% & Npt = 90.90% | | | | |
|---|---|---|---|---|
| 7 - Pump Thrust End | 0.12 IPS | 0.6 IPS | 0.7 IPS | FAIR |
