Fueled Pump Package Inspection Report
Pump Model 59T-3 With 2.5” Plungers

Performed by
Rotating Right (2016) Inc.
10/21/2024

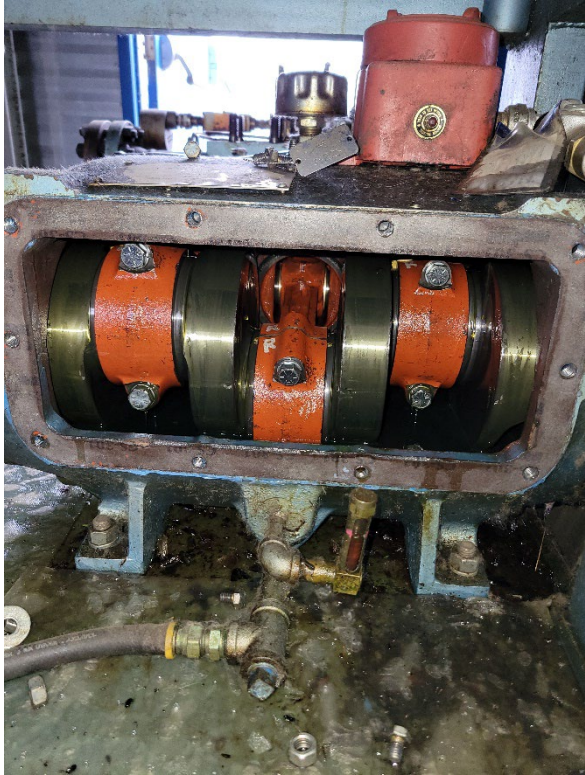
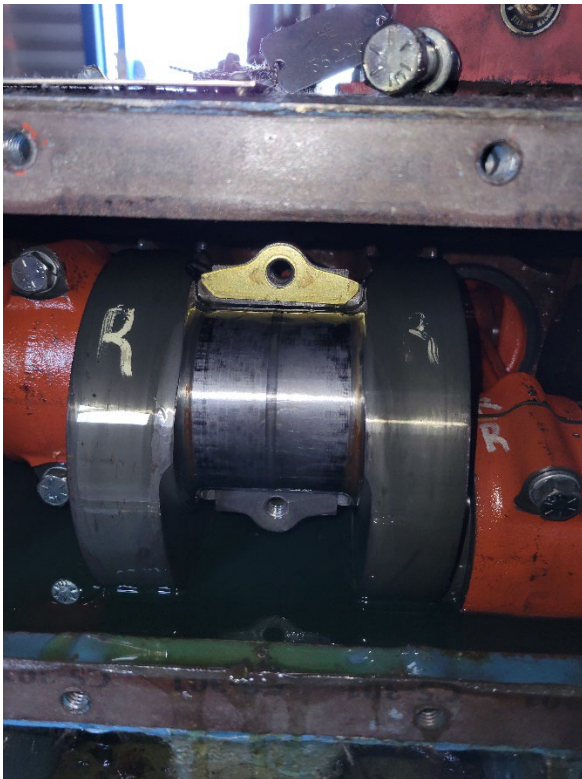
Power End

- 1.1 – Lube oil is clean
- 1.2 - Crankshaft condition is good
- 1.3 - End play is good
- 1.4 - Connrod bearings are good
