VESSEL INSPECTION SUMMARY

Report #: 137868-WG-13
 Inspect Date: 06/09/2009
 Page: 1 of 2
 IRISNDT #: 137868

Client: CNRL District: Medicine Hat Field: 07-32-012-13W4
 Facility: Grand Forks Unit: Oil Battery LSD: 07-32-012-13W4
 Jurisdiction #: A2698238 Equip Tag #: Serial #: P90-0038-A
 CRN #: K3252.2 Nat'l Bd #: Year Built: 1991
 Manufacturer: Process Industries Equipment Description: Free Water Knock Out (FWKO)
 Status: In Service Date Removed From Service: Service: Sour
 MAWP Shell 75 Psi @ 200 °F Height/Length: 432 in. Code Stamp: Y N
 MAWP Tube Psi @ °F Size/Diameter: 120 in. O.D. Insulated: Y N
 Support Type: Saddle RT: 2 Volume: ft³ / m³ PWHT: Y N
 C.A. 0.0625" Coated Y N Clad: Y N Manway: Y N

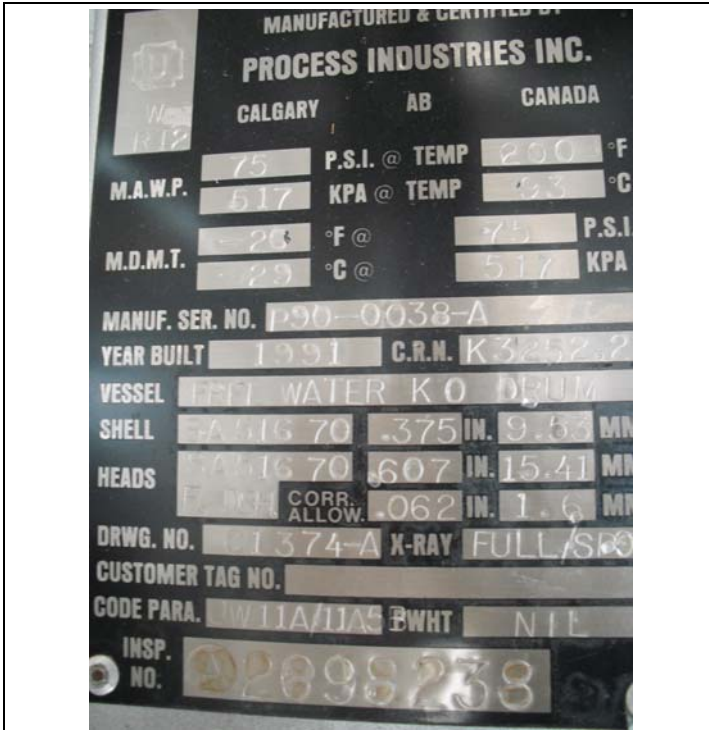
Grand Forks-FWKO_Nameplate

Name plate was intact and readable. PSV removed for servicing, no block valves between shell and PSV-vents to Pop Tank. This bellows PSV should have a 'plastic street elbow' (pointed down) inserted into the threaded opening in body to prevent rain/snow from entering and damaging the bellows.

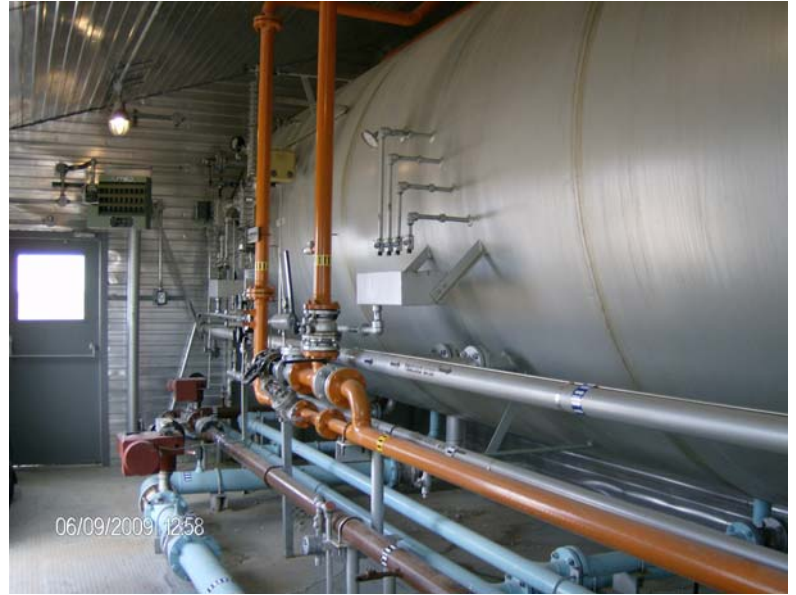
Grand Forks-FWKO_Inside Bldg.

The vessel was removed from service for cleaning and inspection. Associated flanges/bolting/gaskets/threads were intact and showed no evidence of deterioration, visible cracking or process leaks. All inside uninsulated piping found to be secure and in acceptable condition with no corrosion.

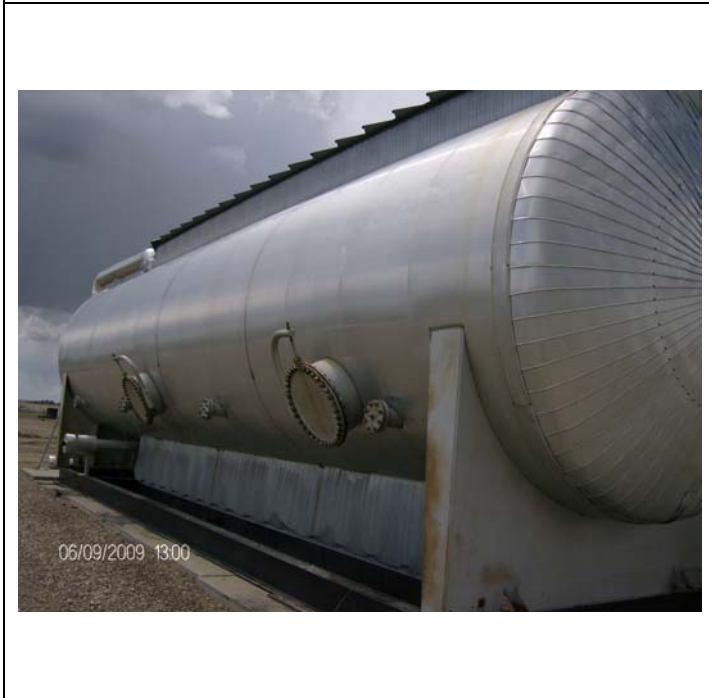
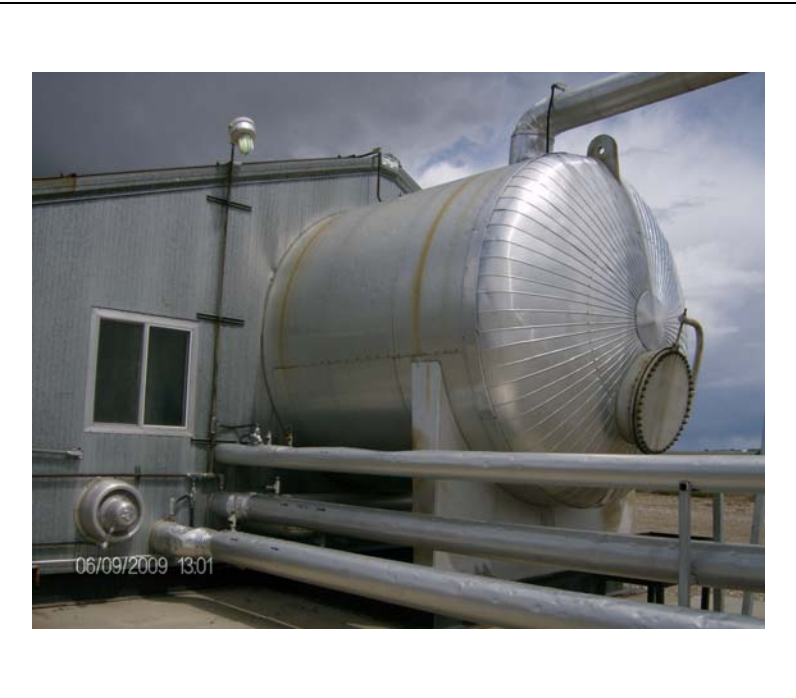
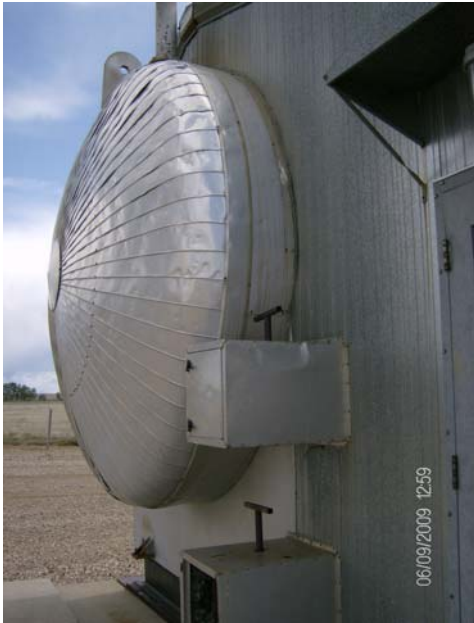
Grand Forks-FWKO_Outside Bldg.

The outside Insulated portion of vessel in good condition (some dimpling from hail-West end). On East side and North/West side of vessel, bldg. to cladding seal broken and open to atmosphere. Insulation cladding of outside piping in good condition, a few crushed areas noted on West side.

Install 'plastic street elbow' on PSV as per comments. Consider re-engineering need for bellows PSV in this application. Loosen off anchor bolts at sliding end (East). Repair broken off anode wire (East end). Re-seal cladding to bldg. seam at East end and North/West end of building. Replace depleted sections of anode strings. Continue to inspect vessel at regular scheduled interval.

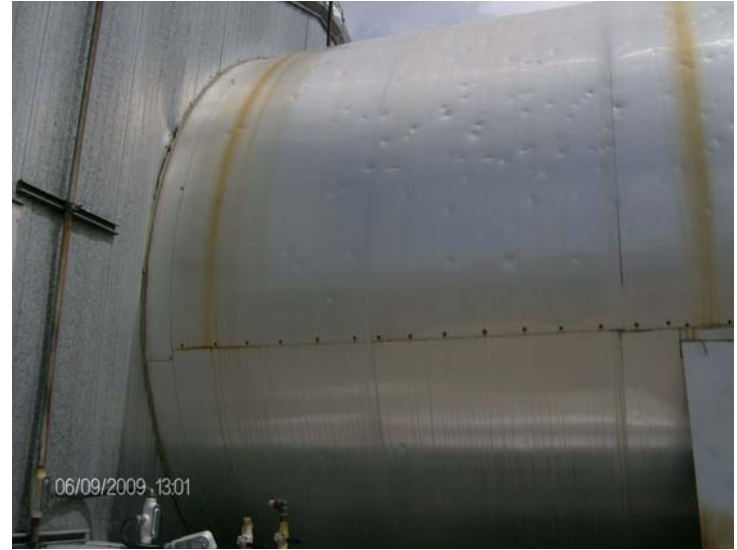
Grand Forks-FWKO_ Dimpled Insulation

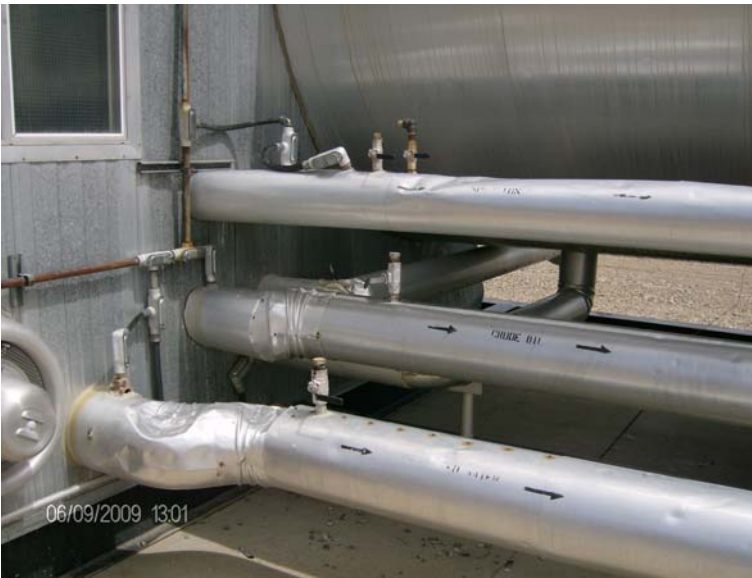
Grand Forks-FWKO_ Crushed Piping Cladding

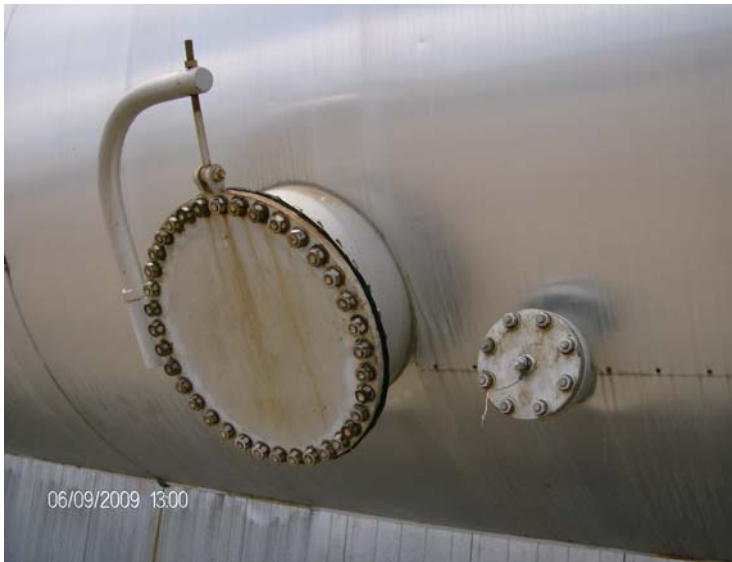
Anode wire broken off (East end). Vessel appears secure and level.

Grand Forks-FWKO_Broken Anode Wire

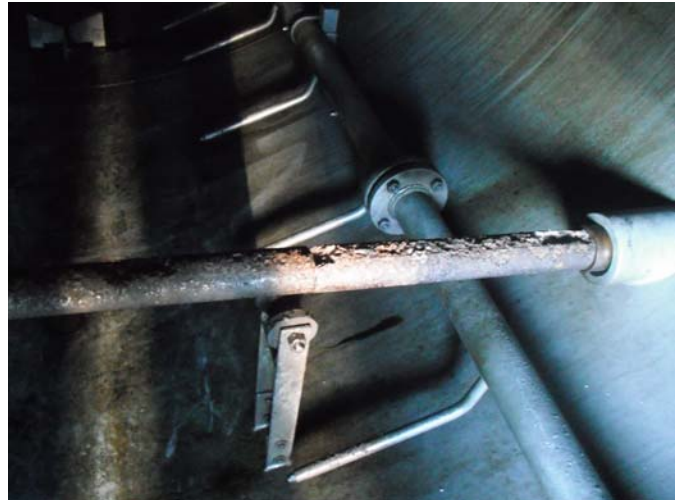
Grand Forks-FWKO_ Anode

Coating in good condition-no repairs required
Replace depleted sections of anode strings-operations was notified
Good condition-no other concerns
