Client >	FUELLED	A# >	243000	Head Mat. >	SA-516-70	OD >	36"
Report# >	4830-2	Ser. # >	8723-102	Head Th. >	1.316"	Year >	1987
Work Order# >	-	CRN# >	H1399.2	Shell Mat. >	SA-516-70	PWHT >	YES
Equipment >	HORIZONTAL SEPARATOR	MAWP >	1300 PSI	Shell Th. >	1.375"	RT >	RT-1
Manufacturer >	ENERFLEX	Temp >	300 F	Cor. Allow. >	.0620"	Cap. >	-

VESSEL EXTERIOR

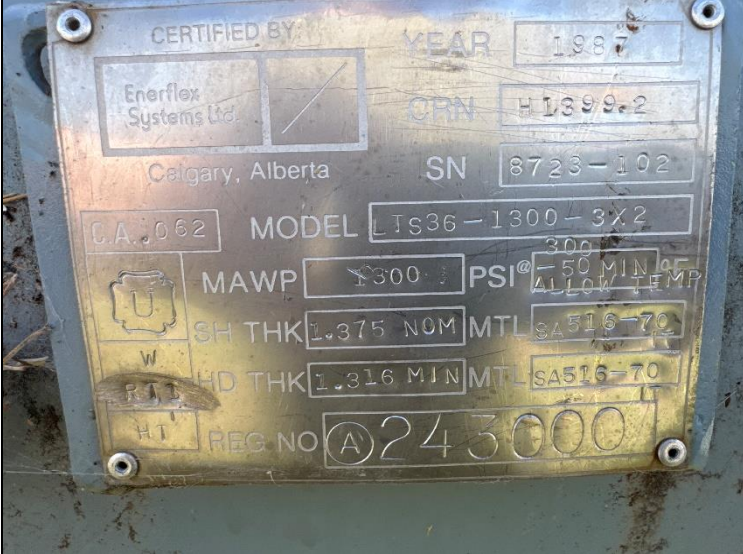
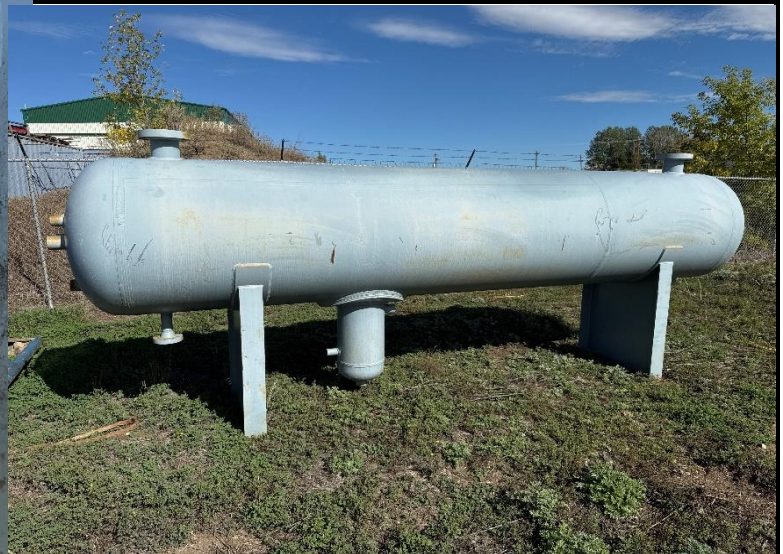
Component	Condition	Comments
Shell	Good	Some random corrosion throughout the vessel prior to latest paint coating. Minor. Deepest - 1/64"
Heads	Good	
Coating	Good	A few random areas had the paint rubbed off. Minor
Insulation	N/A	
Manway	N/A	
Nozzles	Good
