**Magnetic Particle
Inspection Report**

02-02-69-03w5m Comp #2_MT_sep2023

Client: Cardinal Energy	Facility: South Mitsue Plant	Date: Sept 21, 2023
LSD: 02-02-69-03w5m	Item(s) Inspected: All Compressor #2 Scrubbers & Bottles	Job #: 4880
Material: Carbon Steel	Thickness: various	WO #: N/A
Ref. Code: Client Request	Surface Preparation: Painted/Brushed	Surf. Temp: 15°C
Procedure: MT-01 Rev. 8	MT Technique: 5.2 Wet Visible	
MPI Equipment: AC Yoke	Asset#: HY-17	Daily 10 lb Lifting Power Verification Completed
Particle Type: 5.2	MFR: Magnaflux	Name: 7HF & WCP-2
Light Source: White Light	Light Intensity Verified to >1000Lx

Job Scope: To complete black and white wet visible magnetic particle inspection (MPI) on all suction scrubbers, suction bottles & discharge bottles in compressor #2 at 02-02-69-03w5m (South Mitsue Plant). The following welds were inspected as accessible:

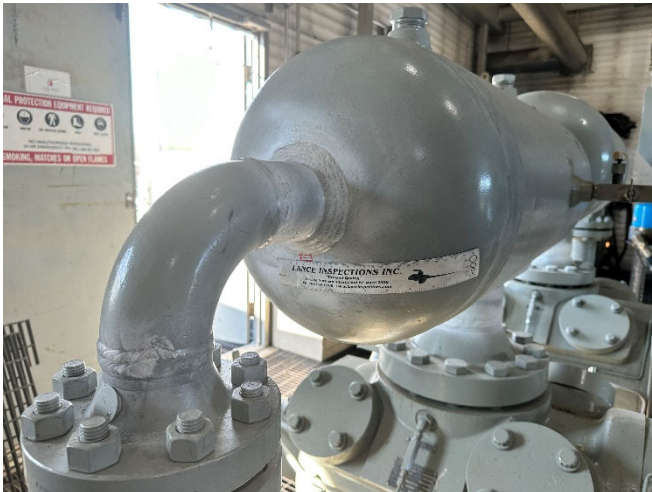
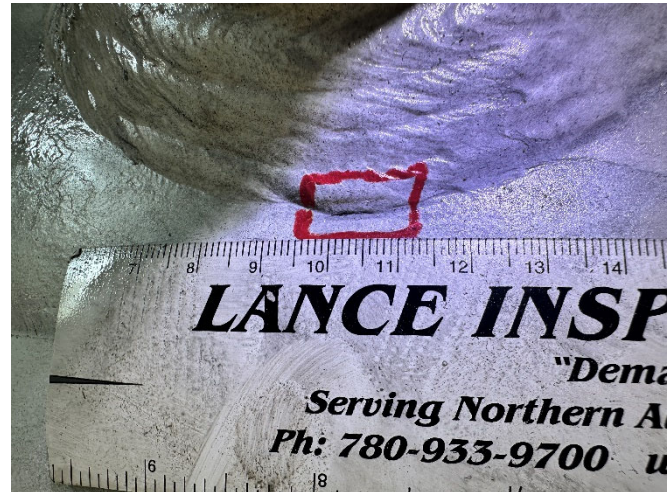
Results: All welds were inspected visually prior to MPI. There were no defects found during the visual inspection. All welds mentioned above were wire brushed or inspected over existing vessel paint. There was one crack measuring 6mm long on the bottom of the inlet nozzle to shell weld on the 3rd stage suction bottle (A#514714). This crack was blended out with a 120 grit sanding disk while on site and passed re-inspection. There were no further cracking or linear indications detected with MPI. All welds are considered acceptable to the reference code regarding MPI.

3rd Stage Suction Bottle (A#514714) Crack - Approx 6mm long, located on bottom of inlet nozzle to shell weld:

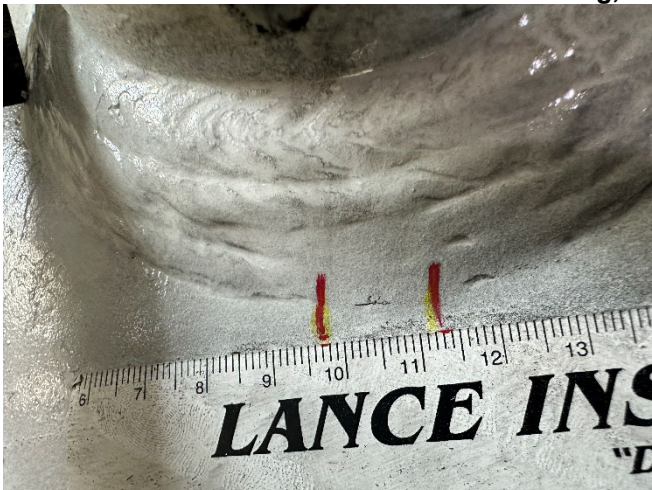
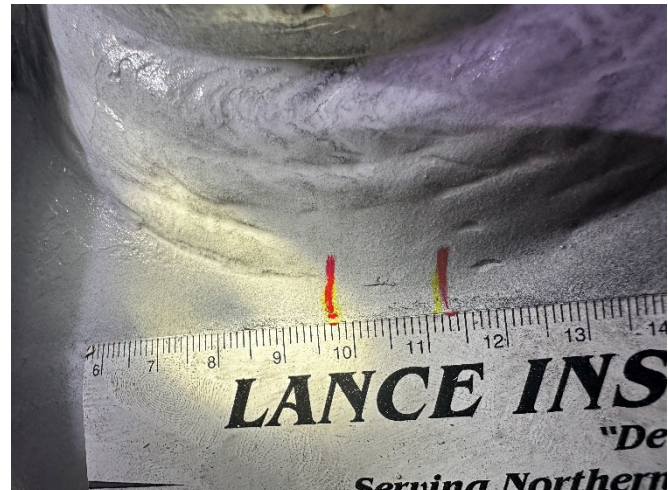
After filing, indication remained:

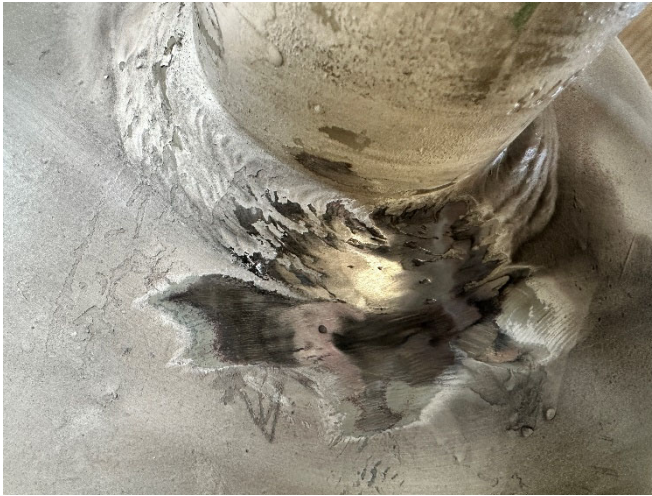
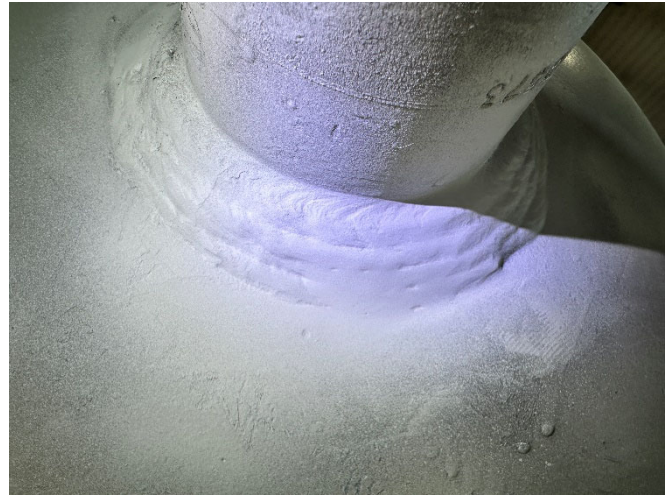
After excavation:

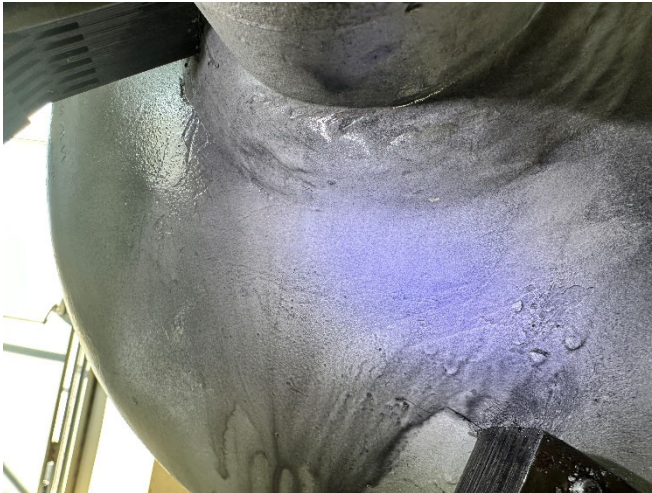
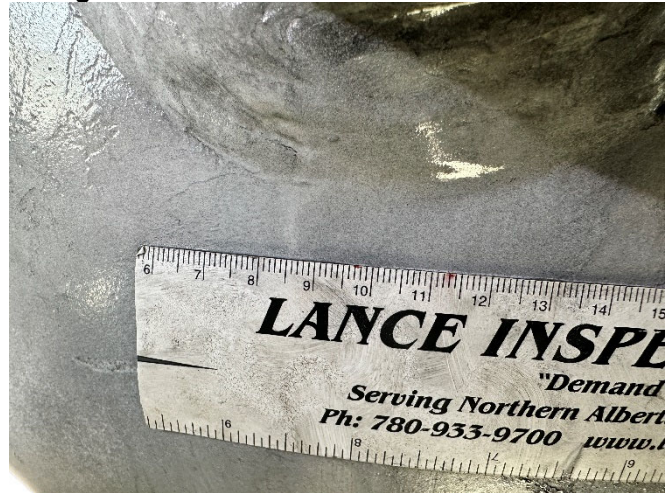
No indication remaining on final MT:
